**THE BUREAU OF OCEAN ENERGY MANAGEMENT,  
REGULATION AND ENFORCEMENT**

**REPORT REGARDING THE CAUSES OF THE APRIL 20, 2010  
MACONDO WELL BLOWOUT**

**September 14, 2011**

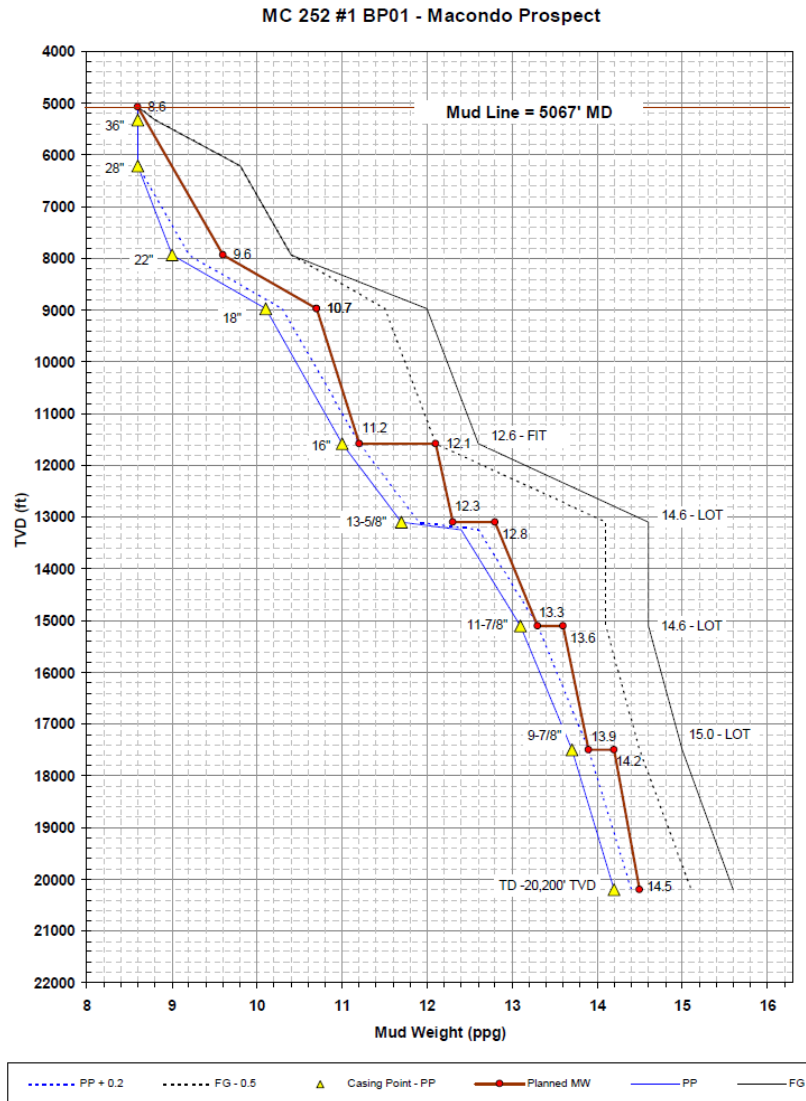
Figure 1 – Macondo Well Pore Pressure Fracture Gradient Plot<sup>65</sup>

The final estimated Macondo well pore pressure, mud weight, and fracture gradient plot submitted to MMS on March 26 is shown at Figure 1. The vertical axis of Figure 1 shows the depth of the well. The horizontal axis shows the mud weight. The red line depicts BP’s planned mud weight, which was designed to be between the kick margin and the swab margin identified in Figure 1.

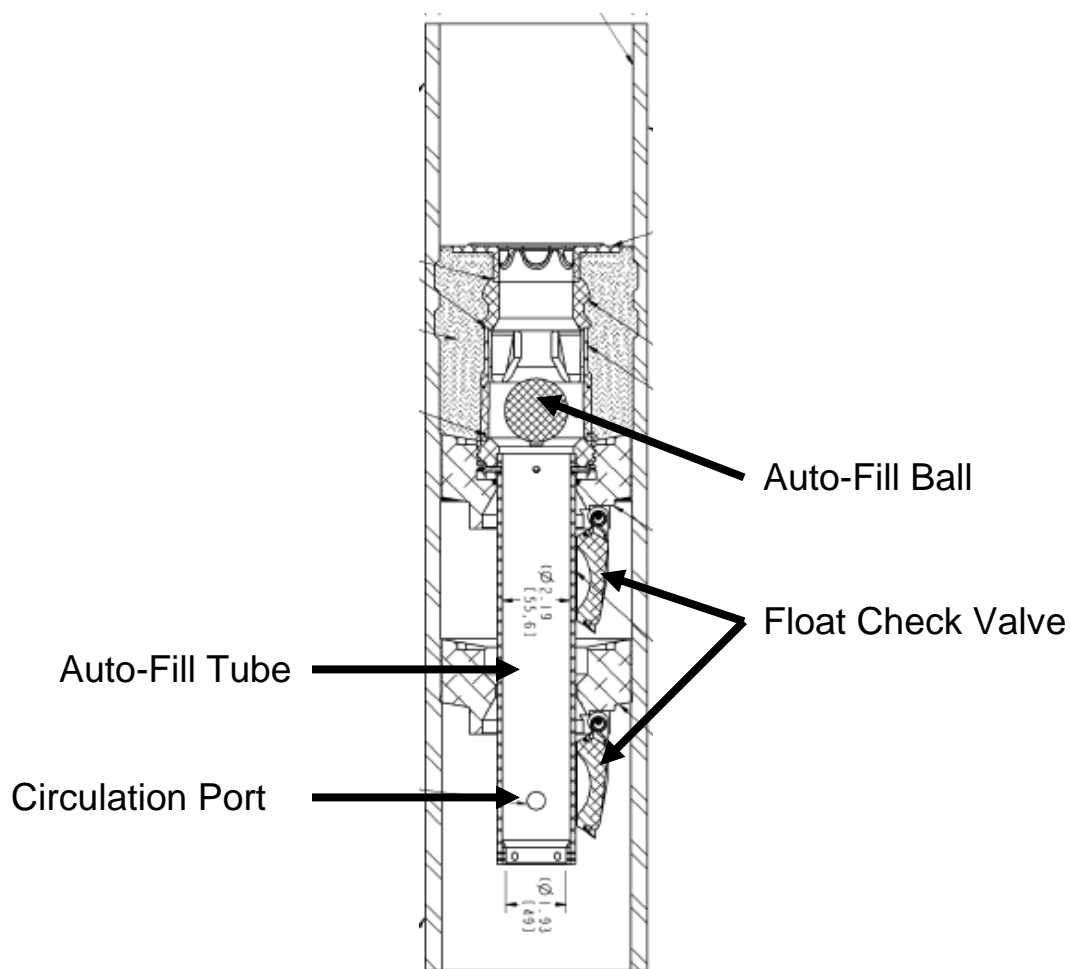
Figure 4 – Float Collar Utilized in the Macondo Well

As discussed above, the float collar was set at 18,115 feet measured depth, within the primary hydrocarbon reservoir sands (see Figure 2, above). Typically, an operator sets the float collar below the primary hydrocarbon sands to allow for perforation of the pay zone without the need to drill out the float equipment to get below the pay zone during the completion of the well. In addition, the lower primary sand was less than 100 feet from the bottom of the production casing shoe.<sup>116</sup> Normally, an operator would set the production casing shoe 200 to 300 feet below the primary sand to improve the chances of proper isolation of the pay sand.

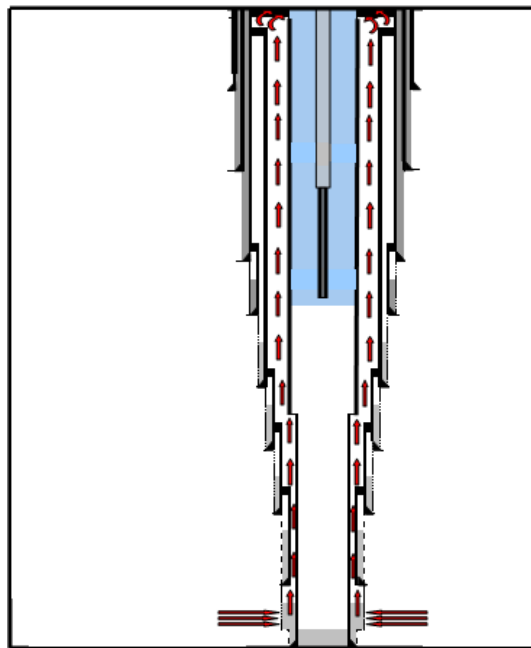
Figure 6 – Flow Up the Annulus and Through the Seal Assembly

Under this scenario, hydrocarbons would have flowed from the reservoir up the backside of the tapered casing string, and through the seal assembly into the riser. If this had occurred, the nitrified annular cement intended to isolate the hydrocarbon zone(s) at the production interval would have failed, the casing would have lifted or floated, and the seal assembly would have failed in conjunction with the casing lifting. This potential flow path is illustrated in Figure 6, below.

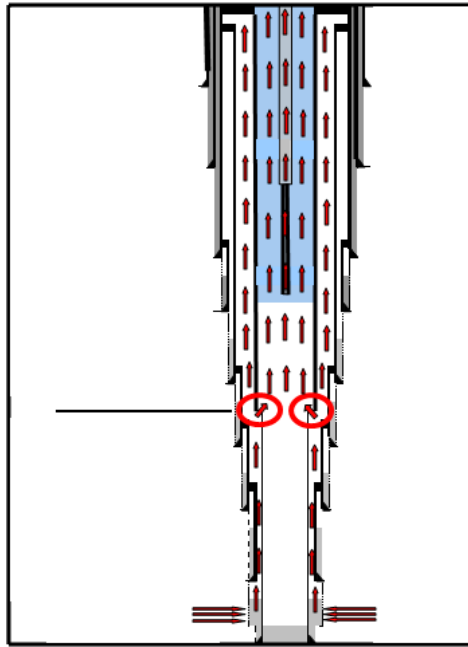
Figure 7 – Flow Up the Annulus and Through Production Casing Crossover Joint

After cementing the production casing, the *Deepwater Horizon* crew conducted a successful 2,500 psi positive casing test against the top wiper plug.<sup>159</sup> Although this pressure test (250 psi low/2,500 psi high) did not confirm a seal below the top wiper plug at the top of the float collar, it did provide evidence that the 9-7/8 x 7 inch production casing and related components that comprise this string above the top wiper plug were most likely leak-free.

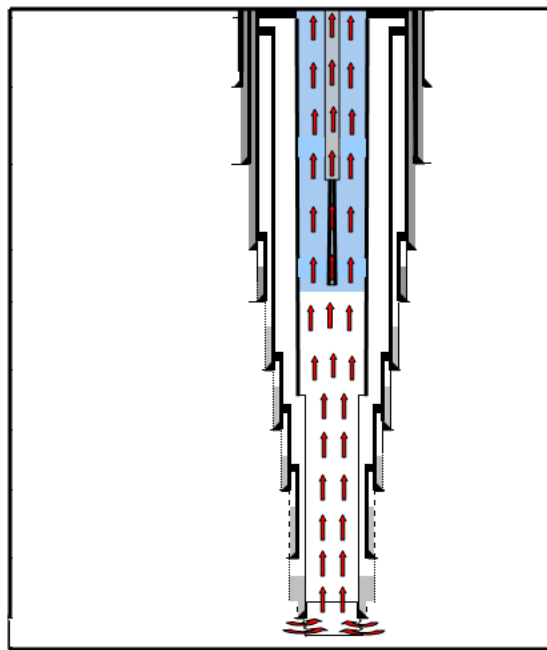
Figure 8 – Flow up the Production Casing Shoe Track

Under this scenario, hydrocarbons would have flowed from the reservoir through the casing shoe, into the well and up the riser to the rig. For this flow path to have occurred, the shoe track cement would have failed. A number of factors could have caused the shoe track cement to fail. First, mud in the wellbore could have contaminated the shoe track cement and caused the cement not to set properly. Second, the shoe track cement might have swapped out with the lighter drilling fluid in the rat hole. Third, some of the shoe track cement could have been lost into the formation. Finally, the failure of the shoe track could have resulted from a combination of these factors. This scenario is represented in Figure 8 below.

The approximately 189 foot bottom section of the casing in the well, called the shoe track, consisted of sections of casing with a reamer-guide shoe at the bottom and a dual flapper float collar on top. These sections of casing that make up the shoe track are meant to contain the top, or tail cement, which in the Macondo well was unfoamed cement.

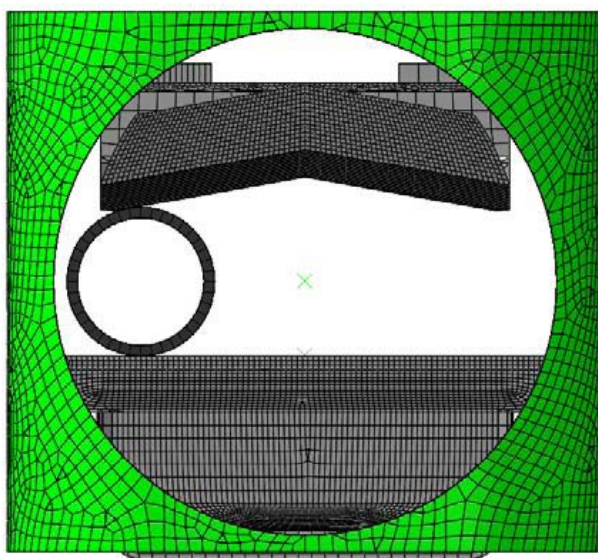
A forensic examination of the BOP stack revealed that elastic buckling of the drill pipe had forced the drill pipe up against the side of the wellbore and outside the cutting surface of the BSR blades. As a result, the BSR did not completely shear the drill pipe and did not seal the well. The buckling of the drill pipe, which likely occurred at or near the time when control of the well was lost, was caused by the force of the hydrocarbons blowing out of the well; by the weight of the 5,000 feet of drill pipe located in the riser above the BOP forcing the drill pipe down into the BOP stack; or by a combination of both. As a result of the failure of the BSR to completely cut the drill pipe and seal the well, hydrocarbons continued to flow after the blowout.

Figure 12 – Off-center drill pipe (Source: DNV)
