California Coastal Erosion and Storm Damage During the Winter of 1982-83

A Reconnaissance Report

Committee on Natural Disasters

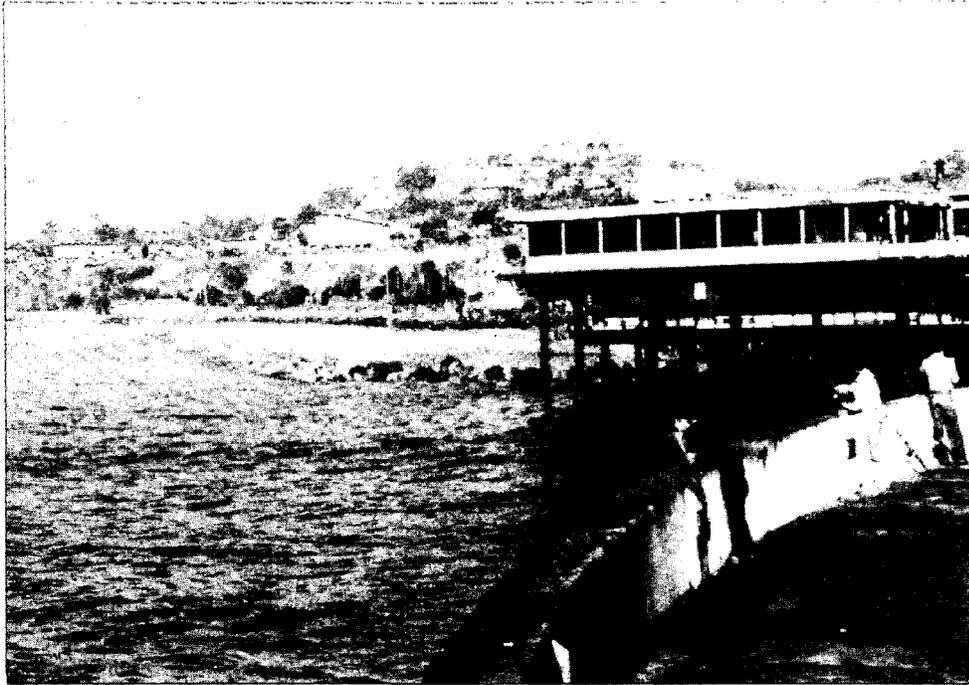
The condition of this revetment during the study team's visit is shown in Figure 9. The storms of 1982-83 removed a considerable amount of sand from behind the breakwater, "stranding" the revetment. It also appears, although it is not certain, that the larger revetment units settled substantially.

FIGURE 9 Revetment adjacent to the Santa Barbara Yacht Clubhouse at the base of the Santa Barbara breakwater. Note the complete loss of sand from behind the revetment.

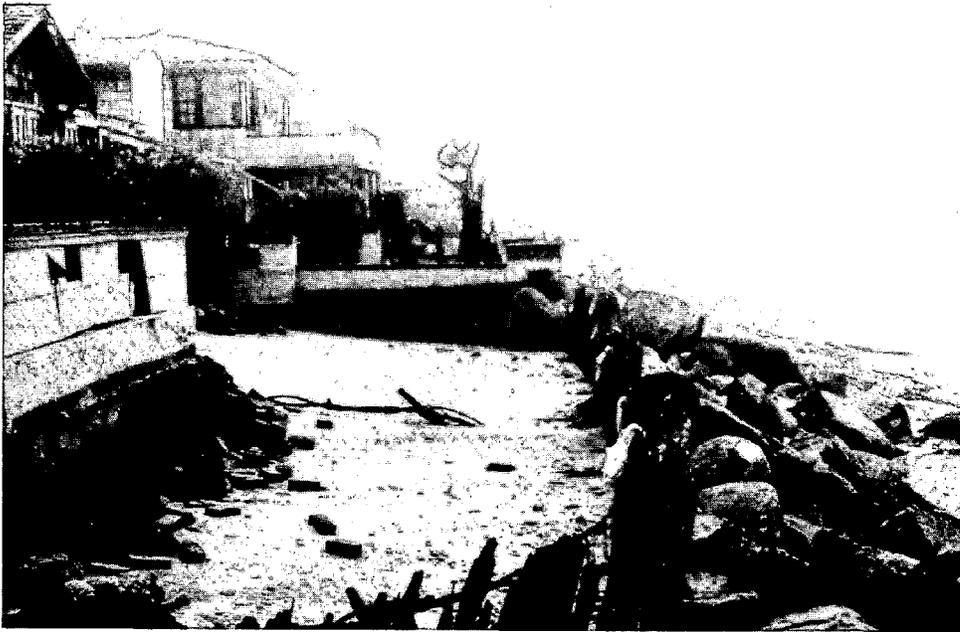
The revetment rock appeared to the study team to be in relatively good condition. However, the Longard tube had been ruptured and contained little sand (see Figures 10 and 11). Moreover, although the revetment had not failed structurally, it had been severely overtopped. The structures behind the revetment had suffered damage from overtopping water and flying debris.

FIGURE 10 A view of Delmar Beach showing the light ineffective seawall, revetment, and damaged Longard tube. Note the small Caterpillar in the background moving sand to the upper portions of the beach.

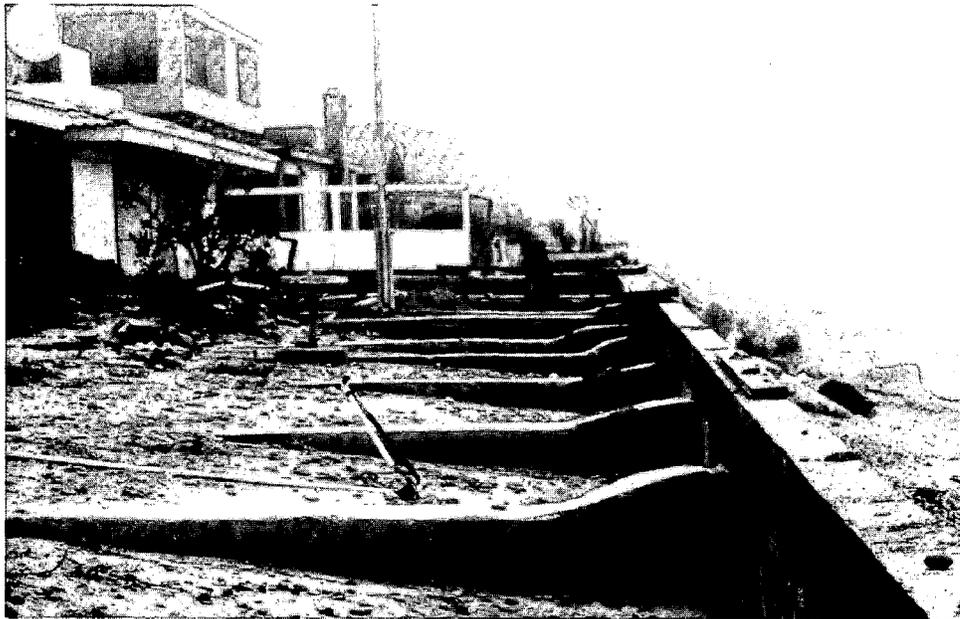
FIGURE 11 Delmar Beach showing the seawall with the damaged Longard tube in the background. Note the effect of the waves overtopping the seawall and causing erosion on the lee side.

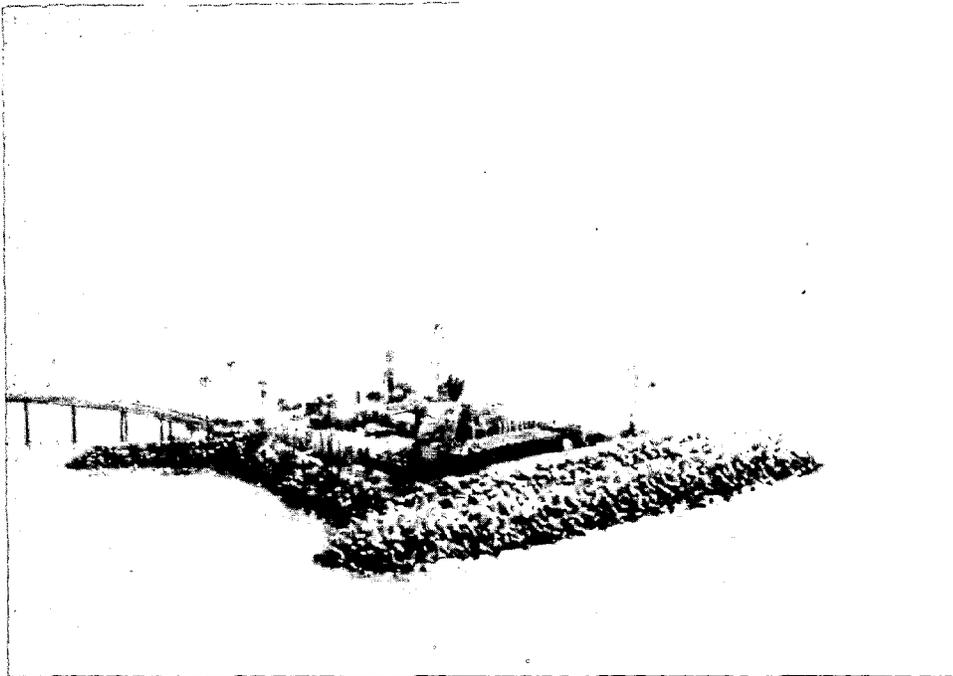
Rincon Island is located in water approximately 15 m deep and is armored by tribar units weighing 31 tons each on the seaward side. Construction of the island was completed in August 1958 (Blume and Keith, 1959). Figure 13 shows an aerial view of Rincon Island taken during the reconnaissance trip. No damage is evident.

FIGURE 13 Rincon Island showing no apparent damage.

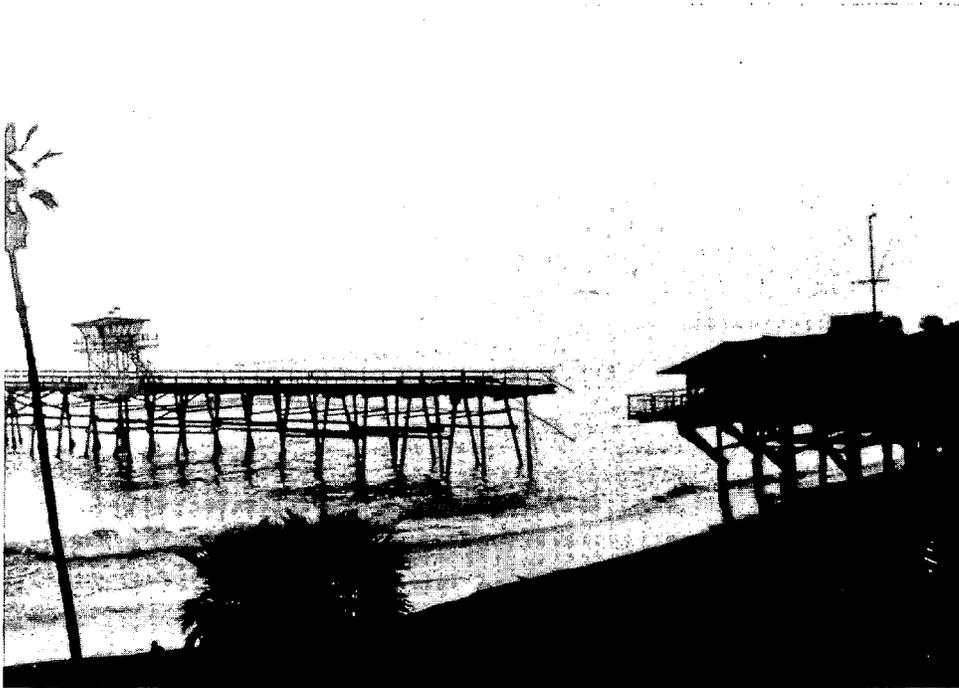
FIGURE 14 Nearshore section of the San Clemente Pier removed by storm.

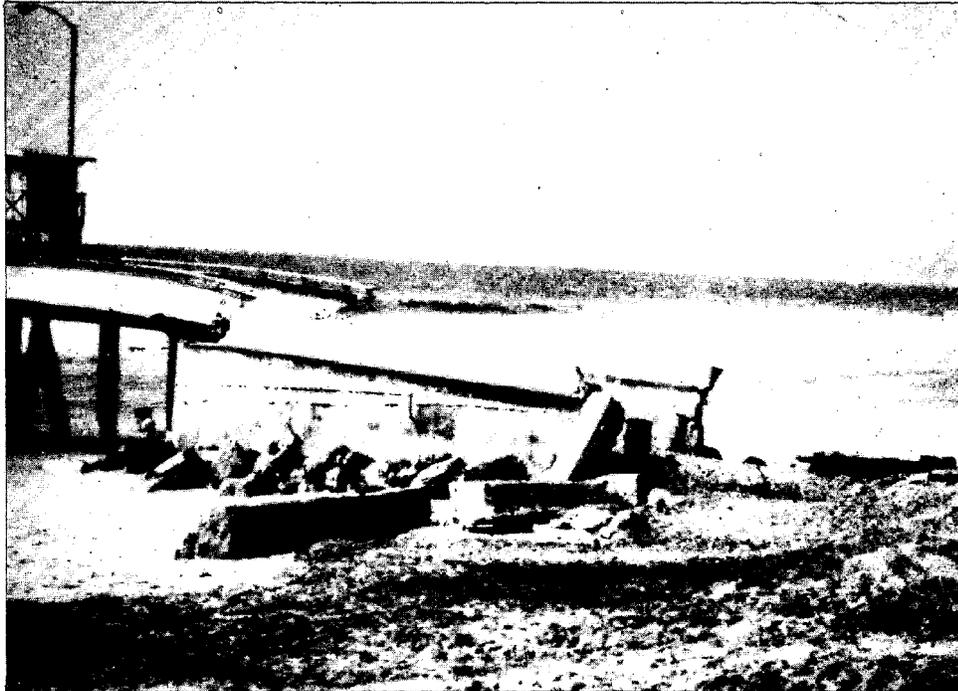
As shown in Figure 15, the nearshore section of Venice Pier was damaged. Some of the park's other facilities also experienced damage.

This failure underscores the importance of taking into account the potential depth of wave erosion when designing the foundations of coastal installations. To illustrate this point, Figure 16 shows a small building housing restrooms and changing rooms adjacent to the Venice Pier. This structure escaped destruction because it was founded on piles, even though spread footings would have been enough to carry the foundation's loads.

FIGURE 15 The Venice Pier was damaged due to undermining and settlement of the approach ramp.

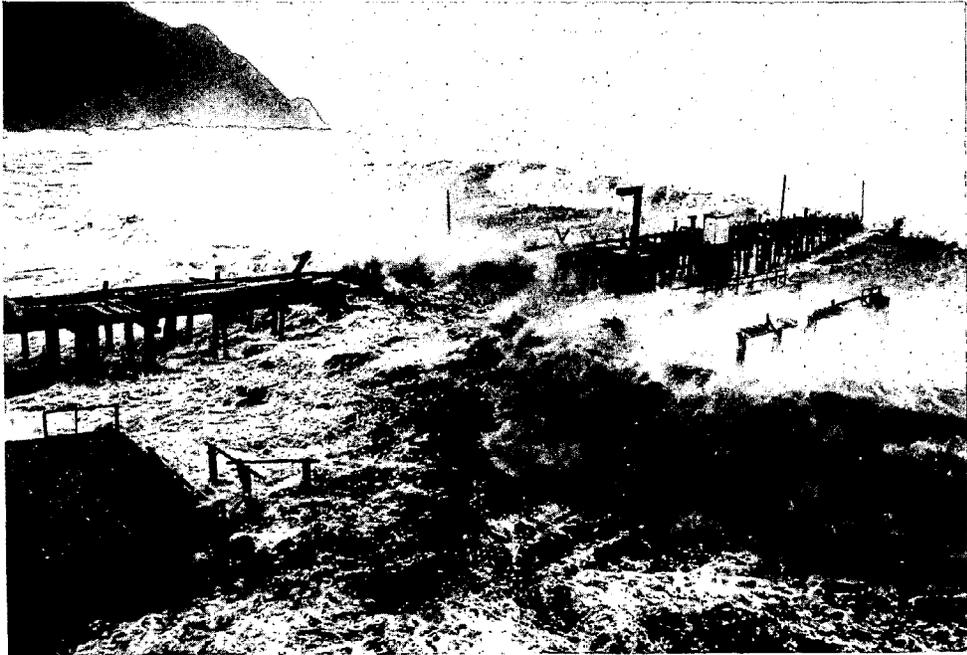
FIGURE 18A Arena Cove on January 26, 1983. The first very large wave is just hitting the top of the pier. Photograph copyright © Nicholas King.

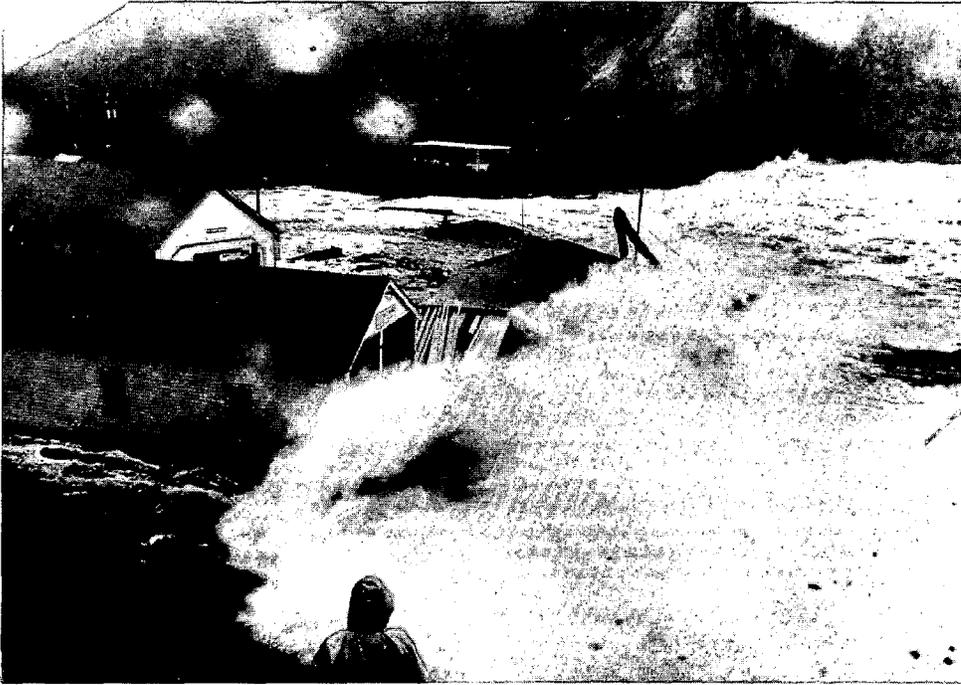
FIGURE 18C The boathouse and fishhouse being attacked by waves. Photograph copyright © Nicholas King.

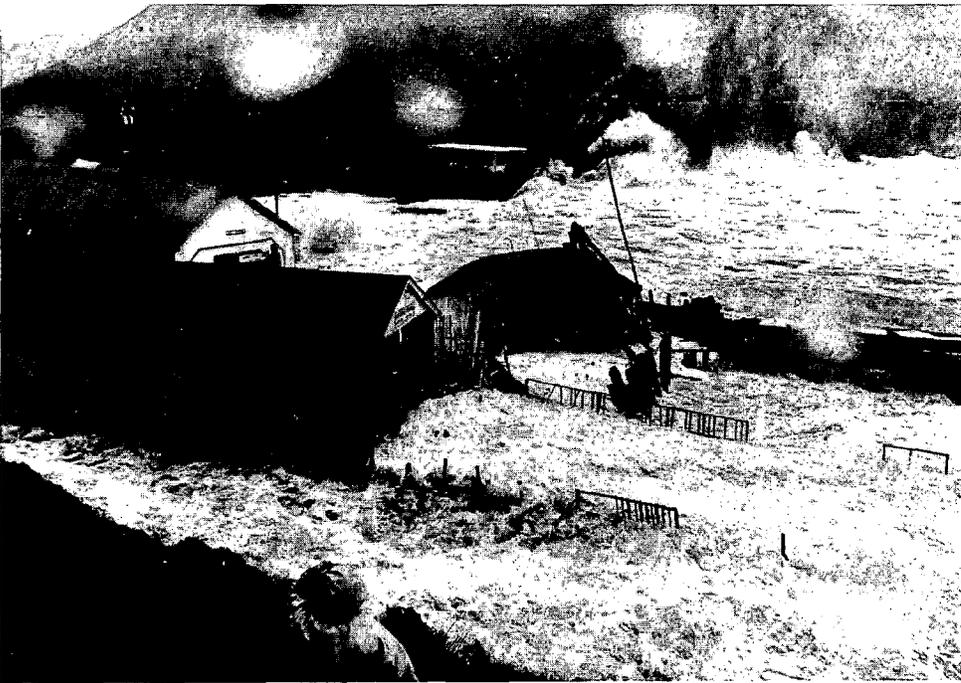
FIGURE 18D The boathouse and fishhouse being attacked by waves. Photograph copyright © Nicholas King.

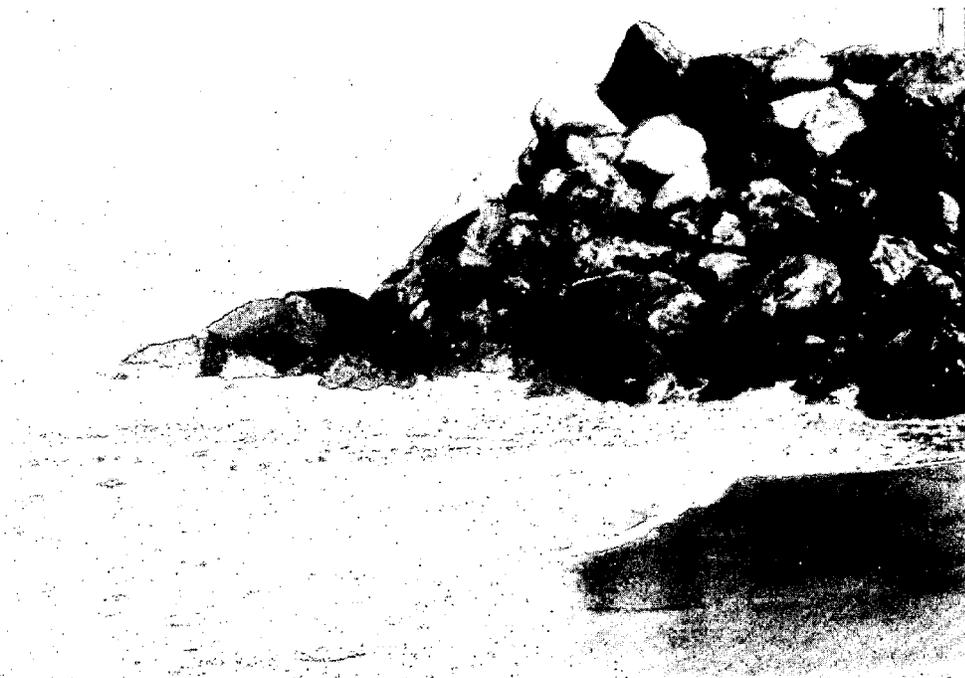
FIGURE 26 Closeup of revetment shown in Figure 25.

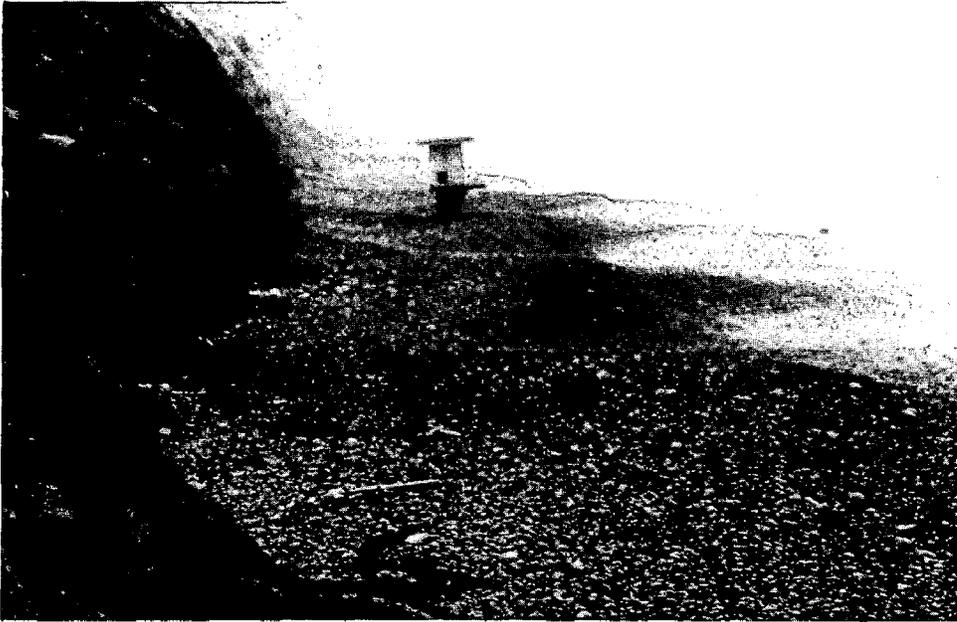
FIGURE 27 Torrey Pines Beach. Note the cobble berm and steep cusp formations.

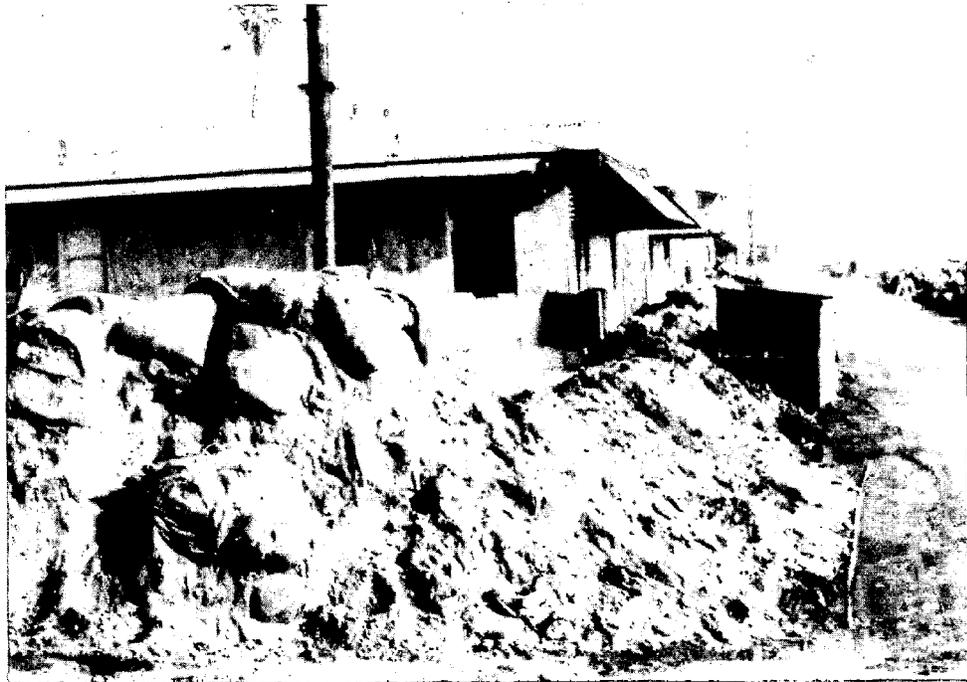
FIGURE 30 Oceanside Beach showing efforts to protect oceanfront cottages against water and debris damage.

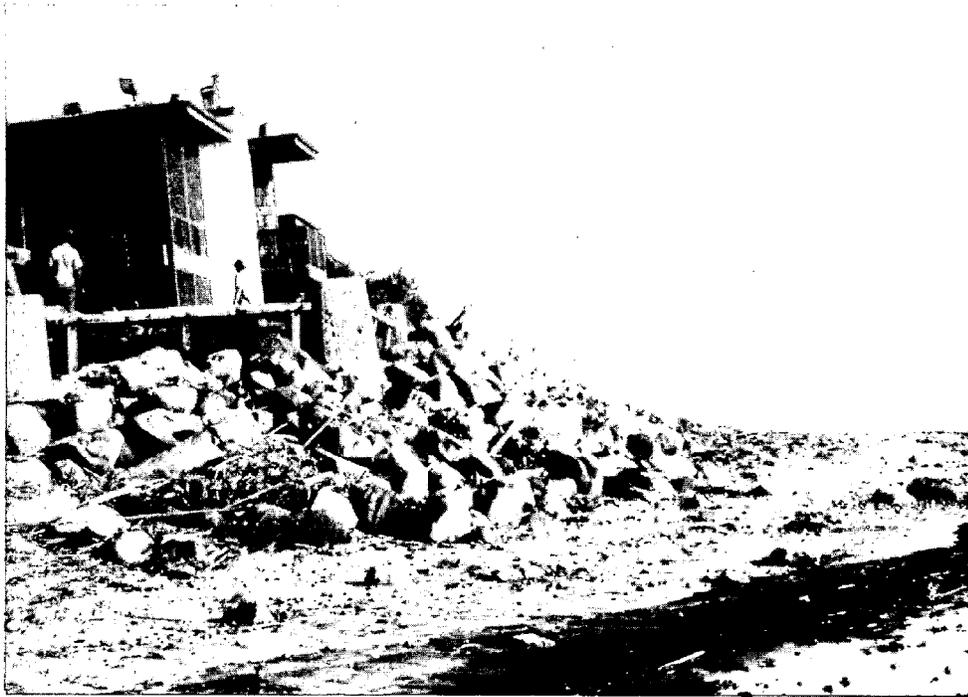
FIGURE 31 Oceanside Beach just south of the mouth of the San Luis Rey River. Heavy revetment and wooden splash guards can be seen. Oceanside Pier is in the background.

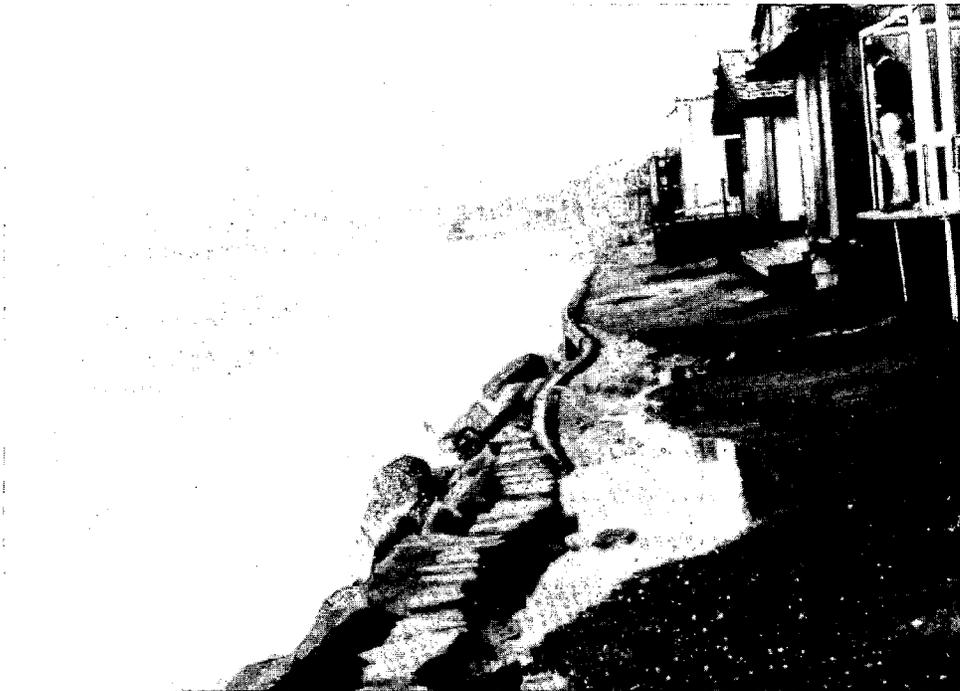
FIGURE 33 Capistrano Shores. A light timber seawall is fronting the trailer park. Note the evidence of overtopping.

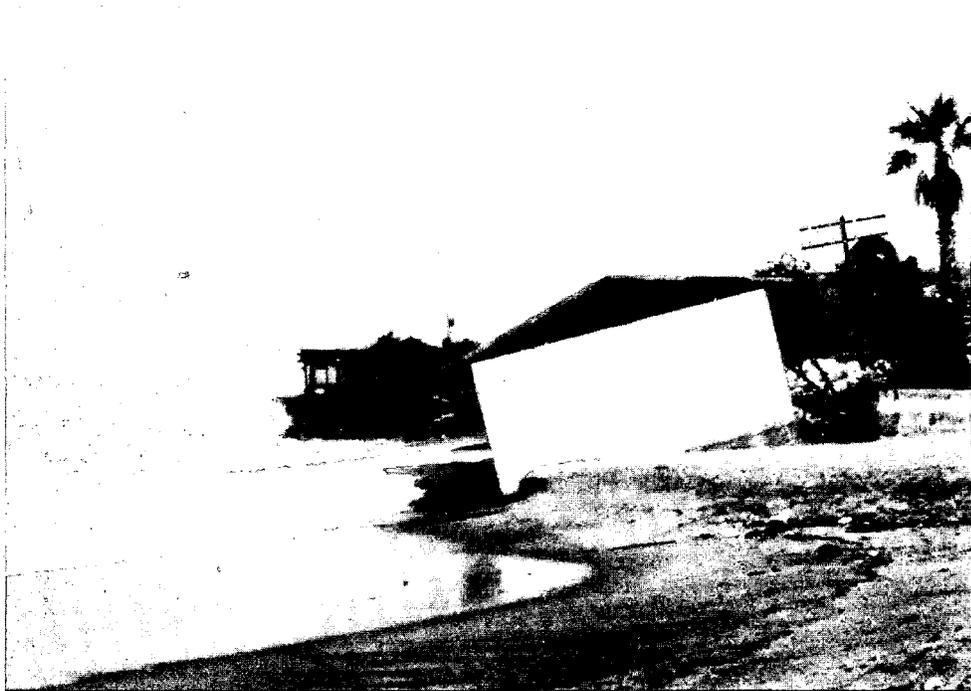
FIGURE 35 This foundation on North San Clemente Beach failed due to undermining of the slab.

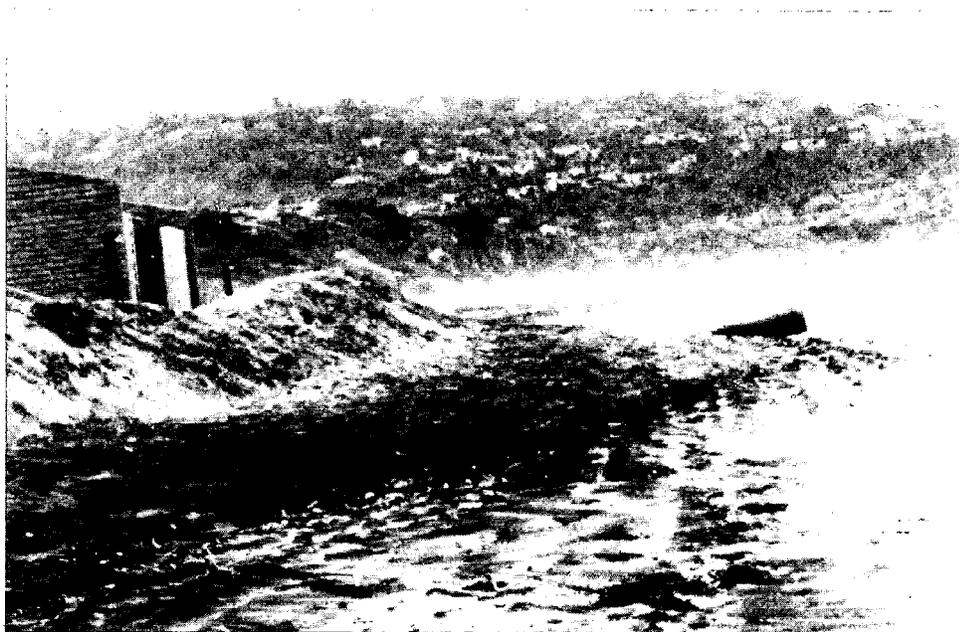
FIGURE 39 Torrance County Beach. Severe erosion is threatening the restroom facilities. Heavy minerals (black sand) were left as "lag" deposits on the beach. The Palos Verdes Hills are in the background.

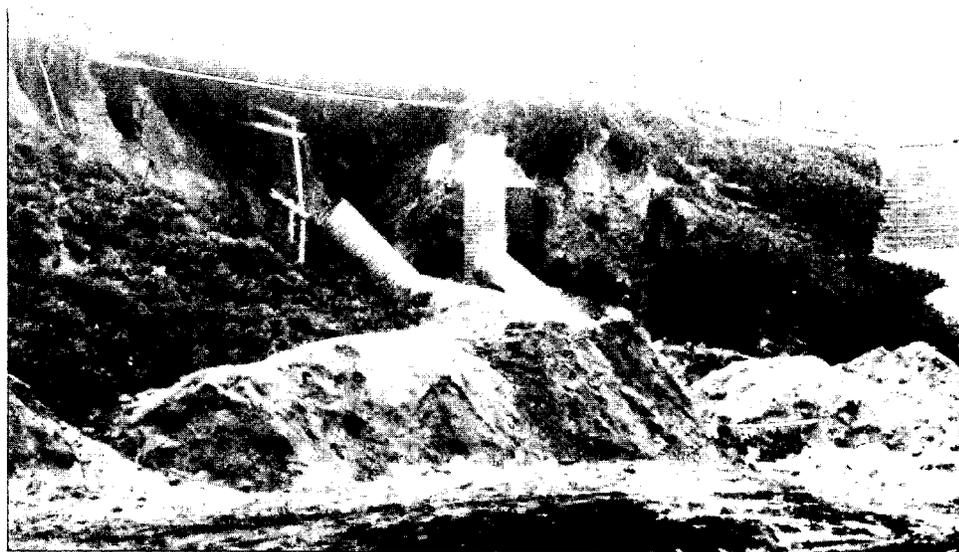
FIGURE 40 Torrance County Park. This view toward land shows damage to drainage conduits and water lines. The erosion was probably due to a combination of waves and runoff.

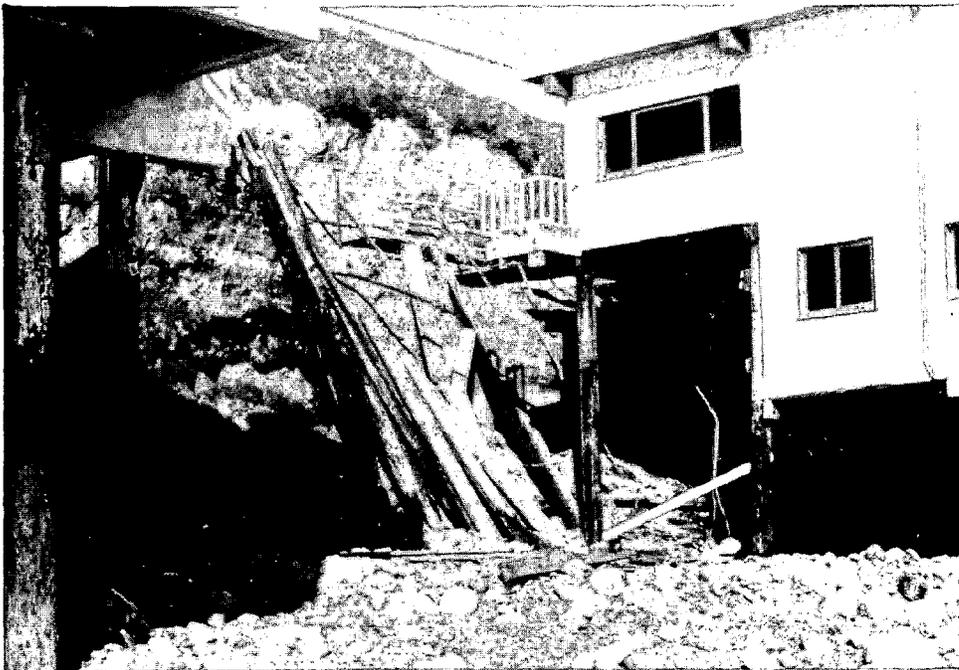
FIGURE 44 Location where a dwelling in Malibu Beach was destroyed by waves. Most of the debris had been removed at the time of this photograph.

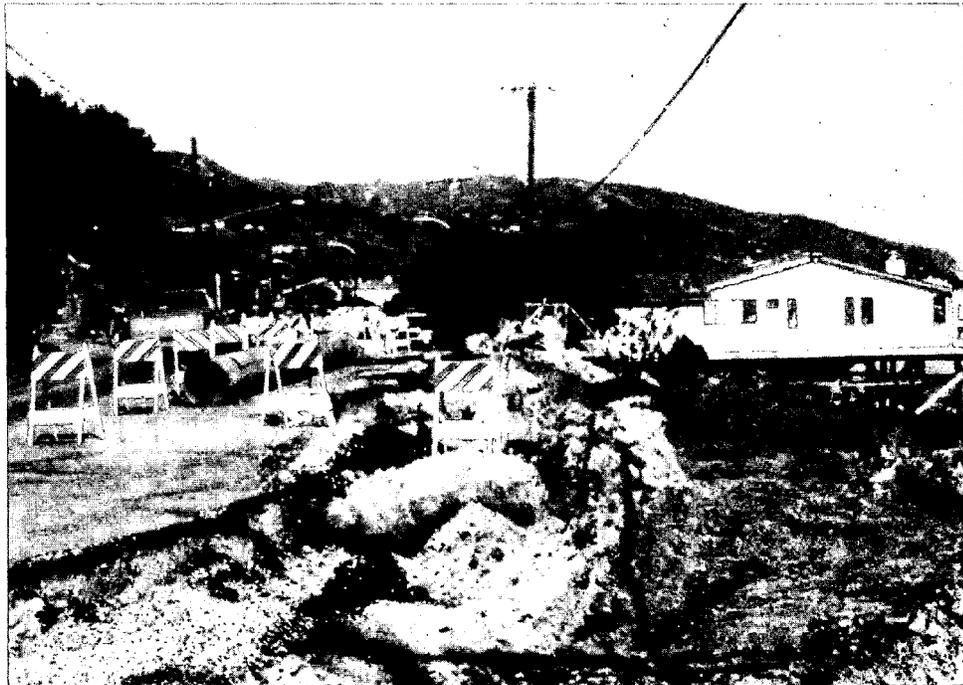
FIGURE 45 Road damage in Malibu Beach due to wave or runoff erosion.

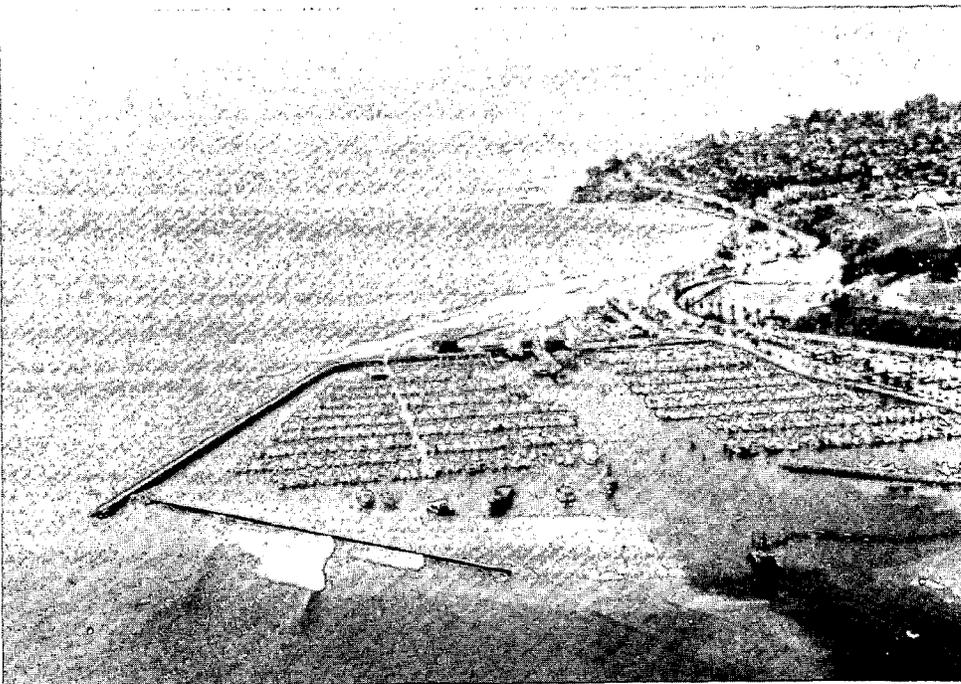
FIGURE 48 The Santa Barbara area. Note the degraded spit and beach areas compared with Figure 47.

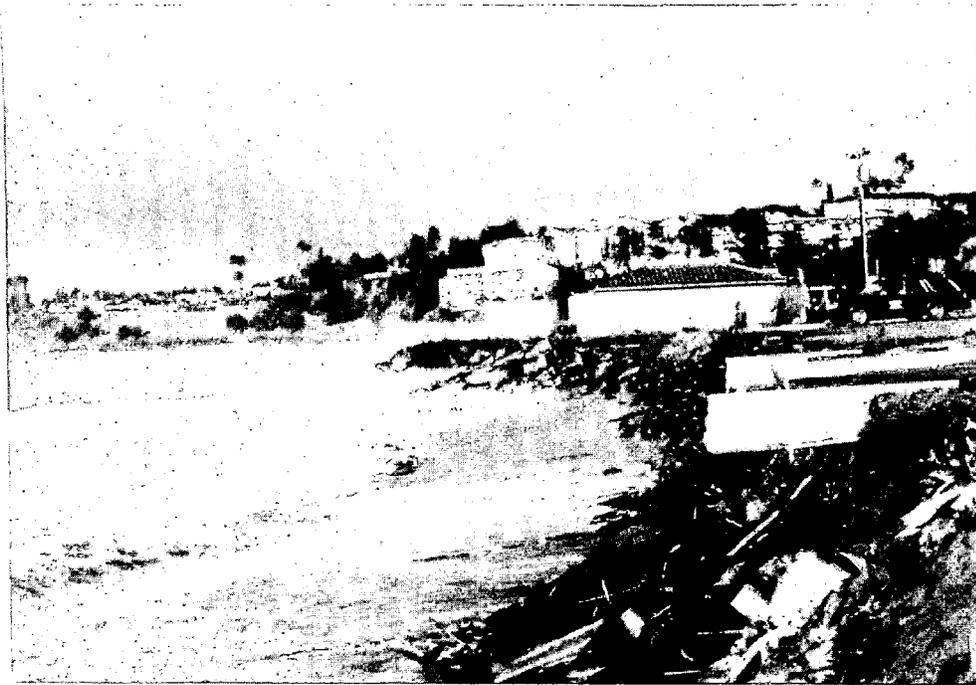
FIGURE 50 View west along eroded Leadbetter Beach.

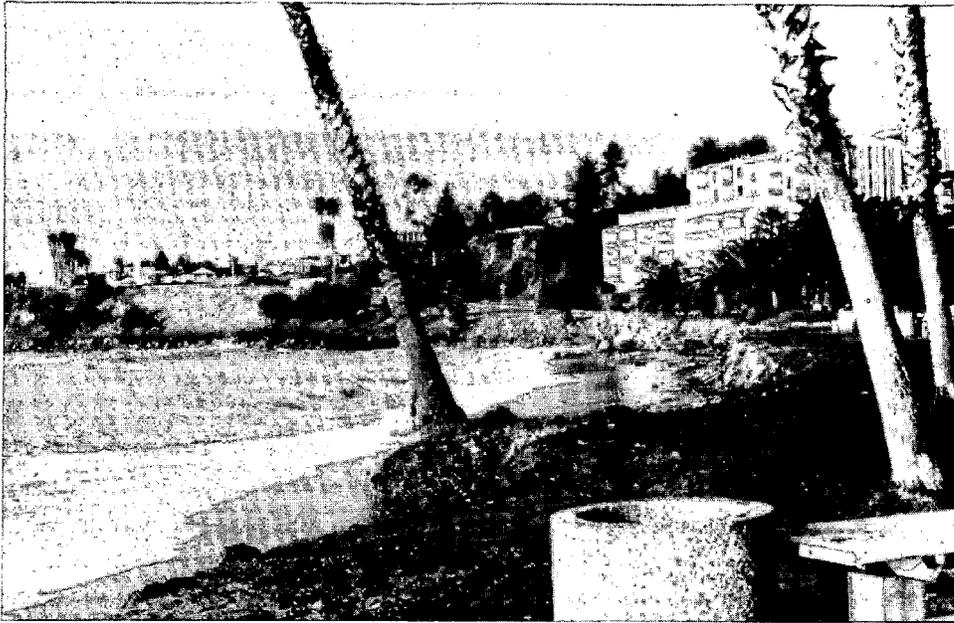
FIGURE 51 View west from west end of Leadbetter Beach. The beach and upland were substantially eroded, with the loss of a number of palm trees.

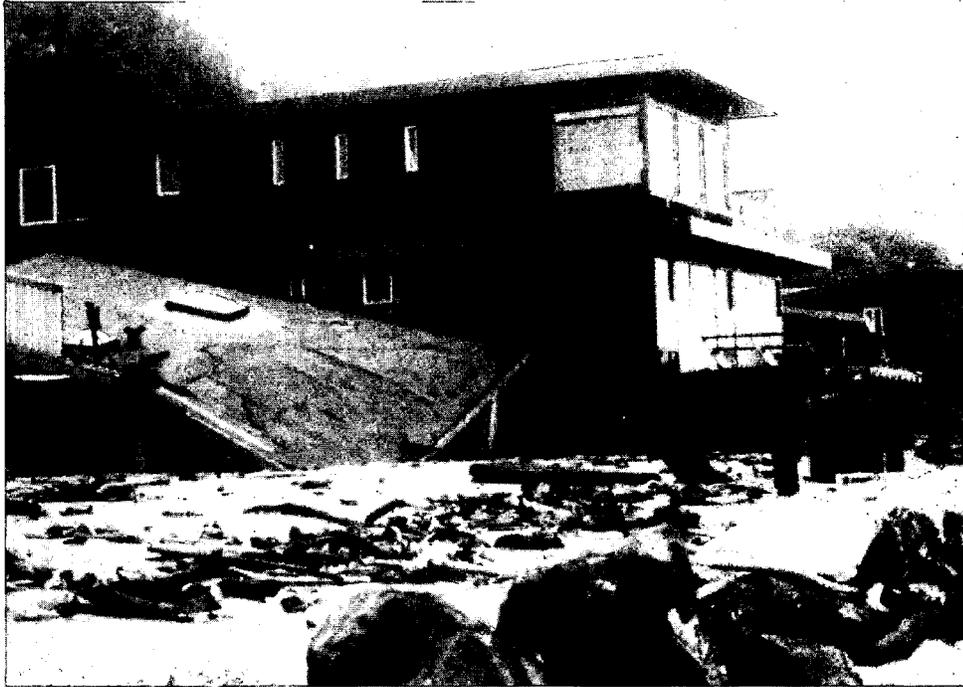
FIGURE 55 Destroyed home in Rio Del Mar Beach. Note the ineffective revetment fronting the structure.

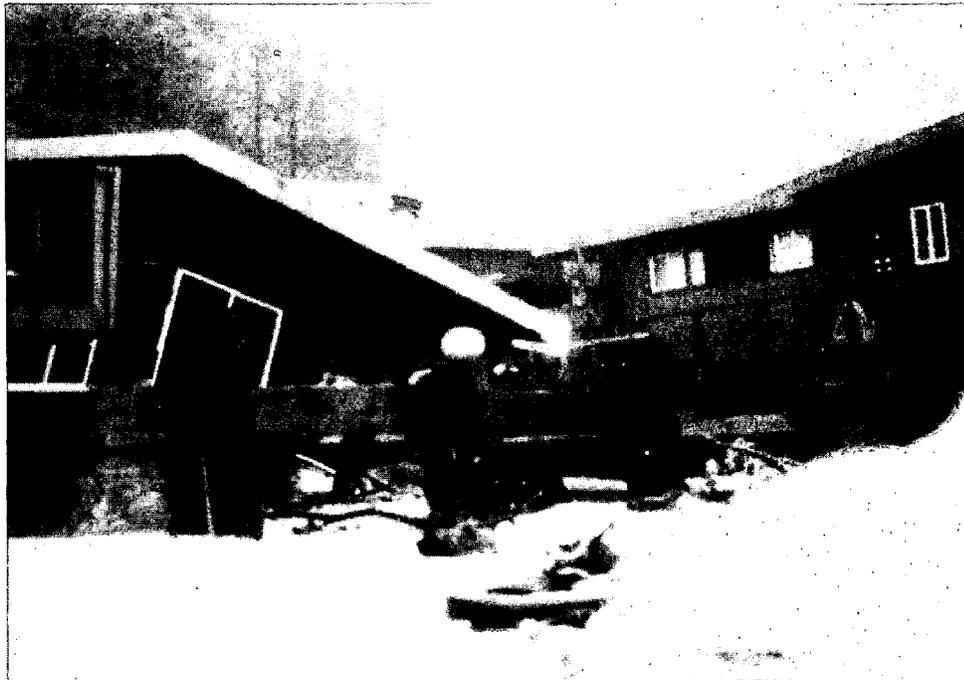
FIGURE 56 Destroyed home in Rio Del Mar Beach fronted by damaged wooden seawall.

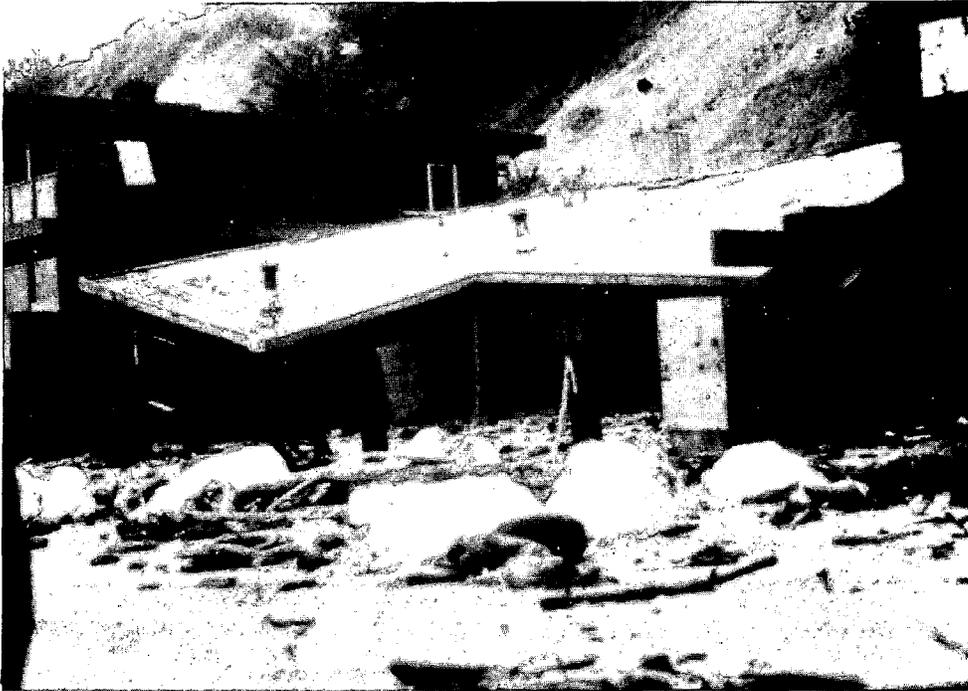
FIGURE 57 Destroyed home in Rio Del Mar Beach with remnants of a poorly designed revetment.

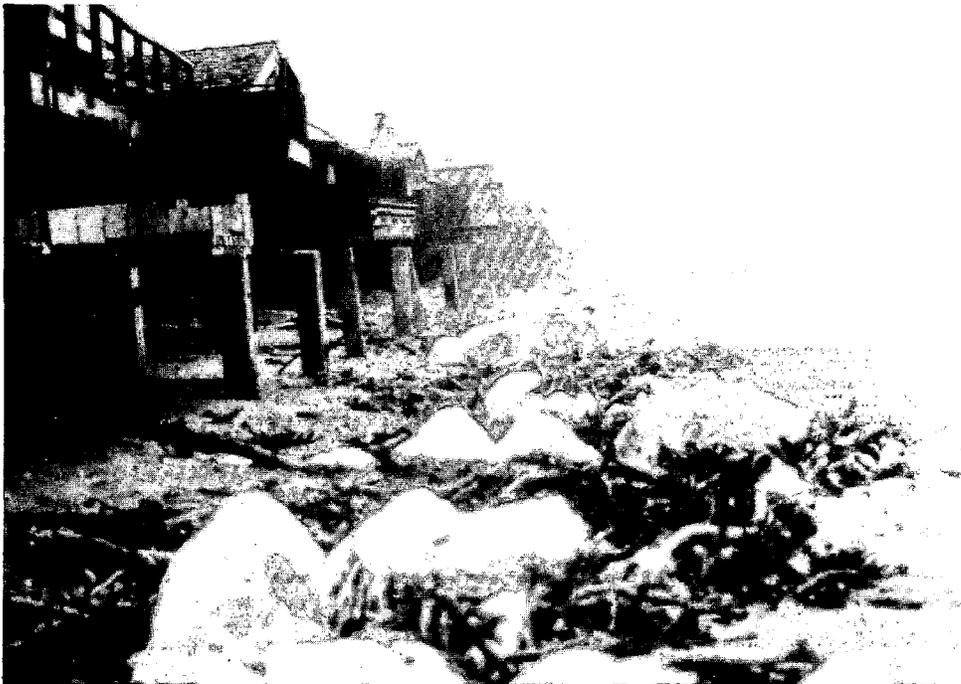
FIGURE 58 Fairly ineffective revetment in Rio Del Mar Beach lowered as a result of scour. The vertical erosion was approximately 2 m.

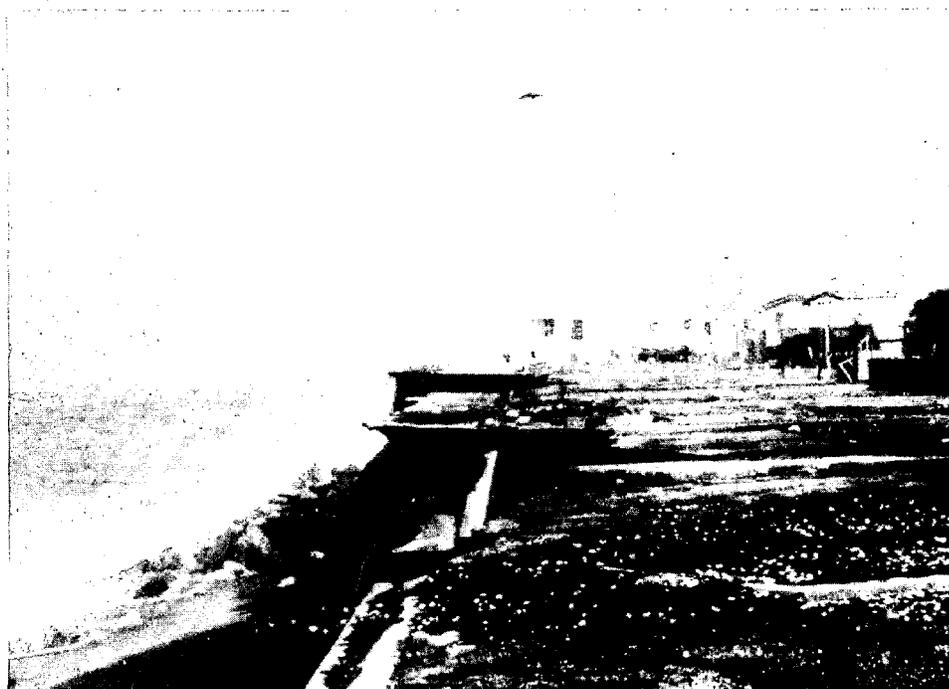
FIGURE 59 Severe erosion in Pacifica adjacent to trailer park.

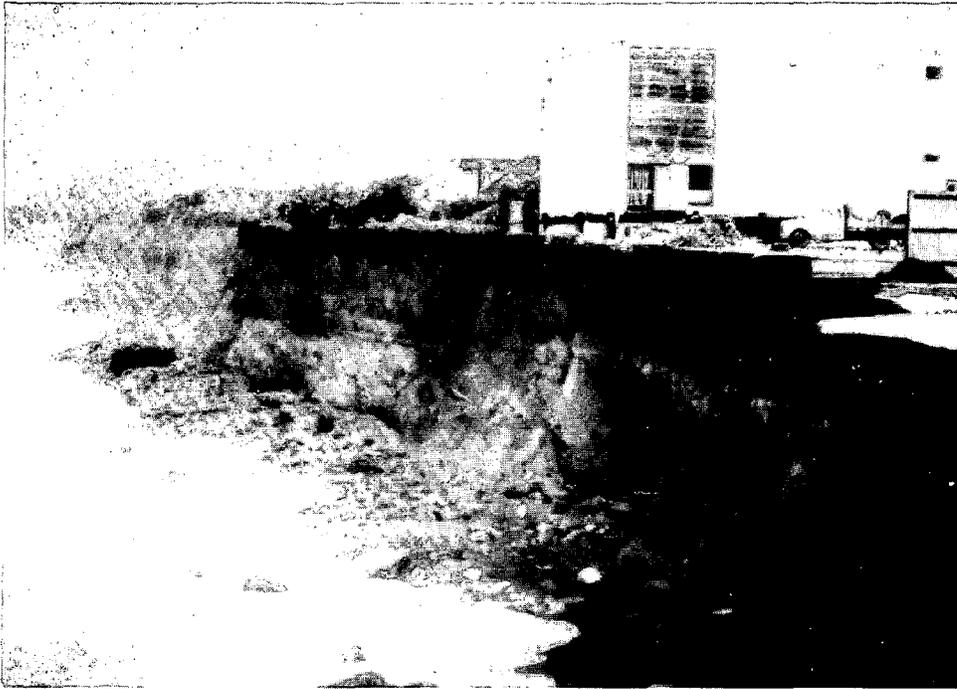
FIGURE 61 Masonic Lodge in Pacifica undercut by wave erosion. The scarp is approximately 10 m high.

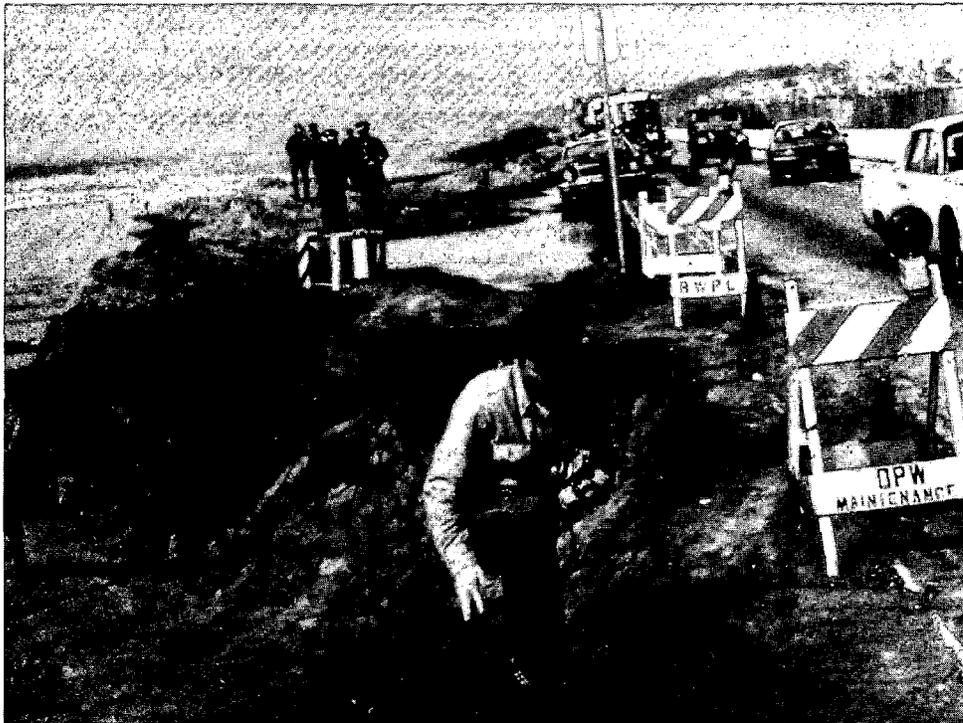
FIGURE 62 Beach erosion and road damage at Ocean Beach south of the entrance to San Francisco Bay.

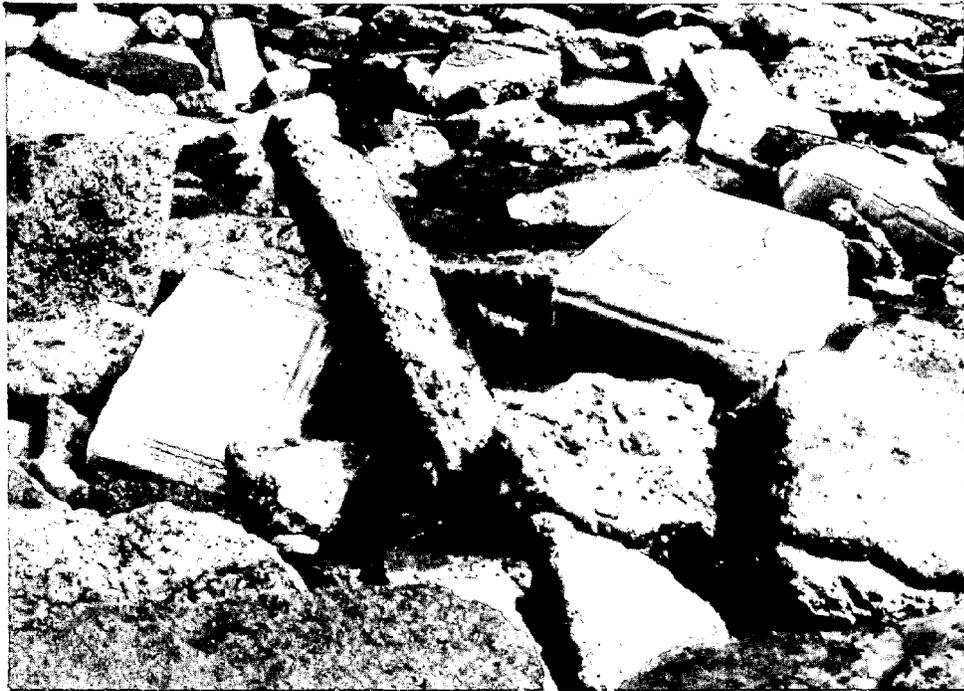
FIGURE 63 Makeshift revetment for road protection at Ocean Beach including headstones from cemetery.

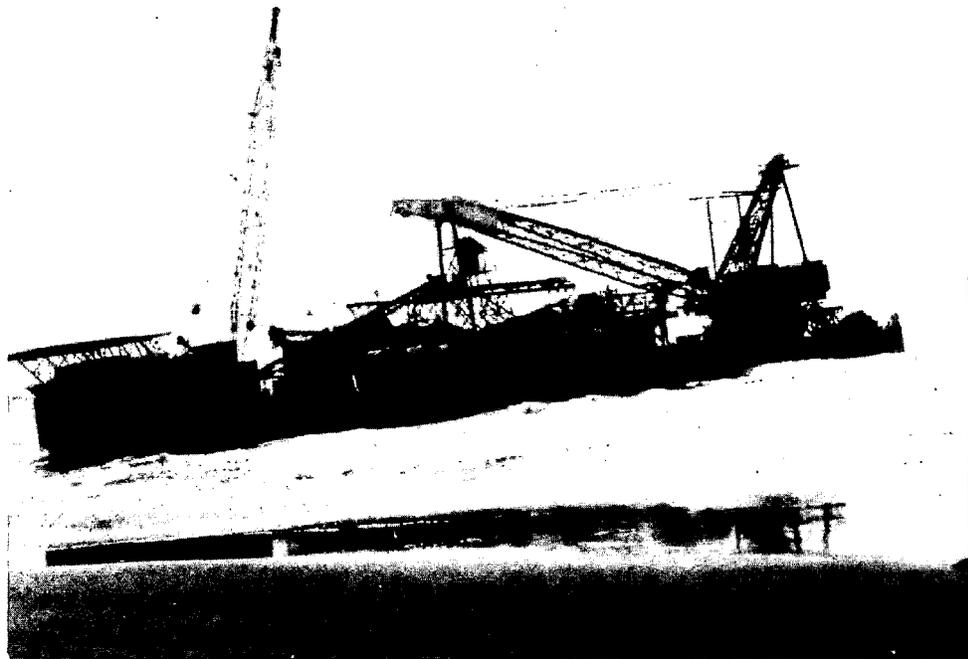
FIGURE 64 The stranded construction barge Betty L at Ocean Beach with efforts under way to free this casualty of the storm.

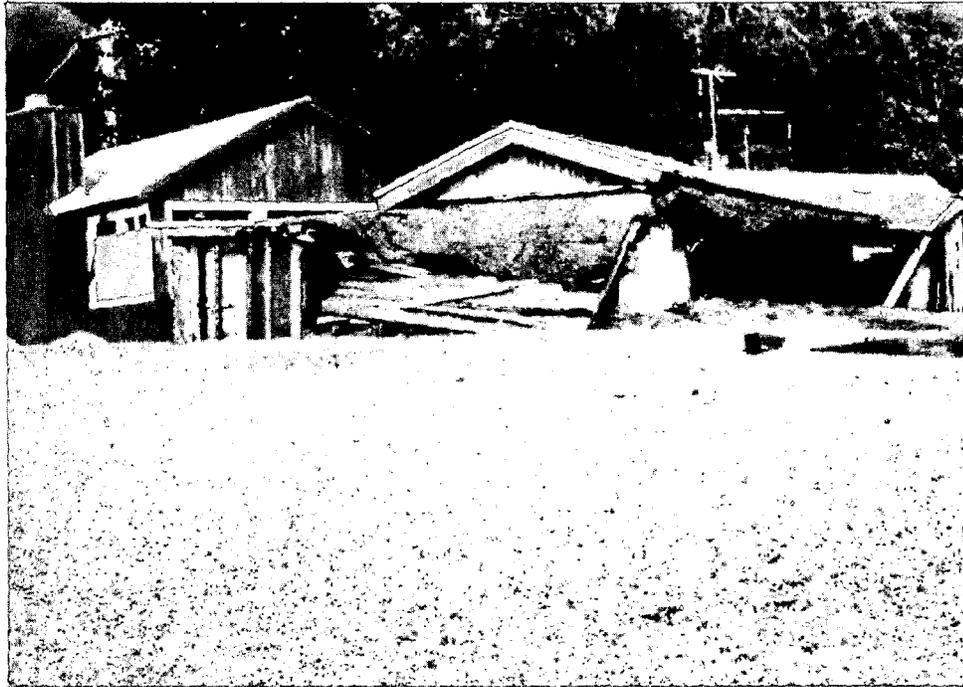
FIGURE 67 Structures in Stinson Beach damaged and destroyed from erosion undermining and direct action of waves.

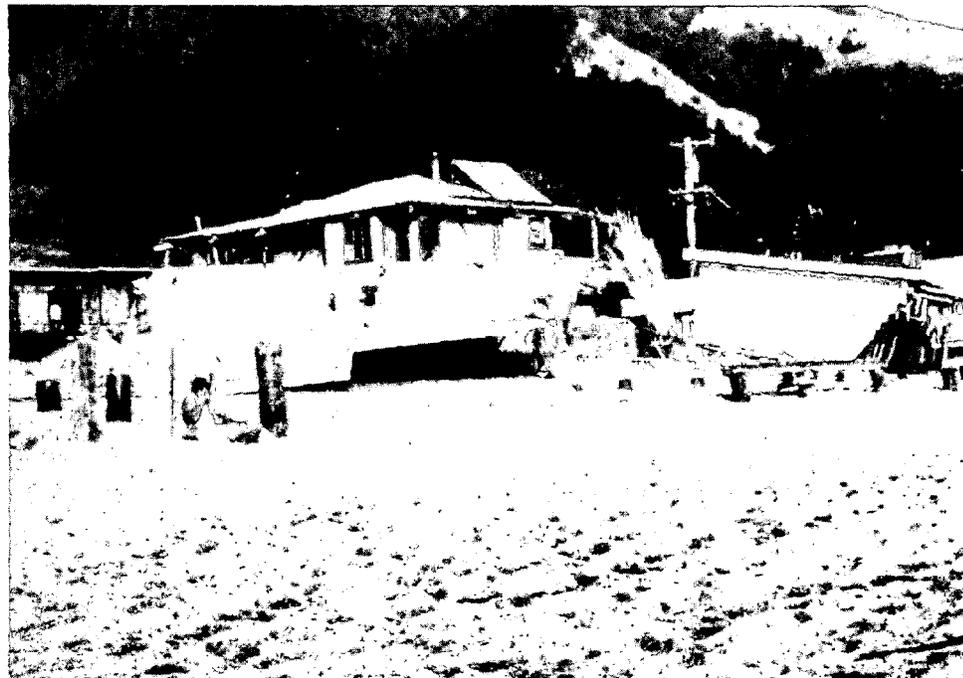
FIGURE 68 Dwellings damaged in Stinson Beach due to erosion undermining and direct action of waves.
