California Coastal Erosion and Storm Damage During the Winter of 1982-83

A Reconnaissance Report

Committee on Natural Disasters

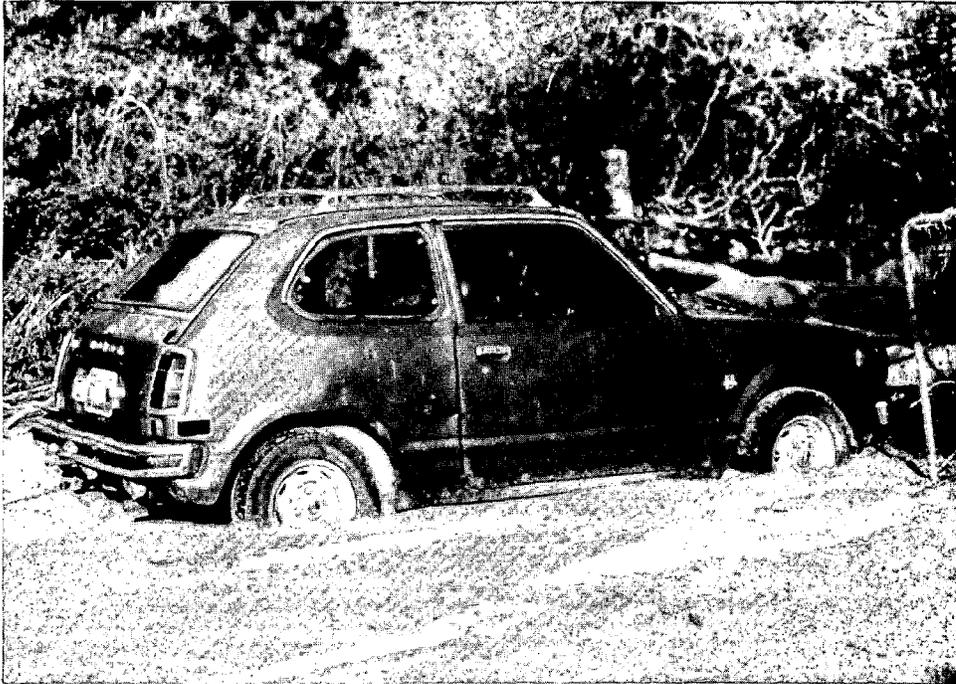
FIGURE 69 Overwash deposits of sand deposited approximately one block inland at Stinson Beach.

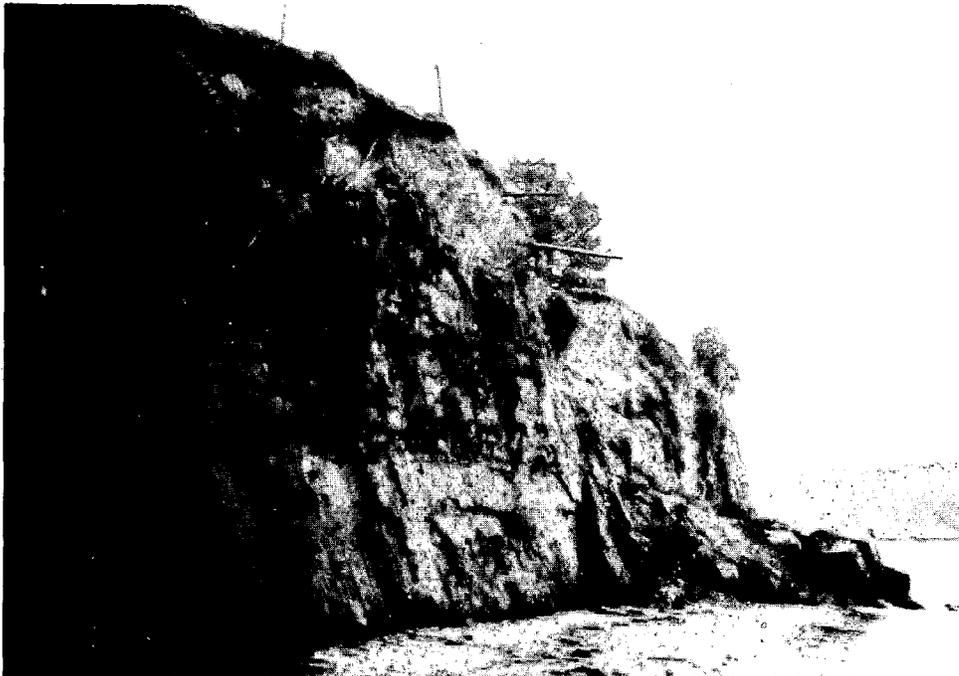
FIGURE 72 Failure of coastal cliff at Capitola.
