National Conference of States on Building Codes and Standards, Inc.

INTRODUCTION

In December 1988, NCSBCS contracted with the U.S. Department of Housing and Urban Development (HUD) to investigate the cause of failures, sustained by manufactured homes following natural disasters. Historically, it has appeared that the number of manufactured homes and the severity of damage caused to those homes have been disproportionate to site built homes which have been exposed to the same disasters. This report covers four separate investigations conducted by NCSBCS at disaster sites involving manufactured homes. The purpose of the investigations was to determine which structural components of manufactured homes are most likely to fail in disaster situations and to recommend possible remedial actions to the Department. Data was collected at disaster sites as an attempt to identify consistent patterns of component failures. Findings from these investigations are intended to identify not only the cause of failures but also which systems are most apt to fail.

Between May and October of 1989, four disaster site investigations were conducted. The types of natural disasters which damaged or destroy

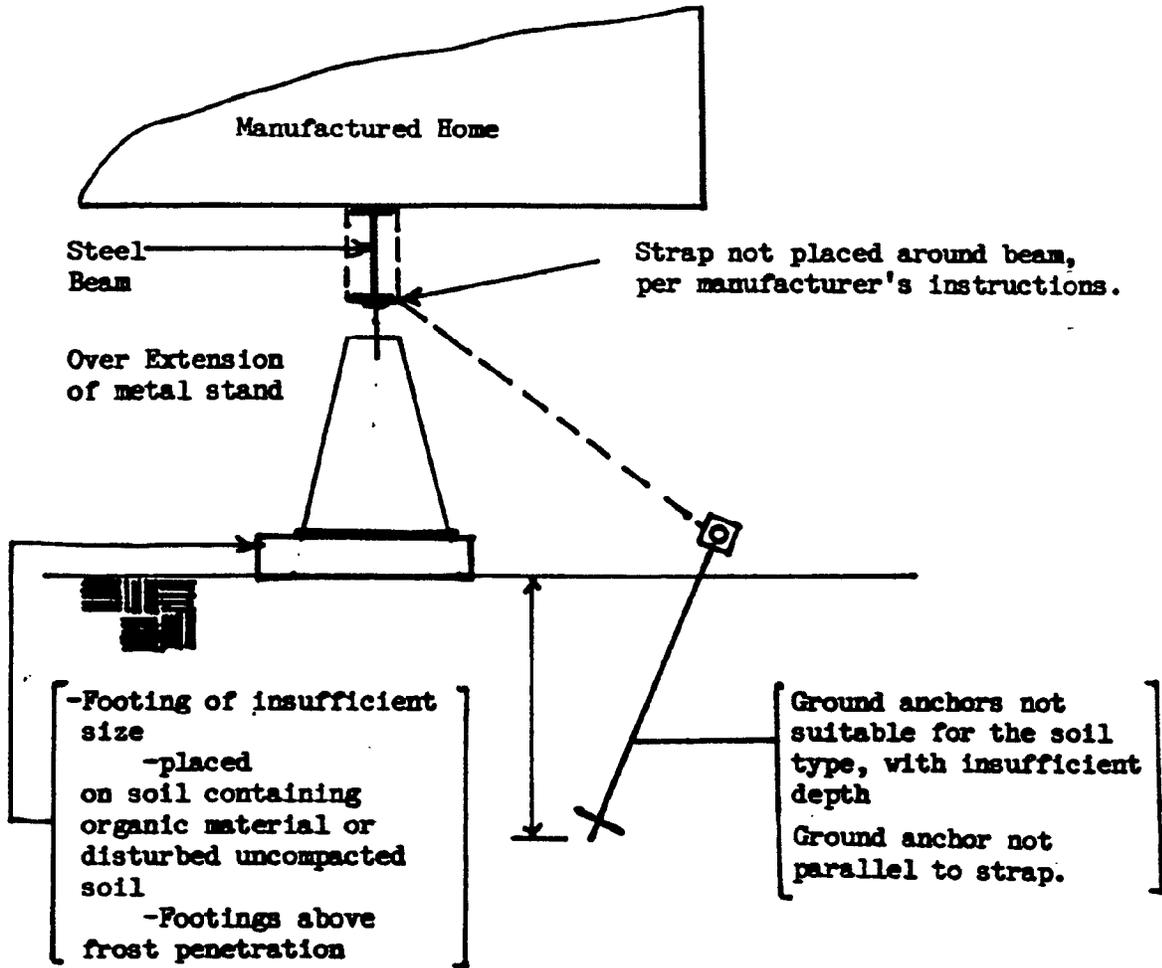
INCORRECT METHOD OF INSTALLATION

1. Improper Anchoring of Units: The installation of ground anchors was not coaxial with the straps. (Anchors were angled in towards the home, see Appendix B.) This method of anchor installation, while not uncommon, is contrary to the installation instructions of all anchor manufacturers. When anchors are installed at this angle there is a tendency for the anchor to slice through the soil thereby creating slack in the tie-down strap which allows the unit to shift off its foundation. (See Appendix C for installation guidelines.) Also, the soil in which the units were anchored did not appear

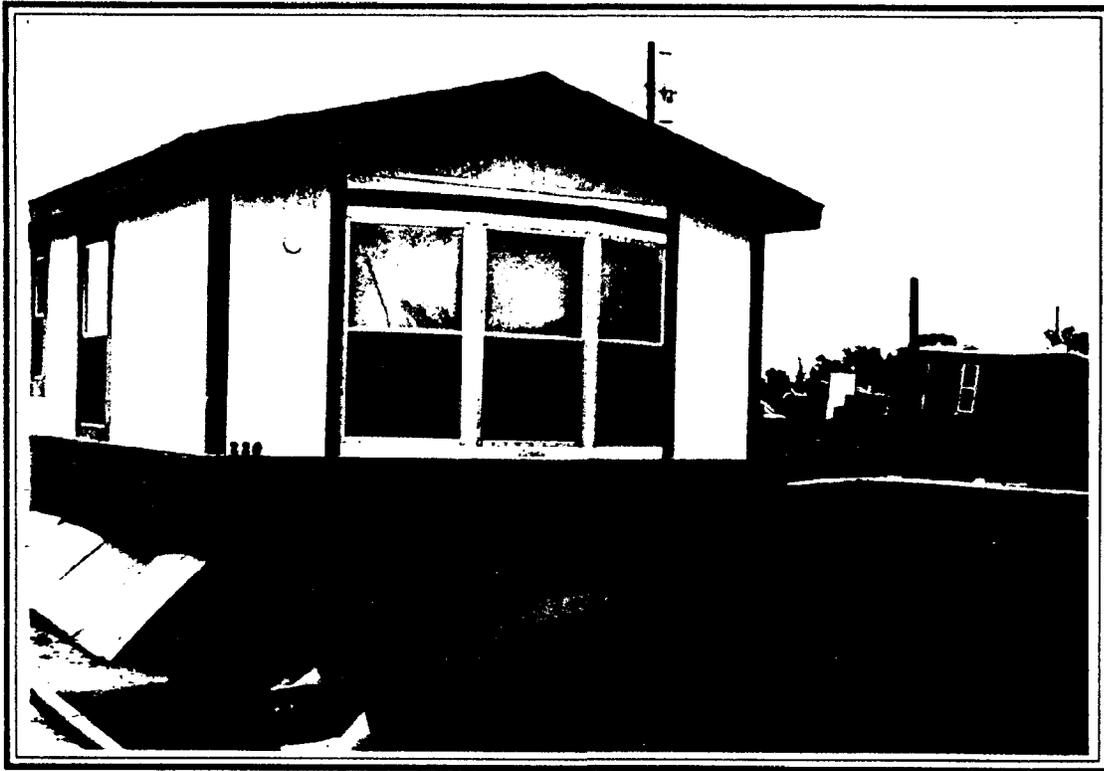
Photo #1

Home shifted off foundation

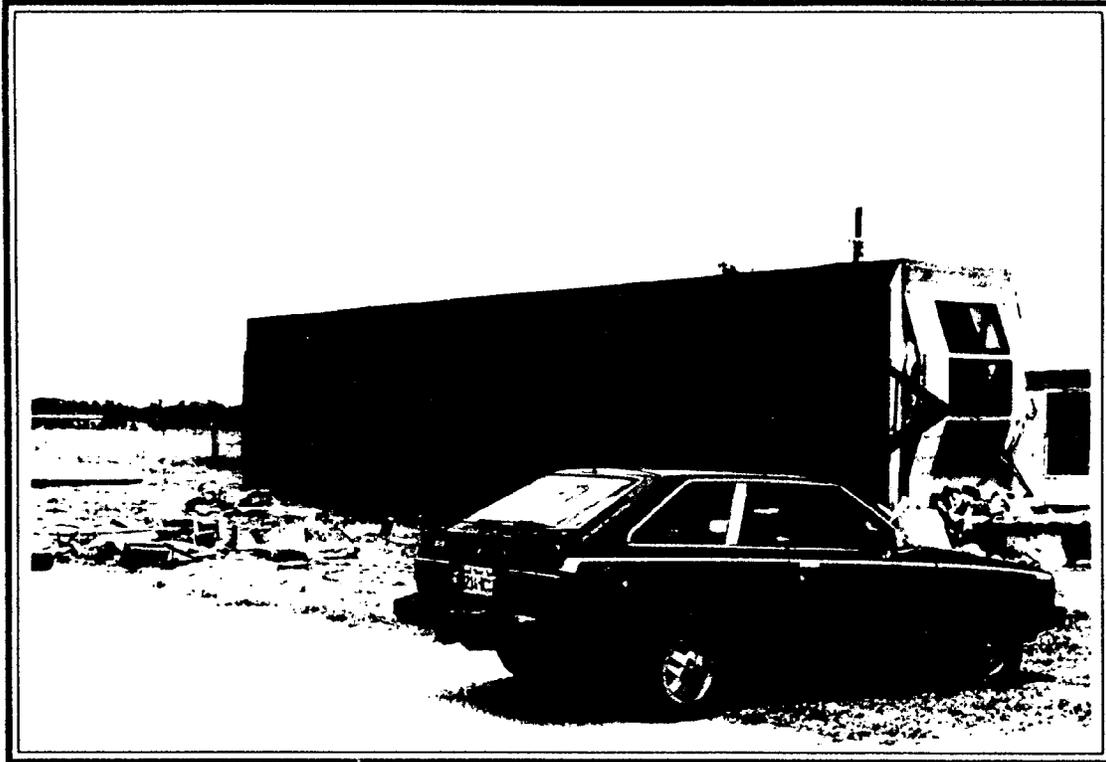
Photo #3

Home flipped on side

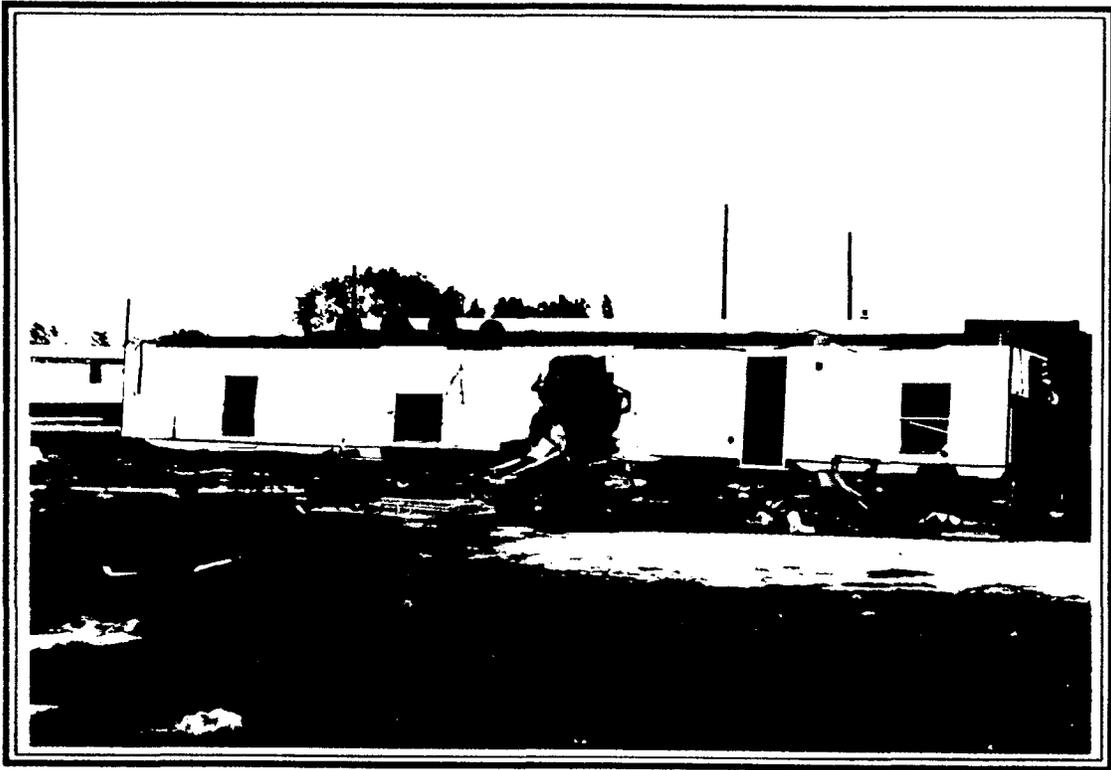
Photo #5

Home flipped upside down

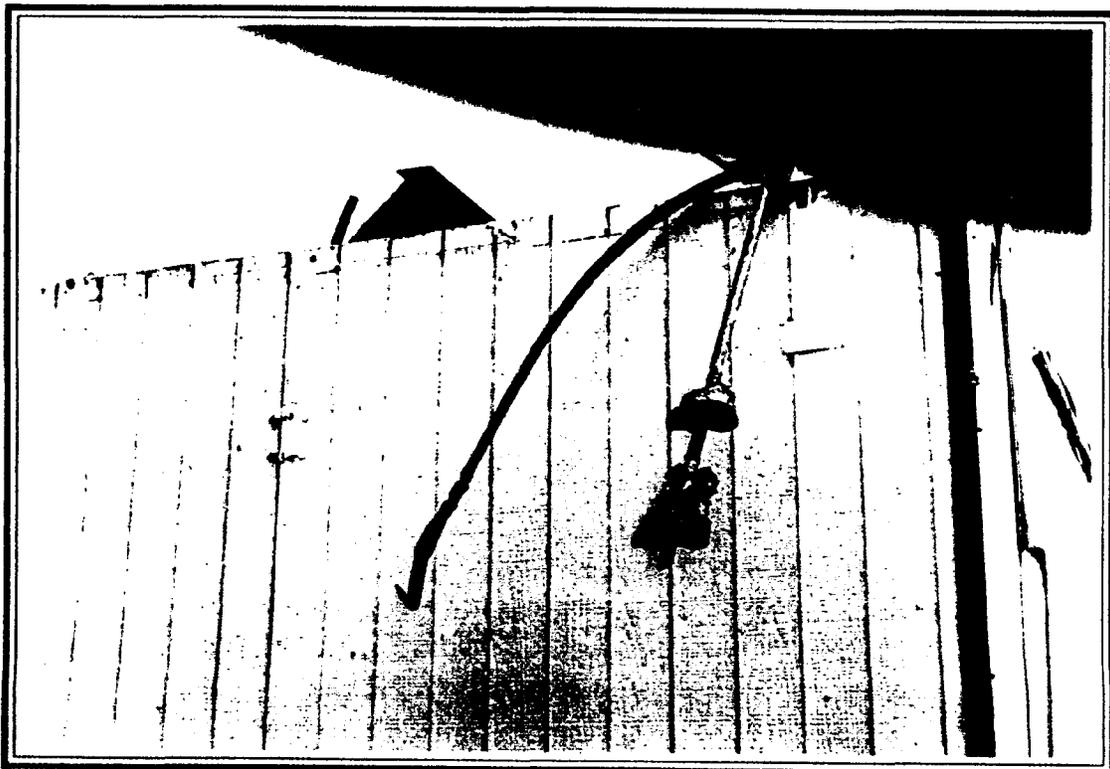
Photo #6

Anchor pulled from soil. Hook fell off I-beam

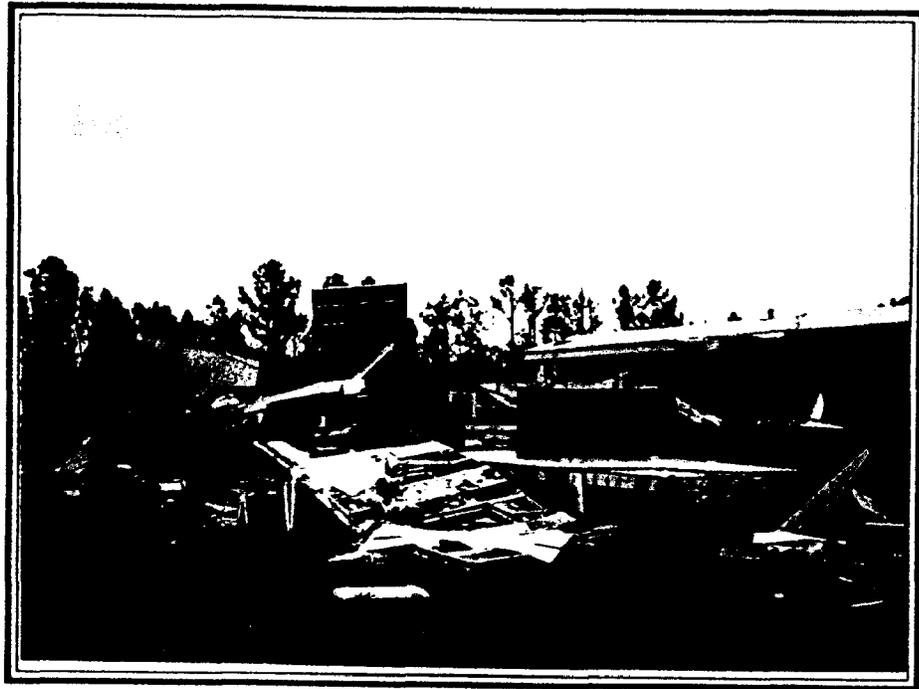
Photo # 1

In addition to the above mentioned damage, approximately 8 percent of the homes were totally destroyed (see Appendix E, photos 1, 2, 5, 6, 9, 10, 11, 12 and 13). It was observed that the homes which had overturned, the anchor and strap failed. Other homes were destroyed as a result of wind pressures that severed the entire roof from the home. Hence, the exterior walls collapsed when the roof trusses no longer helped stabilize the wall. The floor systems remained intact in all of the demolished homes.

Demolished home (Note: chassis and floor intact)

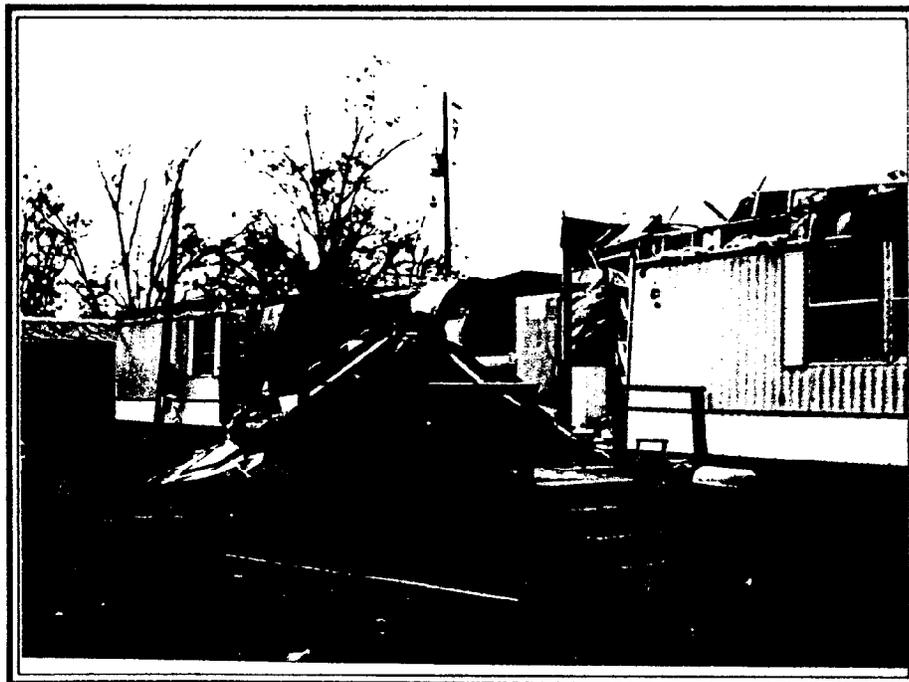
Photo #4

Approximately 15 percent of the inspected homes were missing between 20 to 100 percent of their metal roof covering. Several also suffered minor truss damage. (See Appendix E, photos 3, 4, 7 and 8.) Homes with shingled roofs experienced damage to a lesser extent, generally missing a dozen or less shingles. Typically, individual sections of roofing were completely torn from the homes exposing the units to the massive amounts of rain that accompanied the hurricane and created further damage. In all cases, when the roof covering was torn from the home, the staples fastening the roof to the edge rail were also torn out of the edge rail.

Roof loss and side wall failure

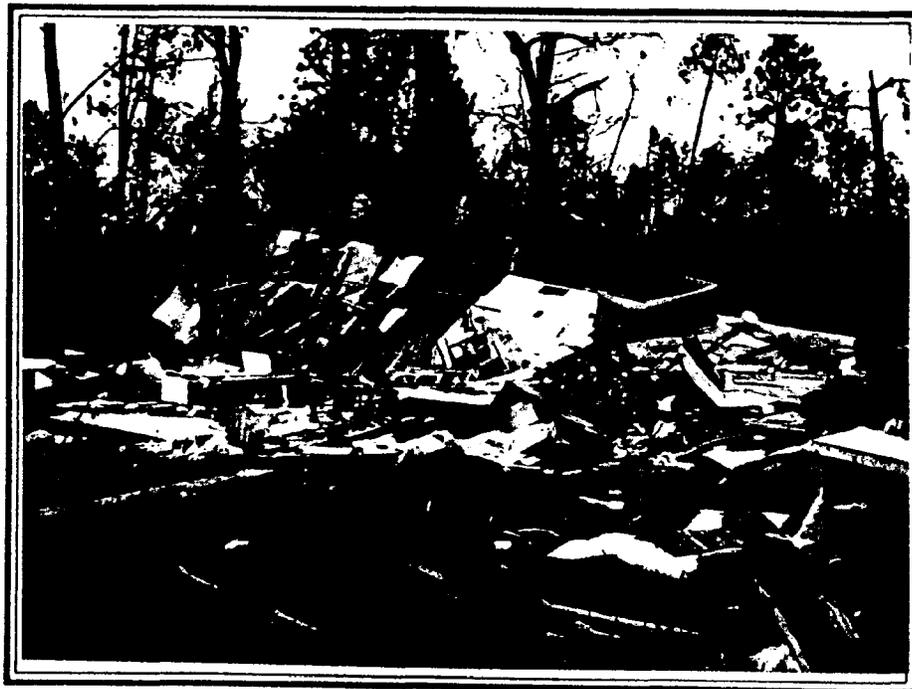
Photo#6

Demolished home

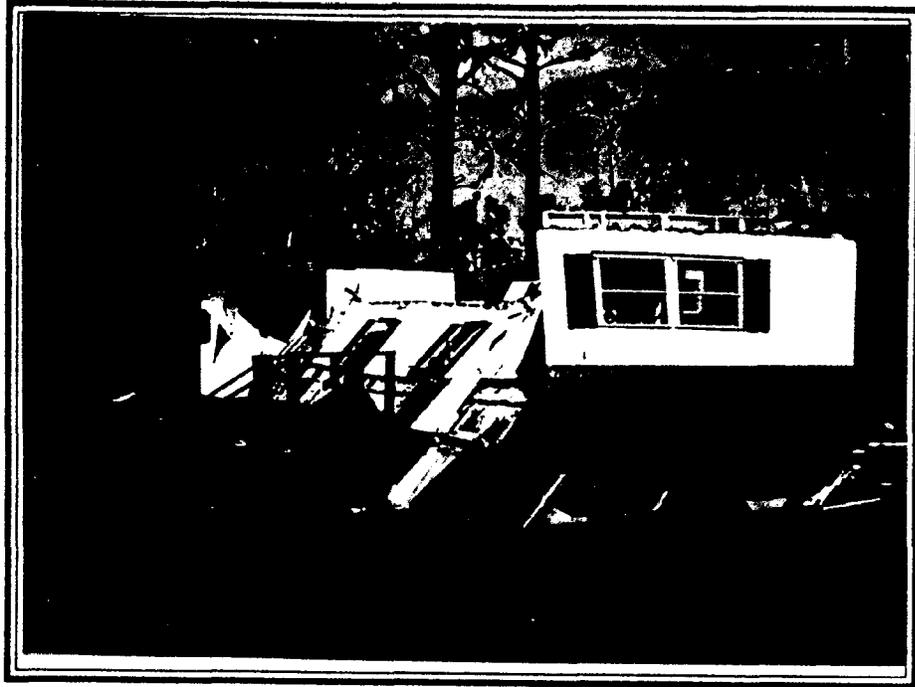
Photo #7

Metal roof loss and leeward wall collapsed

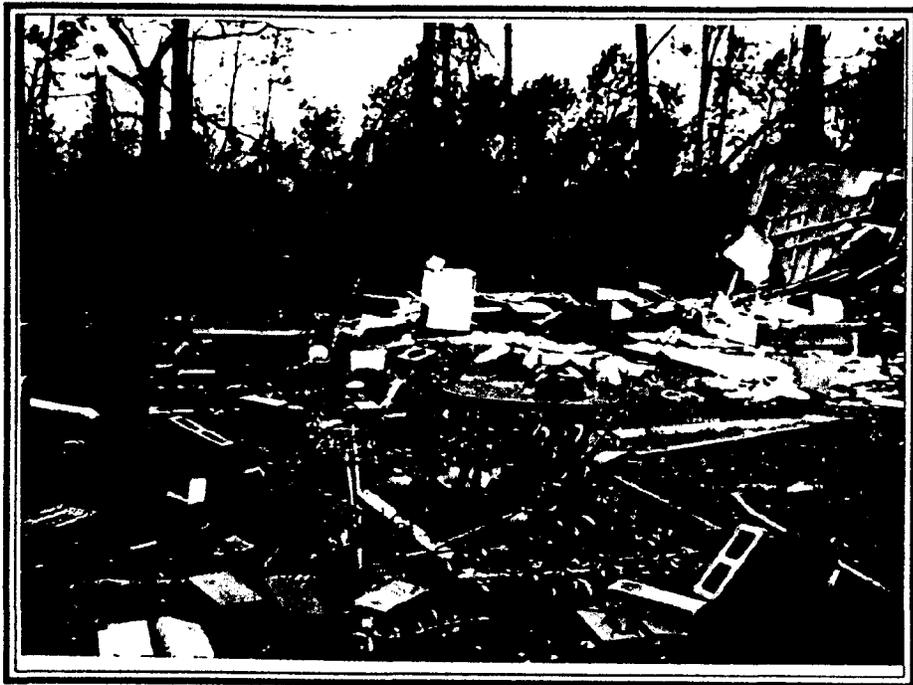
Photo #9

Demolished home blown off piers

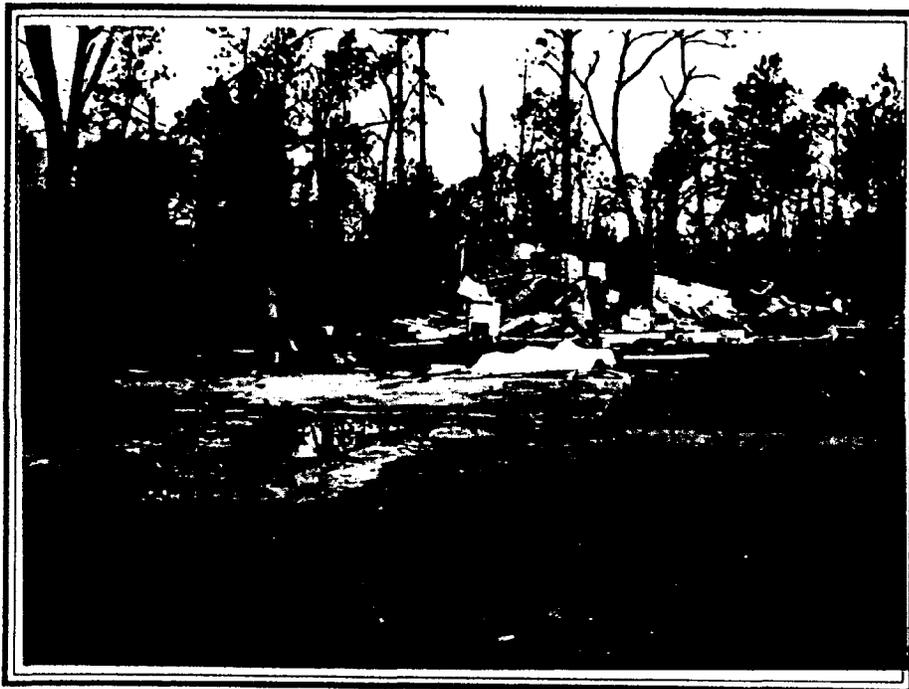
Photo #10

Demolished home

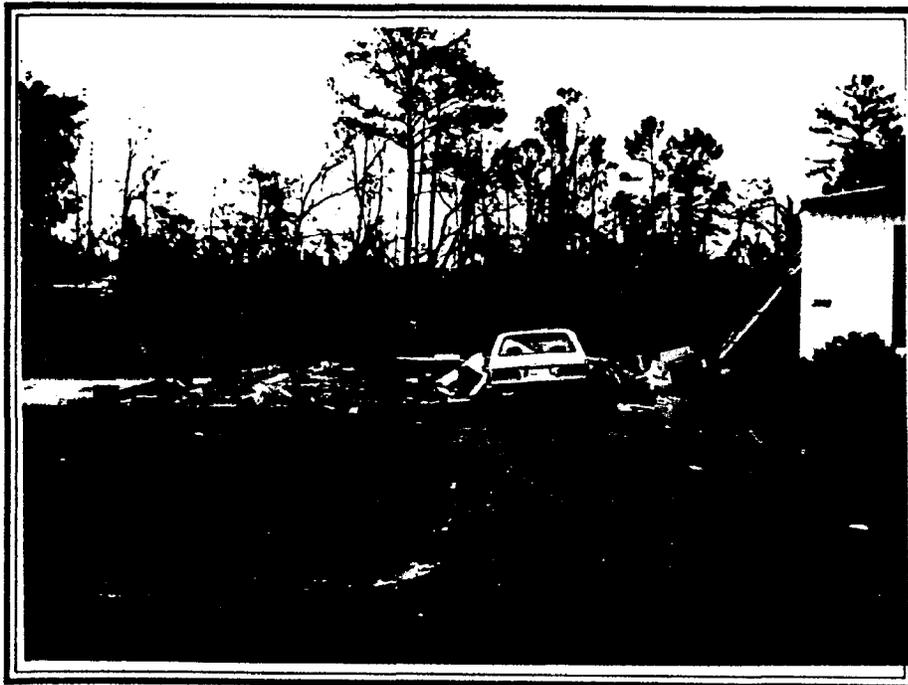
Photo #12

Home rolled over the next mobile home

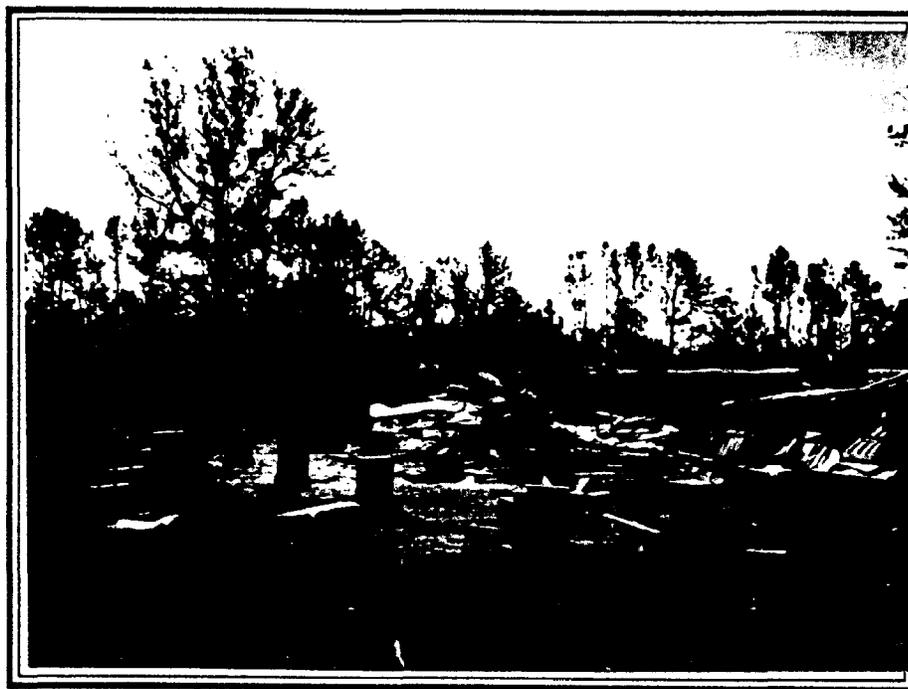
Photo #13

Demolished home

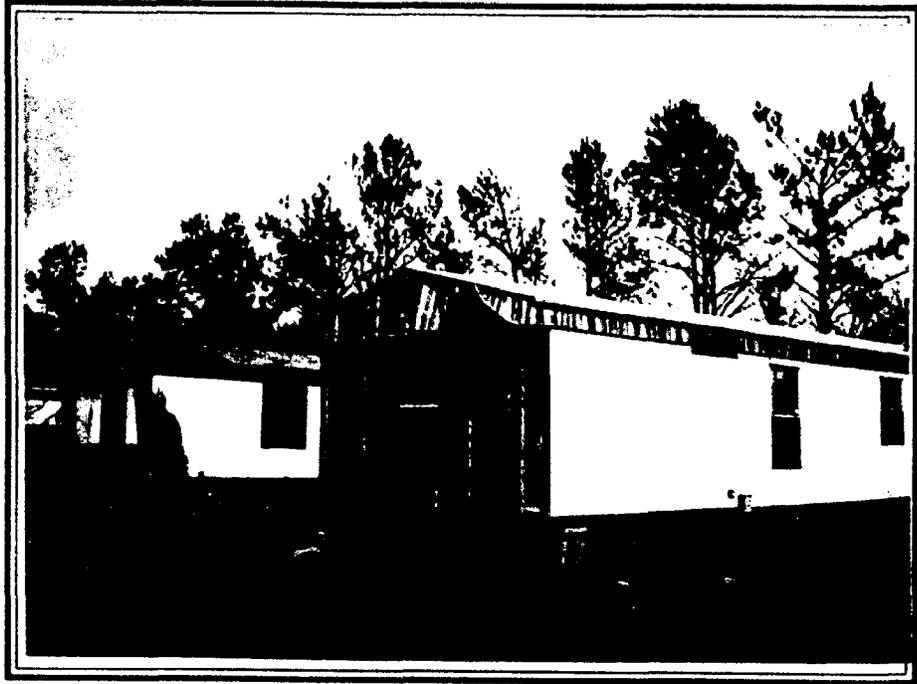
Photo #15

Approximately 15 percent of the homes suffered damage to siding and/or soffit covering. The primary damage was concentrated at the end of the units and affected only homes with metal and vinyl siding (see Appendix E, photos 14, 15 and 16). The primary reason for the loss of siding is the leeward suction forces at edges and ends of homes. When air flows over and around a stationary object, it exerts both inward and suction pressure on the surface of the object.

Portion of end wall overhang siding pulled out

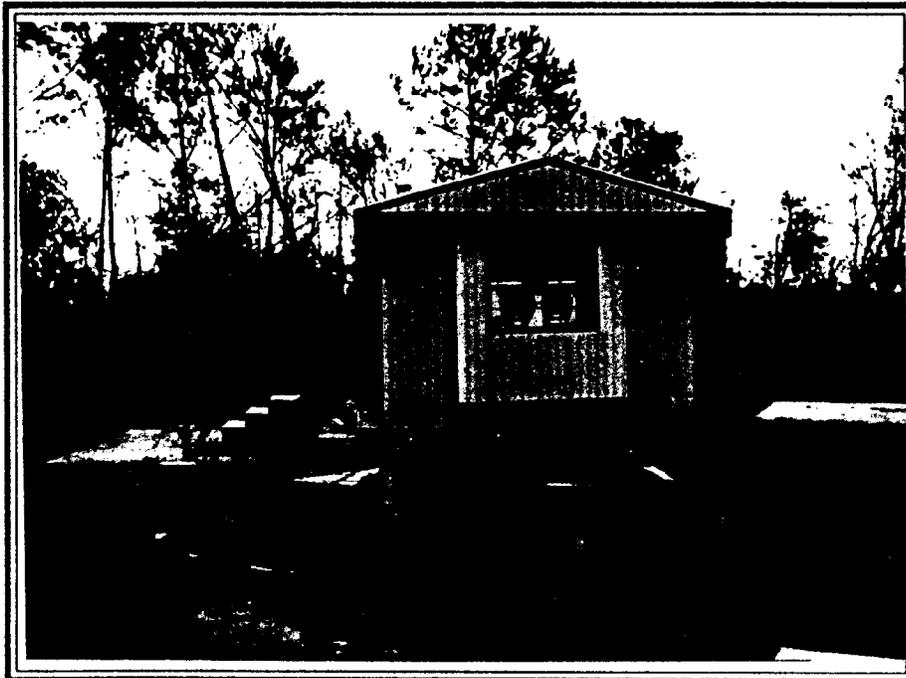
Photo #18

Home shifted from foundation

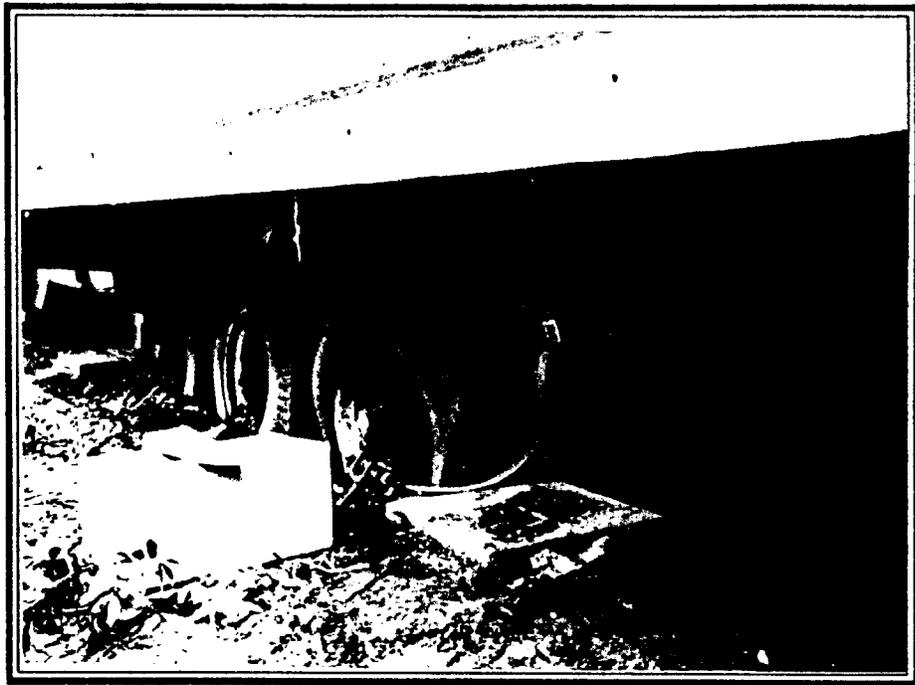
Photo #21

Home shifted off the blocks (Note: strap clip at bottom of I-beam)

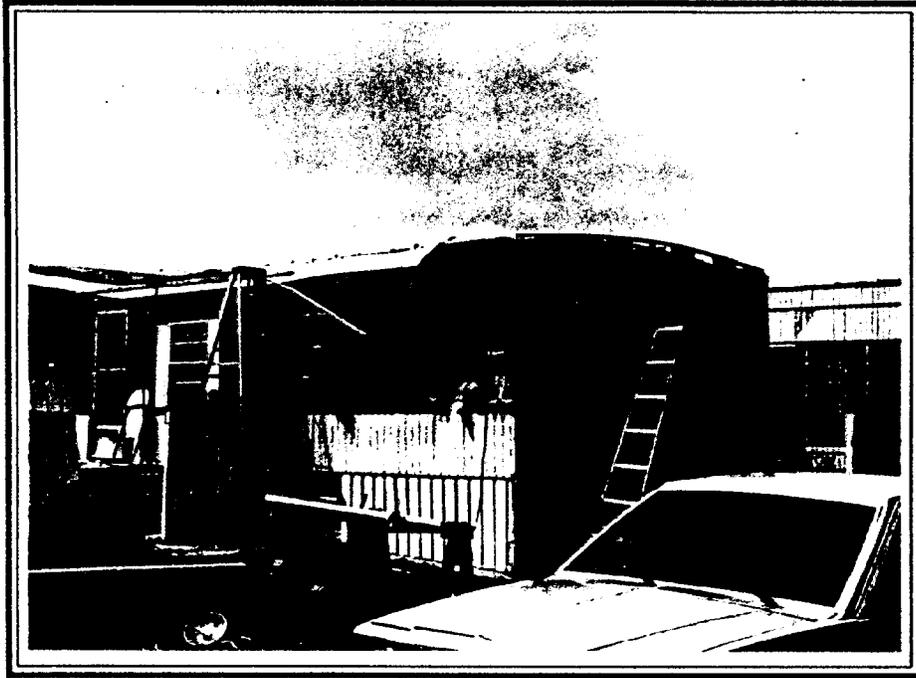
Photo #3

All of the damaged manufactured homes were produced prior to HUD's adoption of the Manufactured Home Standard on June 1976. The average home was 14 to 15 years old. The majority of homes in the park were pre-HUD, single wide units. Only one home was completely destroyed, which was reportedly hit by a tornado. (See Appendix F, photos 1 and 2.) The primary damage sustained by the manufactured homes was 1) loss of roof and soffit coverings and 2) loss of siding. (See Appendix F, Photos 3, 4, 7, 8, 11 and 12.)

Roof and siding loss

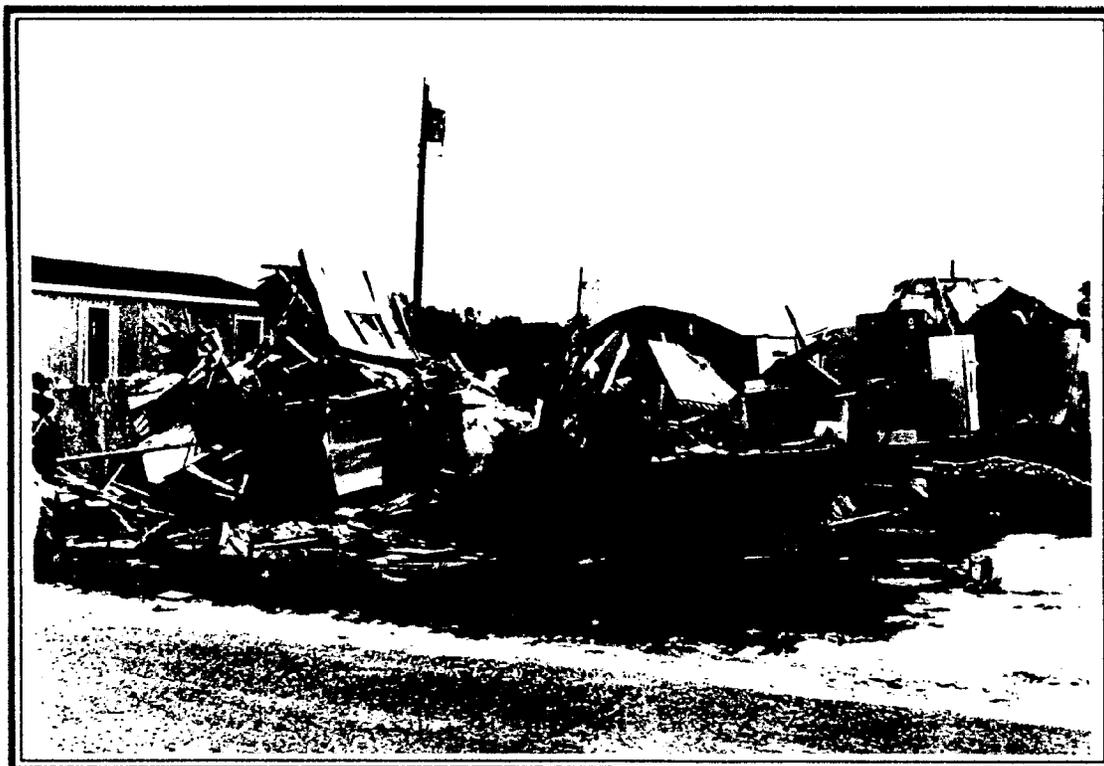
Three demolished homes.

The white one (near post) was airborne and destroyed the other two.

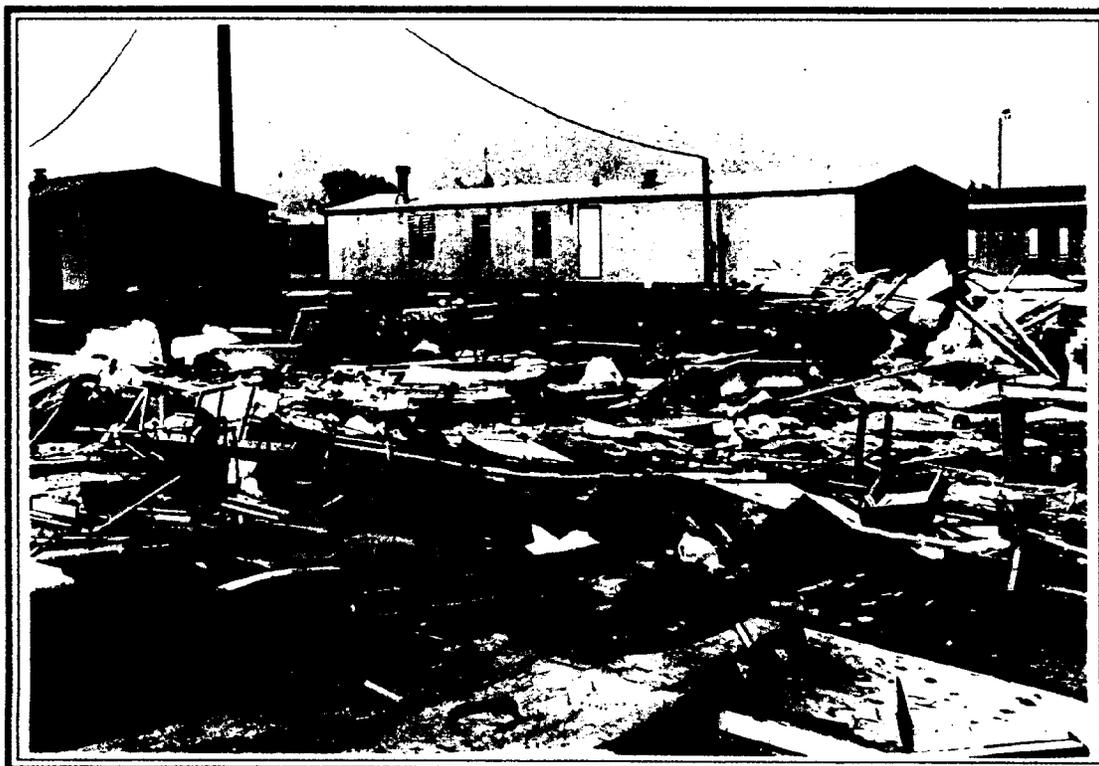
Demolished homes (note undamaged neighboring homes)

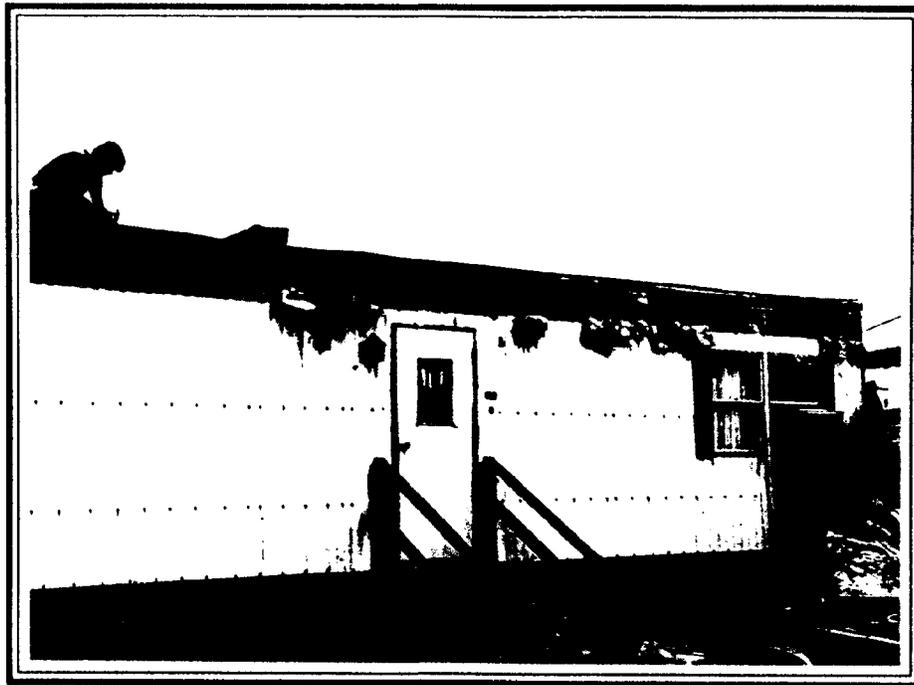
Photo #7

Roof damage

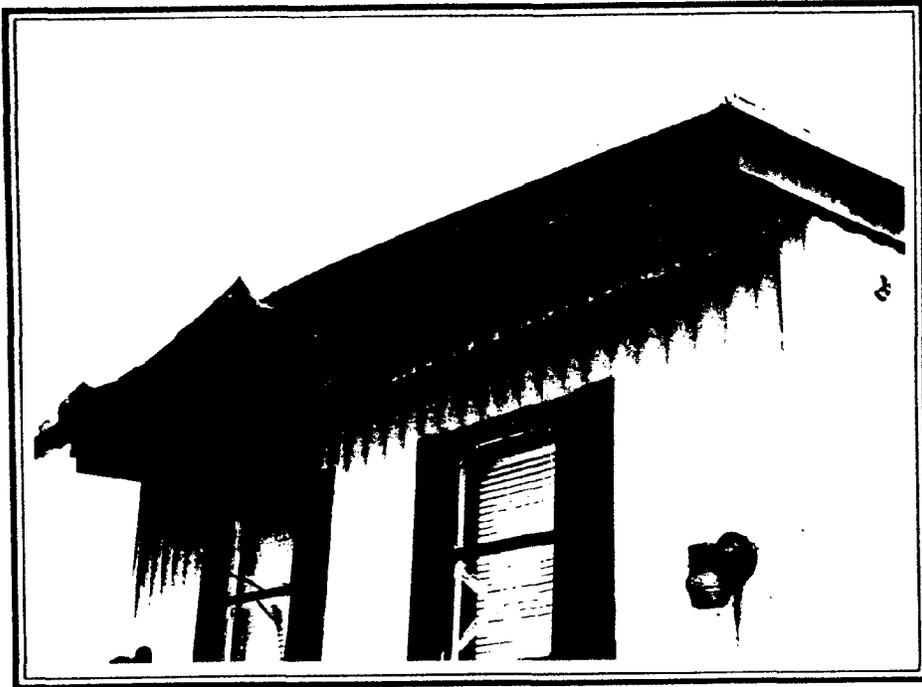
Photo #9

Siding and/or soffit covering on five of the six units was pulled loose or torn completely off (see Appendix F, photos 9 and 10). All of the affected units had metal siding with damage occurring at the ends (see Appendix F, photos 9, 10, 11 and 12). (See hurricane Hugo for explanation.) Similar to the roofing situation, the staples which fastened the siding were pulled away from the wood members.

Eave damage

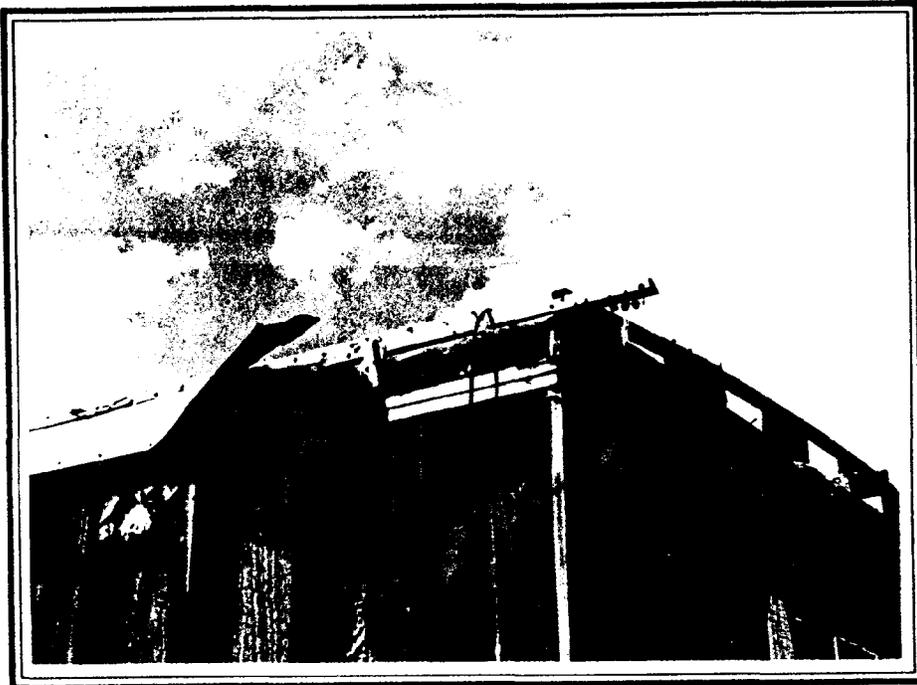
Photo #10

Siding and eave damage

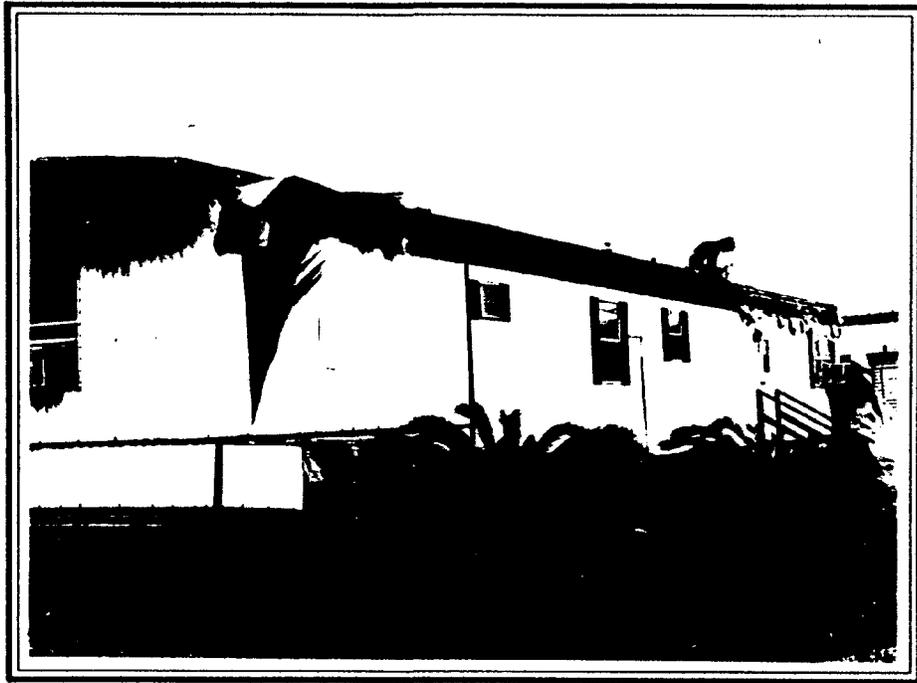
Photo #11

Siding damage

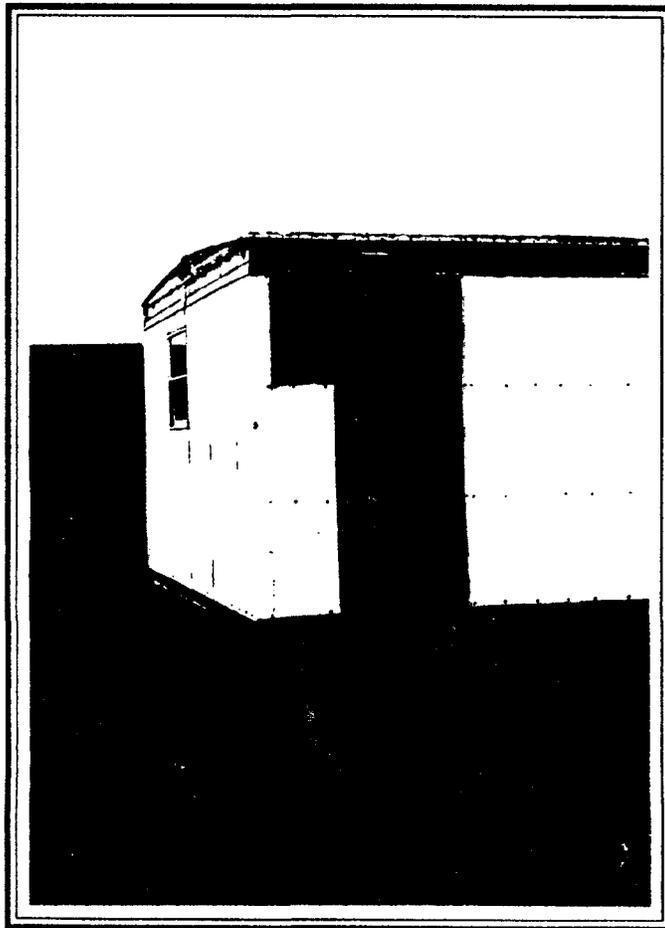
Photo #12

Siding damage

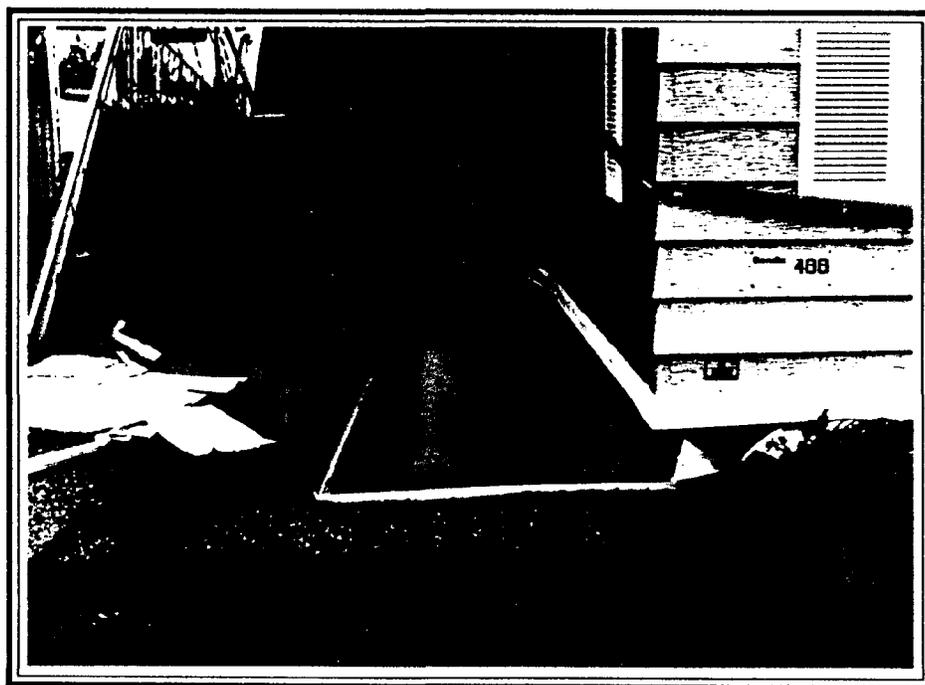
Photo #4

Homes partially shifted off piers
