THE EFFECTS OF A LIGHTNING STROKE

N. ERNEST DORSEY

[National Research Council]

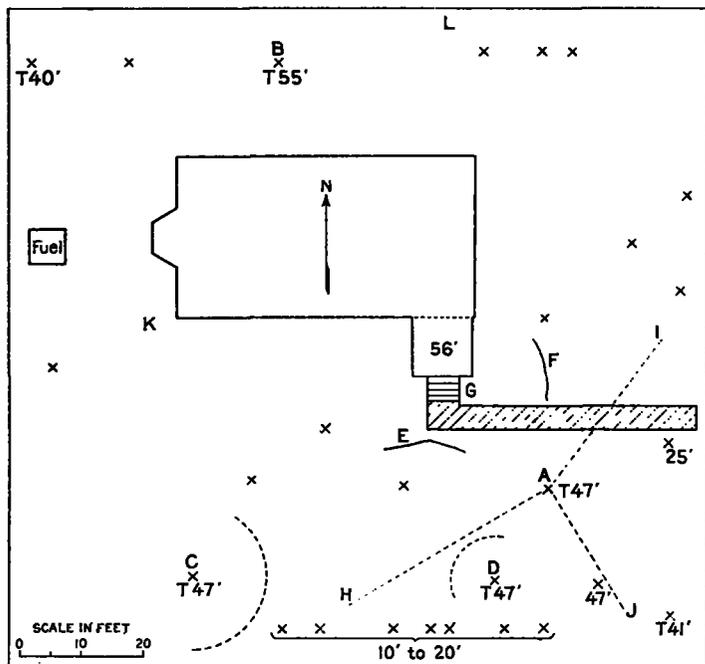
The tree which was struck is A; it was 47 feet high, and 6 inches from the ground it had a girth of 49 inches. It stands between a 56-foot tower (wood, stone foundation, no lightning rod) and three other trees of approximately its own height; of these, two are of the same kind as itself. The highest and most exposed tree in the yard is B; it was not damaged in the least. The stroke ignored both B and the tower, passed in a vertical plane between C and D, each about 47 feet tall, and finally struck A about 8 feet from the ground. The most distant splinters were found at K and L; they were small. Small splinters were on the roof of the chapel, one was sticking in the frame of the door. The only large section torn from the tree lay at E; it was 14 feet long, and was bent about as indicated (see also fig. 7). At F, was a splinter 11 feet long, and 0.5 by 1.5 inches in section. With the exception of a 4-foot splinter which was caught in the branches, and which will be

FIG. 1.—Plan of surroundings of tree A which was struck by lightning on September 13, 1925. Trees are denoted by crosses; tulip trees are marked with a T; numbers indicate height. Fuel shed is 6 feet high. Hatched area is a brick walk. Splintered segment lay in angle HAI, near ground the vertex was 4 inches below surface

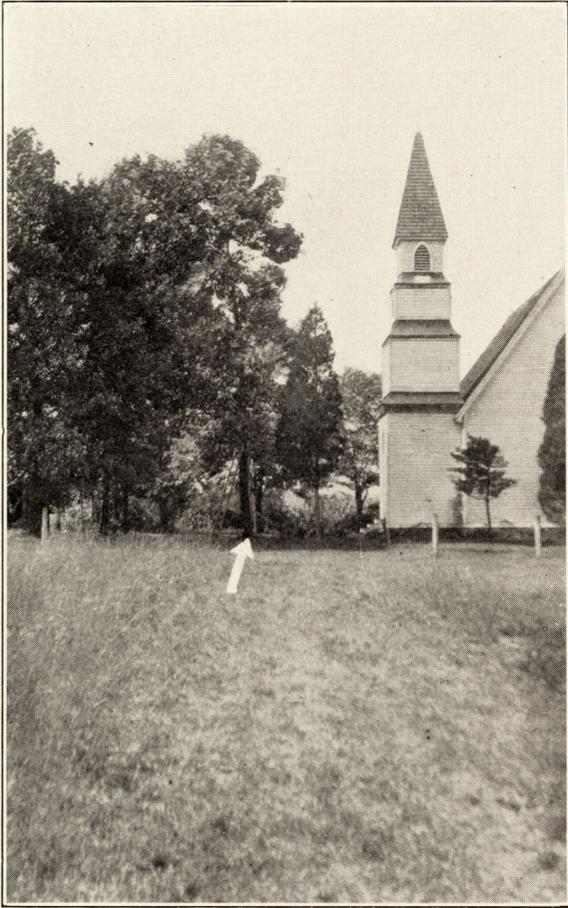
The prominent objects in the neighborhood of the tree are shown in Figures 1 and 2. Excepting a one-story concrete building about 60 feet to the east, there is no other tree or other prominent object to the west,

FIG. 2.—The arrow indicates the tree which was struck

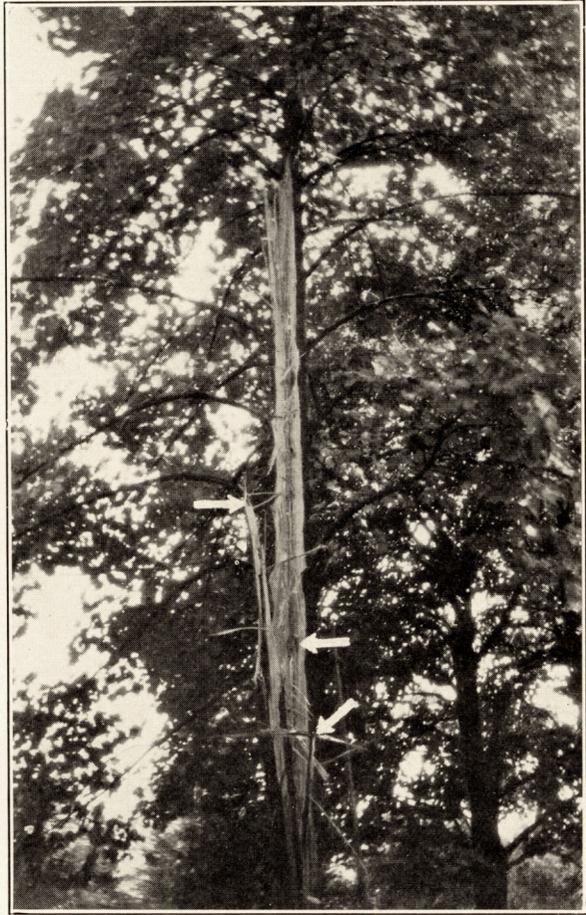
FIG. 3

Figure 3 is a view looking up and slightly to the east of southeast. At 5 feet from the ground, the splintered portion of the trunk lay in the angle HAI (fig. 1), its vertex was 4 inches from the northwest surface of the tree. Notice that the blazed portion did not extend to the top of the trunk. It had a very definite upper limit, 27 feet from the ground. The entire appearance of the damage suggests that the center of violence lay somewhere between the upper and the lower arrow—that is, between 12 feet and 8 feet from the ground. The standing splinter to the left (upper arrow) was 12 feet long, and 6 feet from the ground it had an arc of 4 inches;

sides of wedge¹ were 3.5 inches; some grass and dirt were on its upper end on Tuesday morning. At the level of the central arrow is a knot hole in the trunk, where a branch has been broken off and pulled out. On the upper side of the hole, a sliver from the branch still projected from the trunk; it can not be distinguished in the figure. At the lower arrow, notice a splinter which has been split and bent into the form of a T. This is a valuable reference object which will appear in other figures, and to which we shall have occasion to refer. We shall call it the "T splinter." The black, weathered ends of several stubs of branches, which had become inclosed by the trunk, may be seen.

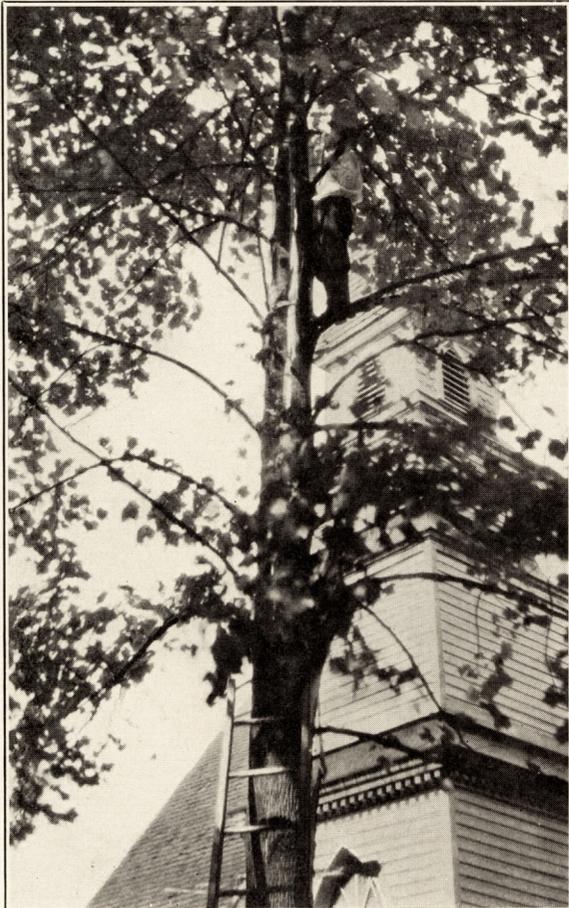
FIG. 4

bowed apart beyond the elastic limit of the wood. The blunt end of the cross of the T splinter is seen projecting across the top of the frame of the door; just below its end is seen the end of a small splinter which was caught in the frame of the door.

Figure 4 is a view looking upwards and to the northwest; it shows the split in the unsplintered portion of the trunk. The split lay in the vertical plane through AJ (fig. 1). The extreme top of the split was near the top of the blaze, about on the level of the boy's head; he is 4 feet 8 inches tall. The lower 30 inches of the trunk was unsplit. The two sides had merely been

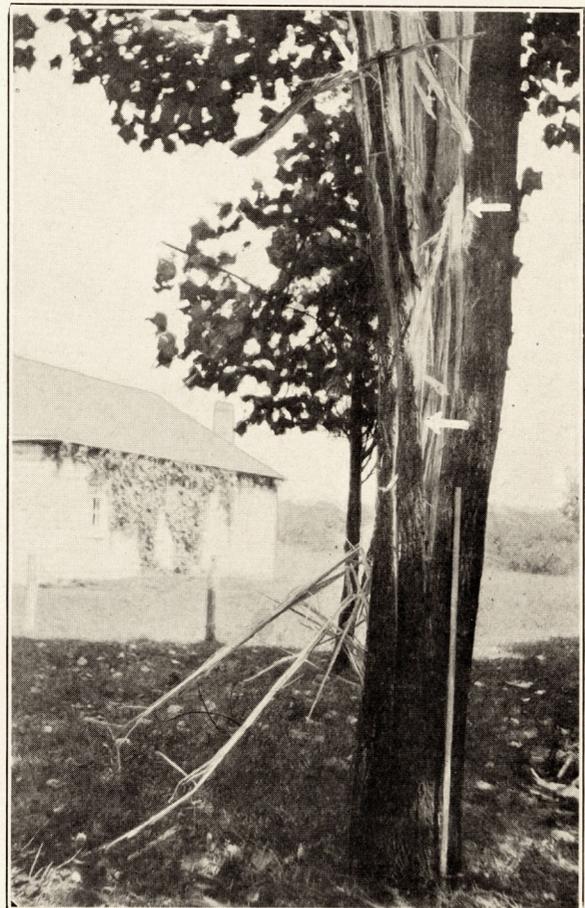
FIG. 5

Figure 5 is a view looking slightly north of east. The rod leaning against the tree is 4 feet long. Note the large standing splinters; also the small ones which have been driven out from the interior and broken down, and which are now firmly clamped between two of the standing splinters. At the upper arrow is the top of the T splinter. At the lower arrow and in the interior, may be seen the upward pointing end of a reflexed sliver which is attached to the farther of the two up-standing splinters. This sliver was one inch wide, 0.5 inch thick, and 28 inches long, and was attached to the standing splinter at a point 54 inches from the ground.

At 5 feet from the ground, the standing splinter had an arc of 3 inches, sides of wedge were 3 inches. In order for the sliver to be able to fly clear of the standing trunk so as to be caught and bent into an angle of 30° , as shown, this splinter must have been blown out to a considerable distance from the vertical. If its deflection was such that it was bent into an arc of a circle tangent to the vertical at the ground, then the radius of that circle could not have been greater than 4 feet, and the chord joining the base of the splinter to the point of attachment of the sliver must have made with the vertical an angle of over 30° .

Along the edge of the unsplintered portion of the trunk, extending from the central arrow to the ground, there was a strip of bark 0.75 inch wide which had been frayed out as if whipped by the wind. It lay along a crack. From its lower end, and in the plane of the crack, there was a shallow furrow in the ground. The furrow was an inch in diameter and about 11 inches long. With the exception of two insulated frayed areas and four small punctures, this frayed strip was the only portion of the bark which was damaged except by a purely mechanical tearing. The four punctures will be described in a later paragraph.

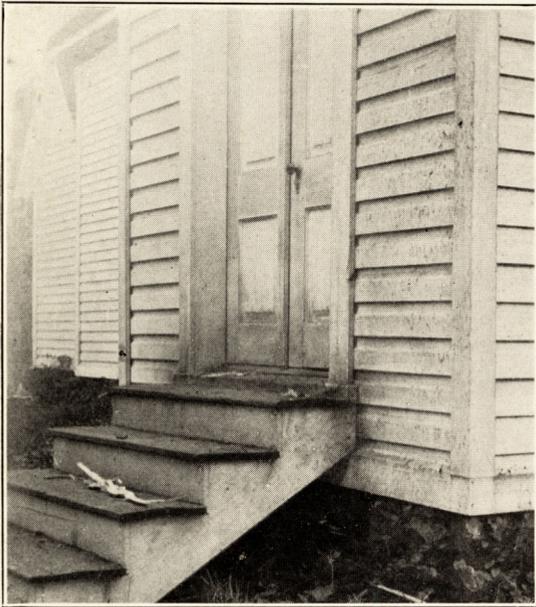
FIG. 6

Some rain had fallen earlier in the evening; it is not known positively whether it rained much after the stroke, but the appearance, the next morning, of the ground in the corner by the steps (G, fig. 1), and the fact that leaves and dirt were still adhering to the wall of the tower (fig. 6) indicate that it probably rained but little after the stroke.

Figure 6 is interesting in showing how small leaves and dirt were spattered over the south side of the tower, to a height of 9 or 10 feet; none was on the east side. The ground in this corner, between the steps and the wall, gave no evidence of more than very superficial disturbance, but that disturbance was pronounced; the grass and débris had the appearance of having been combed upwards. The disturbed area was entirely within the rectangle (28 by 48 inches) between the steps and the wall (G, fig. 1). Only a few small splinters were found in this corner.

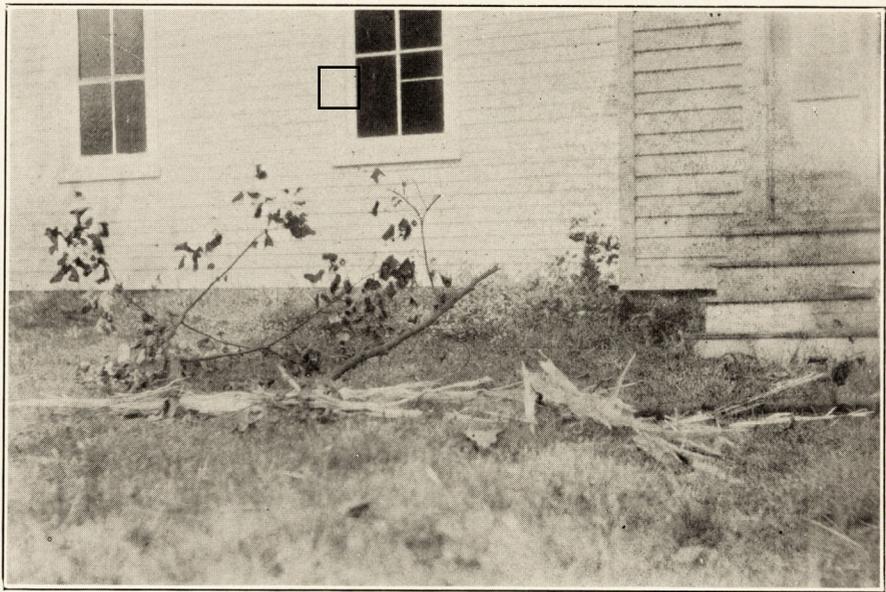
FIG. 7

Figure 7 shows the only large section which was torn from the tree. It was bent approximately as shown at E (fig. 1), convex toward the bark; the lower end was to the east; the bend lay 20 feet from the tree. From the bend to the lower end was about 6 feet. This portion points about 30° to the right of the camera; the branch projecting from it and seen lying in front of the steps is the one which came from the knot hole at the central arrow of Figure 3; its junction with the section was about 3 feet from the bend. Neither end of this section dug into the ground; the condition of the ground and the appearance of the dirt adhering to the bend clearly indicated that the section struck upon the bend. The section must have been so bent before it left the tree.

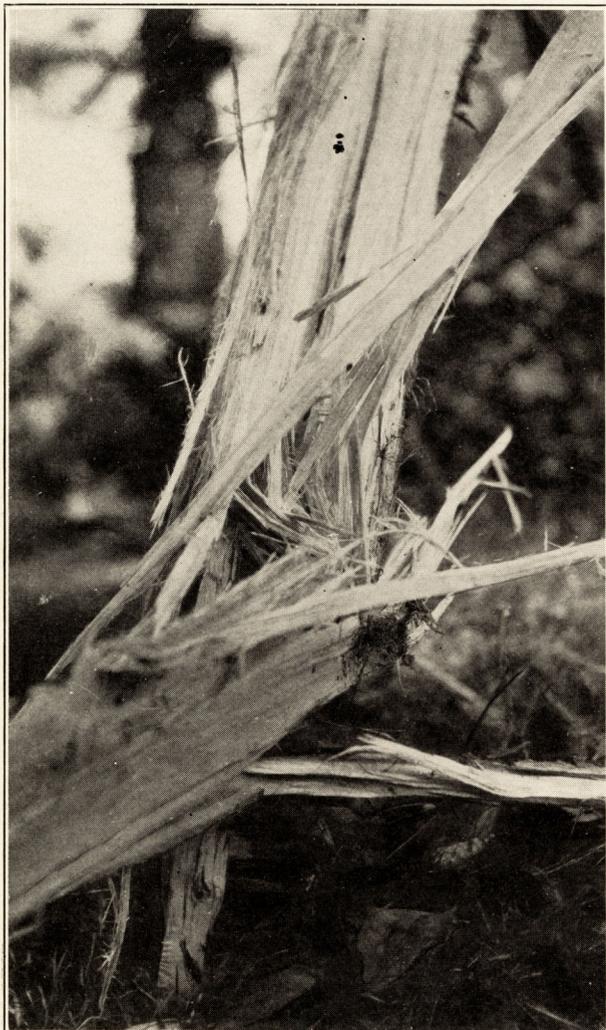
FIG. 8

Figure 8 shows the bend of the large section shown in Figure 7; the section has been readjusted so as to obtain a more suitable view; the upper end extends to the left. Notice how the fibers have been crumpled. An examination of the bend showed that the two portions of the section had been driven together, crumpling and crushing the fibers. As the section struck upon the bend, this damage must have occurred before the section left the tree.

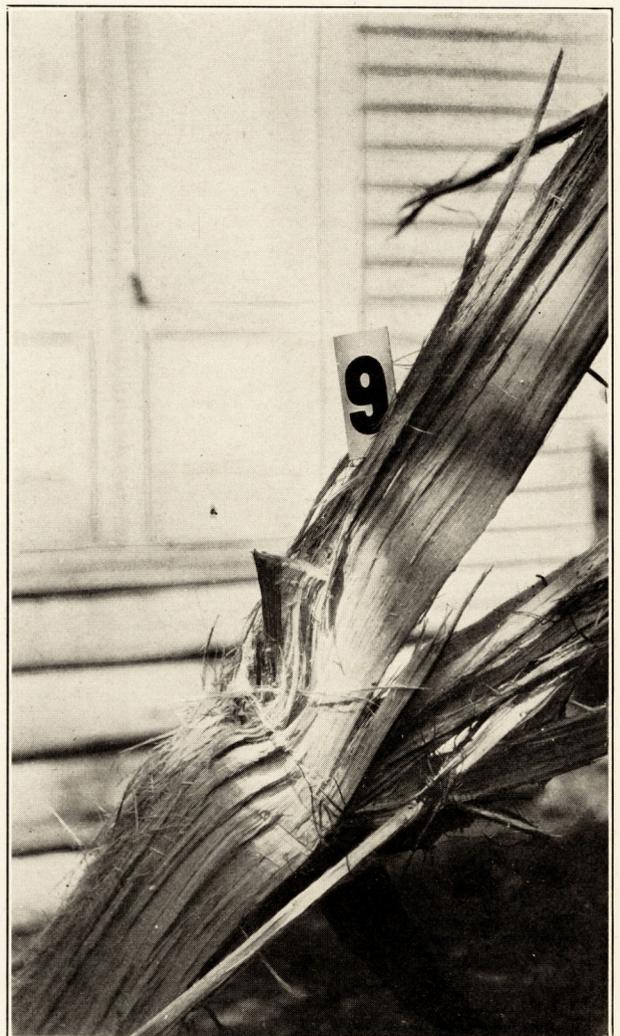
FIG 9

Figure 9 shows the broken butt of the limb projecting from the lower portion of the section shown in Figure 7; here it is upside down. The limb itself may be seen below the section. Notice how squarely the butt has been broken; the fibers were not twisted nor split apart in the least. Where the break occurs, the fibers of the limb have become nearly parallel to those of the main trunk. This broken butt fitted into the knot hole at the central arrow of Figure 3. That hole was 10 feet 3 inches from the ground, and was nearly 1.5 inches deep. Furthermore, the sliver which still projected from the trunk fitted into the cavity at the left of the butt; this cavity was about 2 inches deep. The branch has been broken off squarely across the grain, and has been pulled out of the trunk as a tenon might be pulled from a mortise; in doing this, the sliver attached to the trunk has, reciprocally, been pulled from this section without damage to itself, although it was only 1 inch wide and near its tip was only 0.25 inch thick. Such a breaking and pulling apart could have resulted only from a tension which was quite closely along the direction of the fibers lying in the plane between the sliver and the butt; these made an angle of 33° with the vertical. What seems to have occurred is this: A force directed about 30° from the vertical was exerted upon the lower portion of the section (fig. 7) containing the limb; when the limb tore apart, this portion of the section drove into the upper portion, crumpling and crushing the fibers at the bend (fig. 8), prying off the upper 8-foot portion and driving the entire section upward and outward. This tore loose from the outer portion of the trunk a bark-covered splinter, 4 feet long, arc 5 inches, sides of

Herein seems to lie the explanation of the square break. In its rush up the fibers, the shredding agent encountered the overhanging and somewhat cupped fibers above the branch, and was unable to penetrate them transversely with sufficient freedom to prevent the stresses from becoming greater than the tree could stand, even though most of the agent continued along the fibers, around the bend, and upwards.
