NOAA TECHNICAL MEMORANDUM NMFS F/NWR-28

A BRIEF REVIEW OF DAM REMOVAL EFFORTS IN WASHINGTON, OREGON, IDAHO AND CALIFORNIA

BRIAN D. WINTER

APRIL 1990

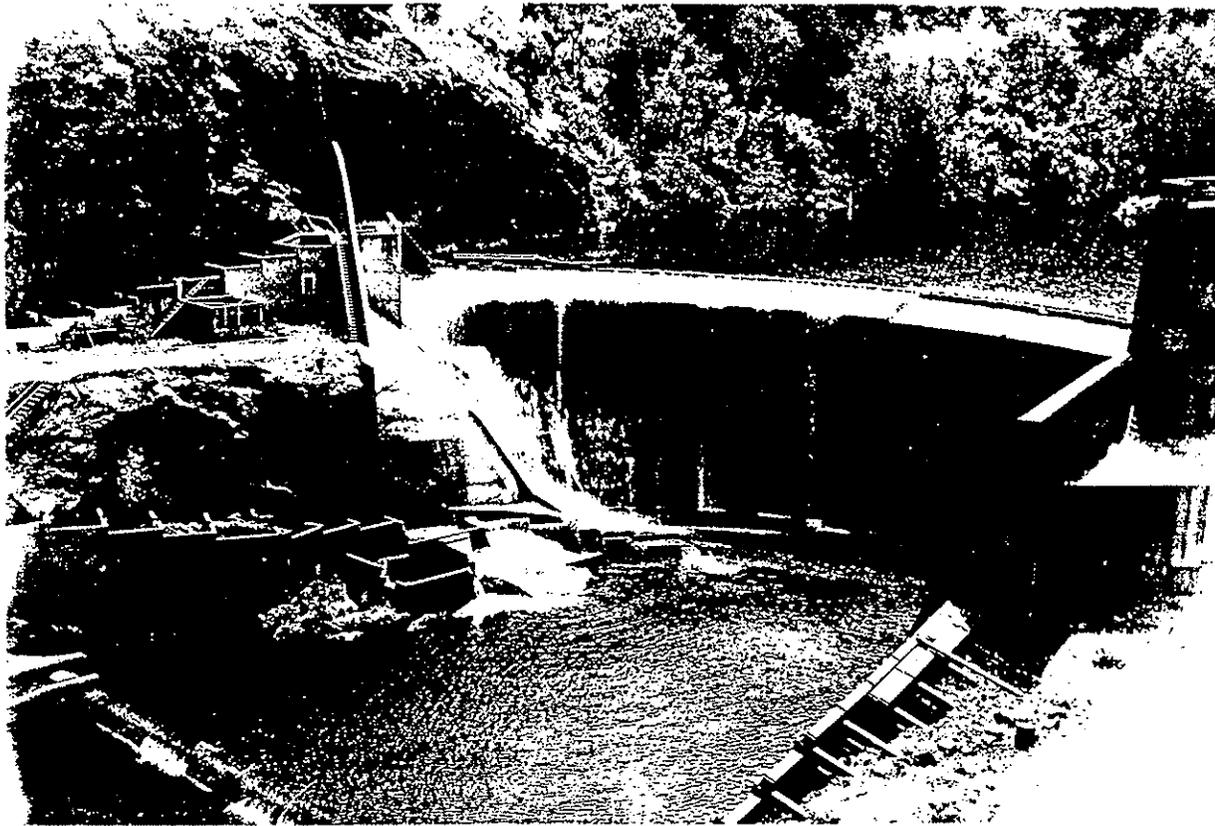
FIGURE 5. Sweasey Dam.

Sweasey Dam was located northeast of Eureka, California, on the Mad River (Figure 4). The spill crest rose approximately 55 feet above the river bottom (Figure 5) and was provided with

a functional fish ladder (Walter, pers. comm.). The dam was built to provide approximately 1,300 acre feet of municipal water supply storage. However, the dam was designed for only a limited (about 20 years) life expectancy (Walter, pers. comm.). By 1969, severe winter storms had completely silted in the reservoir. According to the Humboldt County Department of Public Works, this represented "...2,400,000 cubic yards of sand, gravel and logs" (Titera 1969a).

In September 1969, a COE representative inspected Sweasey Dam. Based on this site visit, the COE developed some general conclusions: (1) there was an estimated 1,500 acre feet of sediment behind the dam; (2) release of sediments downstream could result in an increase in flood stage of about one foot; (3) if an abundance of fines were present, some adverse impacts to fish spawning could occur; and (4) adverse impacts should decrease with time but could disappear in just a few years (Reilly 1969).

On October 14, 1969, the California Department of Fish and Game (CDFG) granted the City of Eureka the permission to remove Sweasey Dam through the use of explosives. Two of the conditions set forth by the CDFG included: (1) all rubble or debris could not exceed three feet in diameter and (2) a 30 foot wide channel had to be cleared upstream and downstream of the dam site (CDFG 1969).
