Subject: Technical Memorandum, Characterization Soil Sample Collection at the Former
Big Polovina Hill Debris Pile

This technical memorandum documents the results of a characterization sampling effort at the Big Polovina Hill Debris Site (debris site), owned by the National Oceanic and Atmospheric Administration (NOAA) on St. Paul Island, Alaska. The site is also known as NOAA Site 44, a non-Two Party Agreement (TPA) site (NOAA 1996). St. Paul Island is approximately 800 miles southwest of Anchorage in the Bering Sea (Figure 1). Big Polovina Hill is located at the east end of the Island, approximately 2 miles northeast of the airport, at Latitude: 57 11 7.40 N Longitude: 170 11 36.38 W. During the fall of 2005, NOAA submitted a sampling plan (NOAA 2005) for the collection of soil samples at the site to characterize potential petroleum contamination that had been found in an earlier sampling effort. The sampling plan was subsequently approved by ADEC (ADEC 2005), and the sampling was carried out by NOAA in October, 2005. This Technical Memorandum provides the results of that sampling effort.

Photo Log
October 15, 2005 Characterization Sampling at the Big Polovina Hill Debris Pile

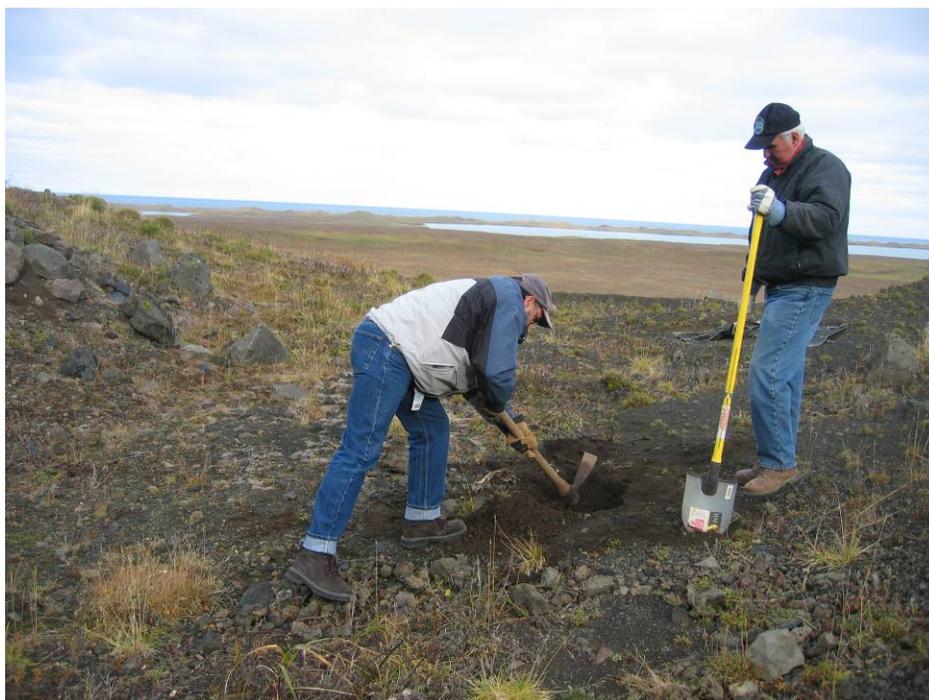
Photograph 1. NOAA employees digging to 18 inches deep at sample location SP44-CH001 at the Big Polovina Hill Debris Pile site, facing north. October 15, 2005.

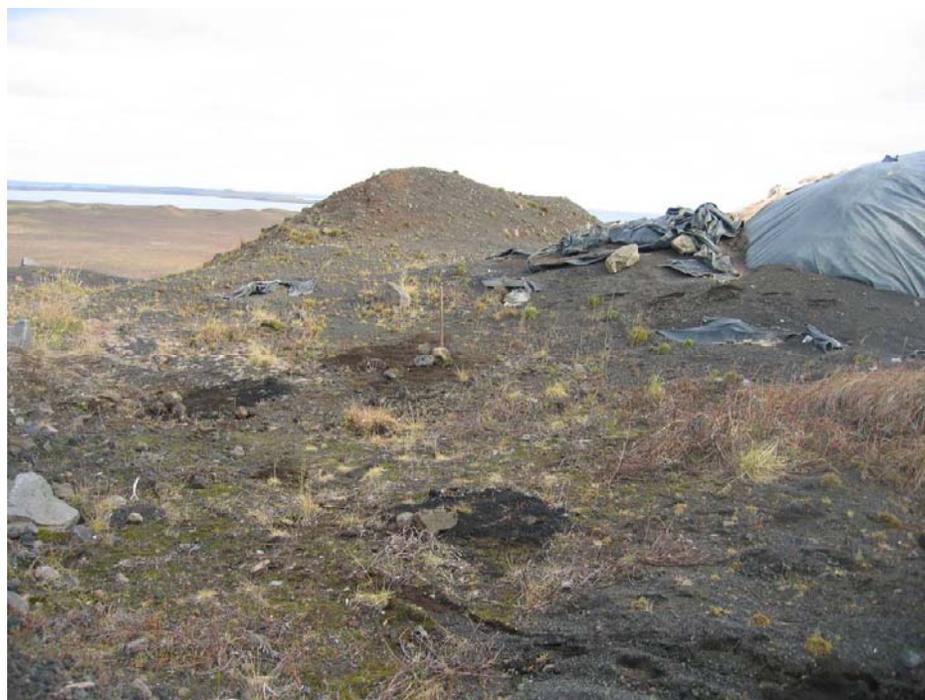
Photograph 2. Disturbed soil showing locations of the three characterization samples collected by NOAA on October 15, 2005. Facing Northeast.
