Port of Miami *Acropora cervicornis* Relocation Report

Final Report

Prepared by NOAA National Marine Fisheries Service

February 13, 2015

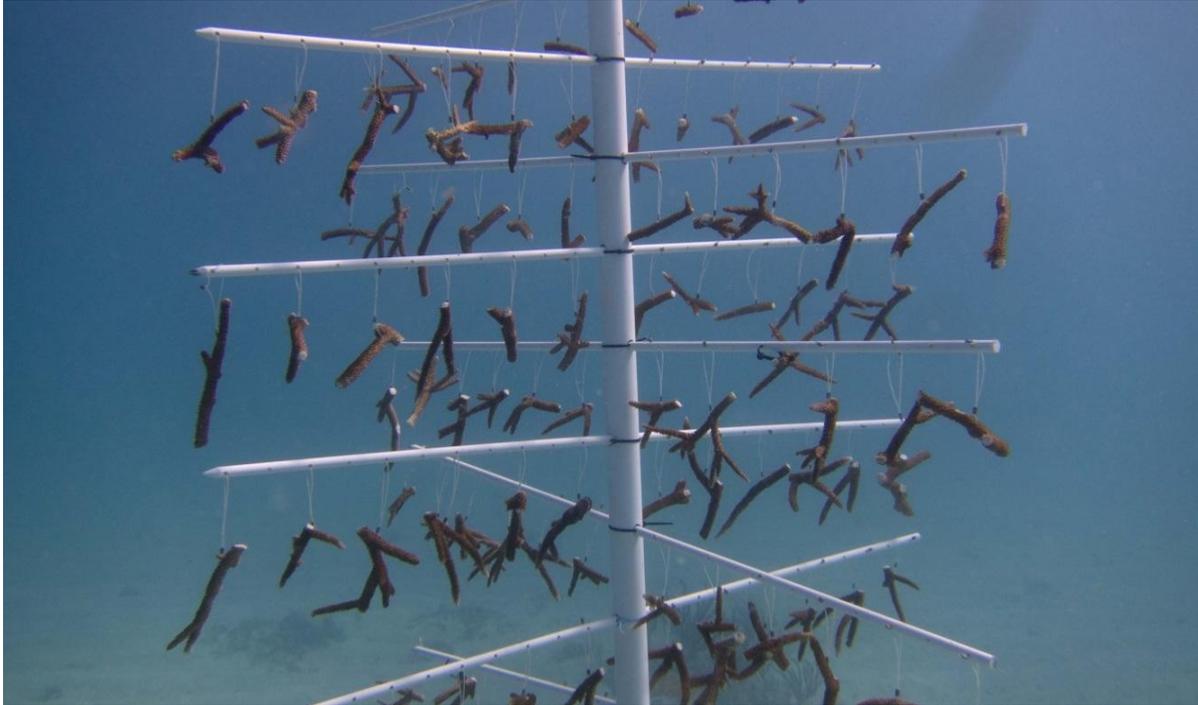
Figure 4: Photo of *A. cervicornis* fragments on PVC trees in the coral nursery off Key Biscayne where they will be allowed to recover until dredge operations finish at the Port of Miami and sedimentation issues are no longer a concern.

The colonies were relocated to the coral nurseries off Key Biscayne run by partners from the University of Miami. These corals were used to generate 1,059 fragments (average 10 cm diameter) in the nursery after dead portions were trimmed away, and the fragments were prepped for nursery hanging (Figure 4). There, they will be allowed to recover until dredge operations finish at the Port of Miami and sedimentation issues are no longer a concern. The corals can then either be transplanted back onto the reef where they originated or used as broodstock in the nursery to propagate more corals for future restoration.

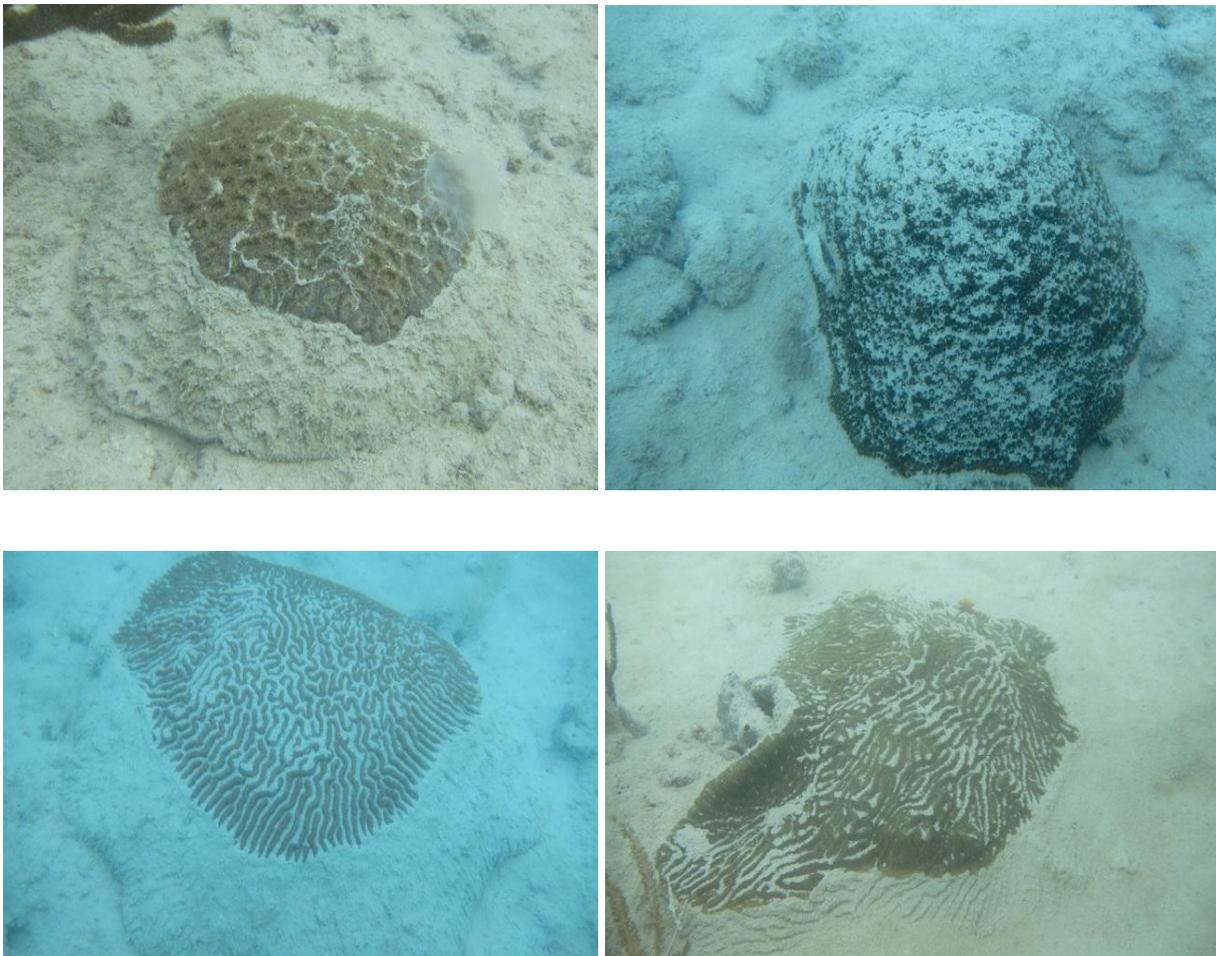
Figure 6: Accumulation of sediment on corals (and resultant partial mortality of basal portions of the colonies) in areas adjacent to the dredging. The colony of *Montastraea cavernosa* on the top left has its tentacles out and is actively producing mucus to remove the sediment. This sediment then accumulates on the lower section of the colonies causing mortality.

Divers reported observations of severe sediment impacts on the Inner Reef located north and south of the Federal Channel. Observed sedimentation impacts included, but are not limited to coral mortality, burial by sediment, accumulation of fine and clay-like sediment on the coral tissue forcing the corals to expend energy to remove the sediment either through polyp distension, tentacular action and/or mucus production. Examples of this can be seen in Figure 6. NOAA's observation of mortality above does not represent the total mortality, even of colonies surveyed. NOAA's observations are consistent with well documented, easily observable stress reactions to recent sedimentation on corals (Hubbard and Pocock, 1972; Erftemeijer et al., 2012; Pollock et al., 2014). There are additional stress factors related to sedimentation that are not so easily measured or discernable from background levels including reduced fecundity, productivity, growth and photosynthesis; and increases in algae, bleaching and susceptibility to disease (Erftemeijer et al., 2012; Flores et al., 2012). Coral mortality associated with the sedimentation on Inner Reef from the ongoing turbidity/sedimentation event varied from complete tissue mortality or colonies that exhibited a distinct concentric ring of mortality around the base of the colony (Figures 6 and 7). Some colonies were unable to keep up with sediment removal, resulting in an accumulation of sediments around the lower portions of the colony resulting in smothering and eventually tissue mortality. Notably the stony coral species documented to have this pattern of mortality include, but are not limited to, *Colpophyllia natans*, *Montastraea cavernosa*, *Dichocoenia stokesi*, *Porites astreoides*, *P. furcata*, *Meandrina meandrites*, *Diploria strigosa*, *D. labyrinthiformis*, *Solenastrea bournoni*, *Stephanocoenia intersepta*, and *Siderastrea siderea*. One reference dive was completed on October 29, 2014, at a reef located near the coral nursery, referred to as Emerald Reef. While bleaching was observed at Emerald

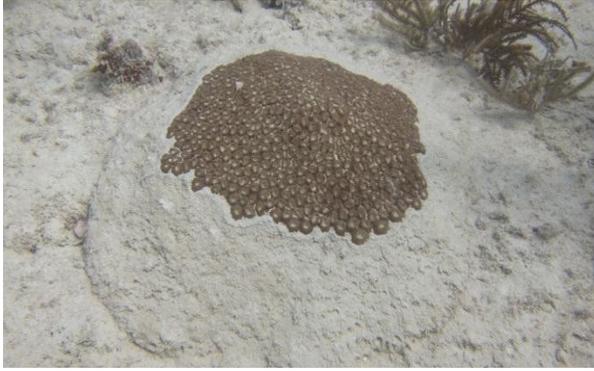
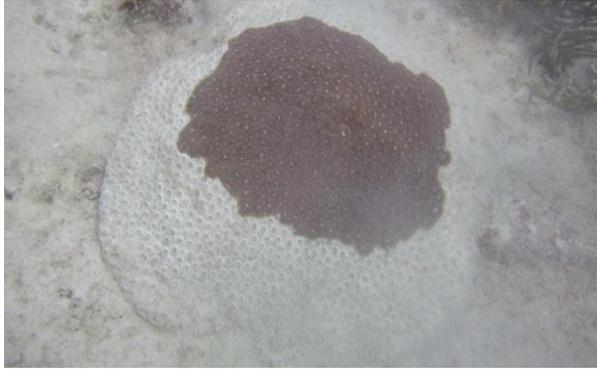
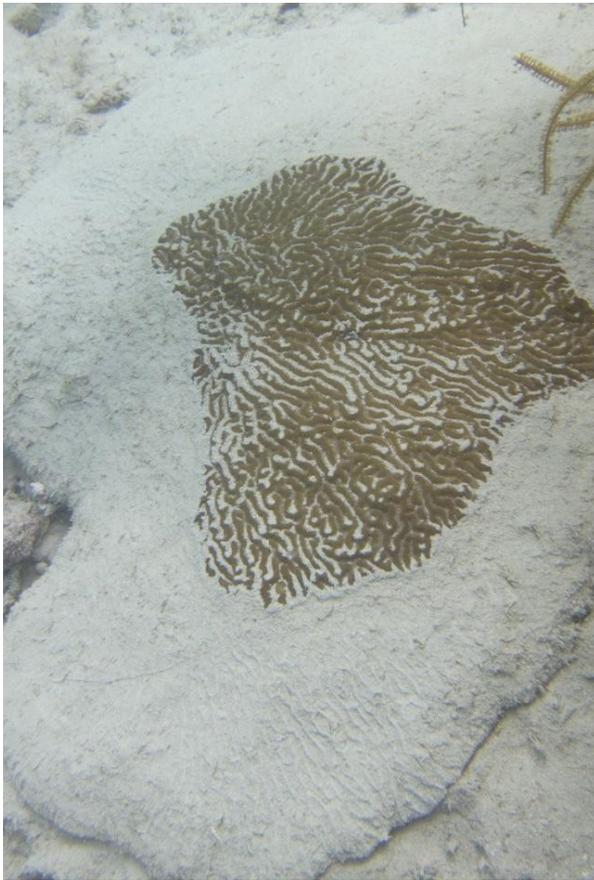
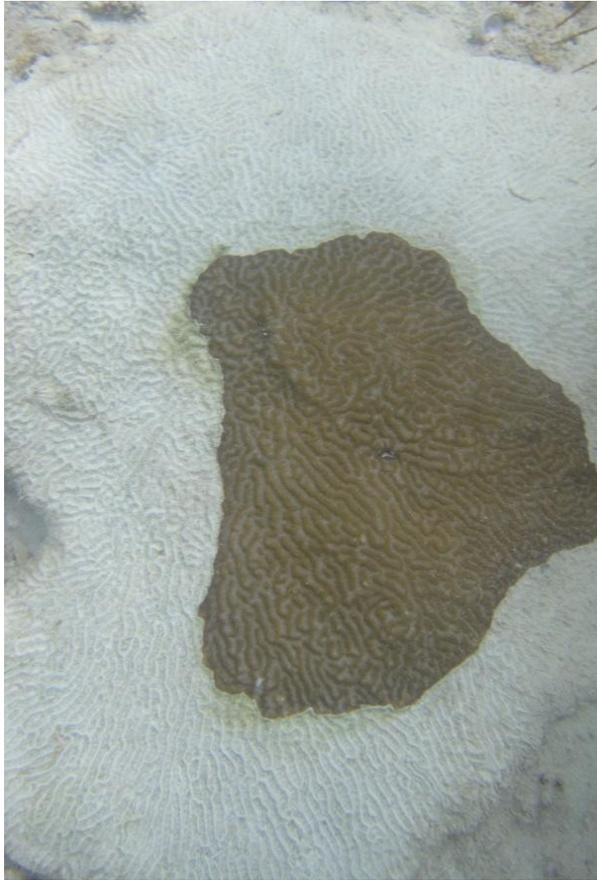
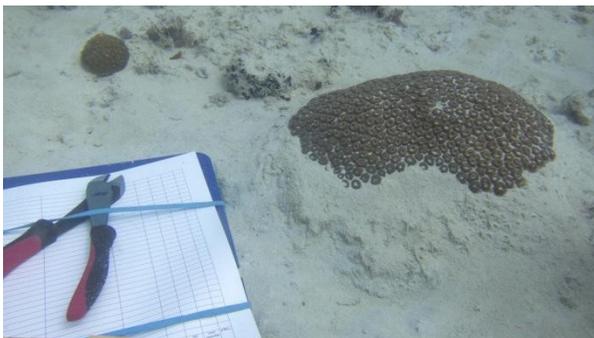
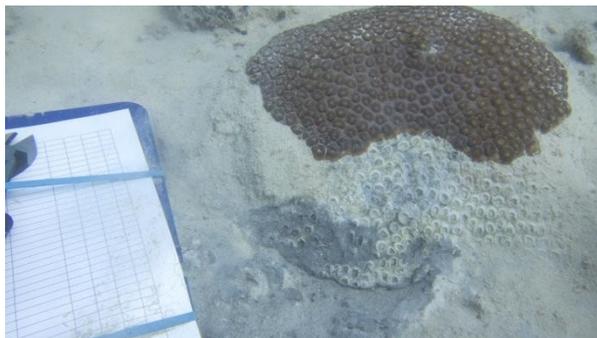
Figure 7: Coral colonies before (left photos) and after (right photos) divers cleared sediment from the corals showing accumulation and recent mortality (exposed white skeleton) along the lower portions of the colonies as a result of accumulation of fine and clay-like material (sedimentation)

Reef, the distinct pattern of mortality (i.e., concentric ring of mortality around the base of the colony) observed on Inner Reef adjacent to Federal Channel during dredging operations was not seen at Emerald Reef nor was the fine and clay-like material observed. It will be easier to detect sediment impacts with a high degree of confidence in the immediate short-term. As time goes by, the dead portions of the colony could be colonized by algae and it will become more difficult to determine sediment impacts.
