STEER Watershed Existing Conditions Report

May 2013

Horsley Witten Group, Inc.

The STEER Watersheds Assessment and Planning Project is part of a three-pronged effort sponsored by the NOAA Coral Reef Conservation Program to support protection of the St. Thomas East End Reserves (STEER) through monitoring, use studies, and watershed restoration activities. This report supplements the 2013 STEER Watershed Management Plan.

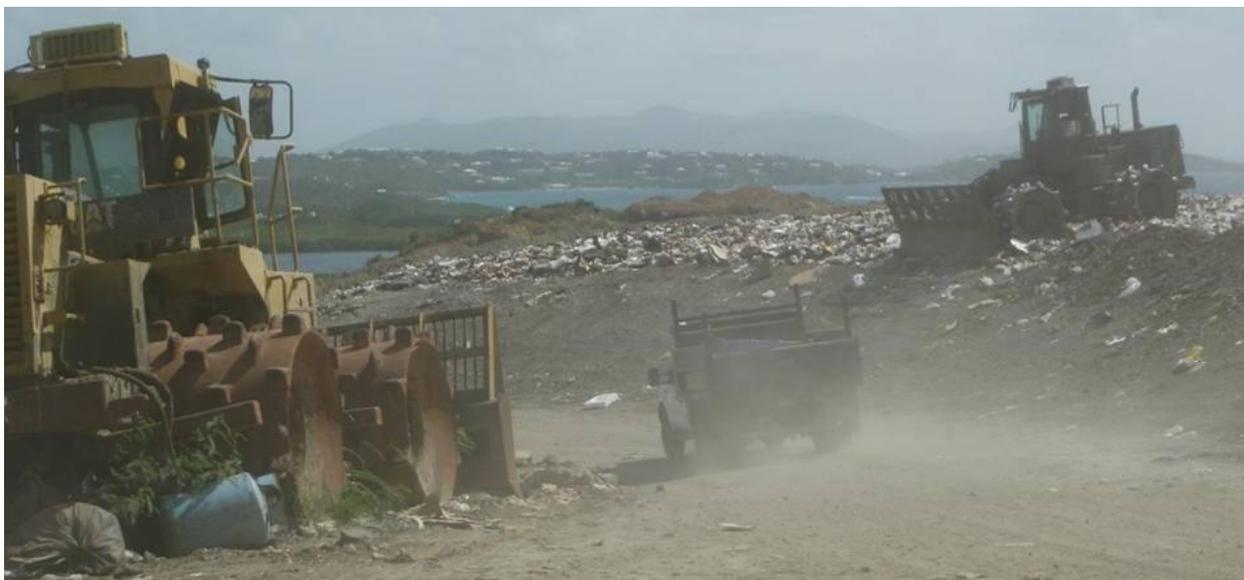
One of the biggest sources of pollution from the Bovoni Subwatershed is the Bovoni Landfill.

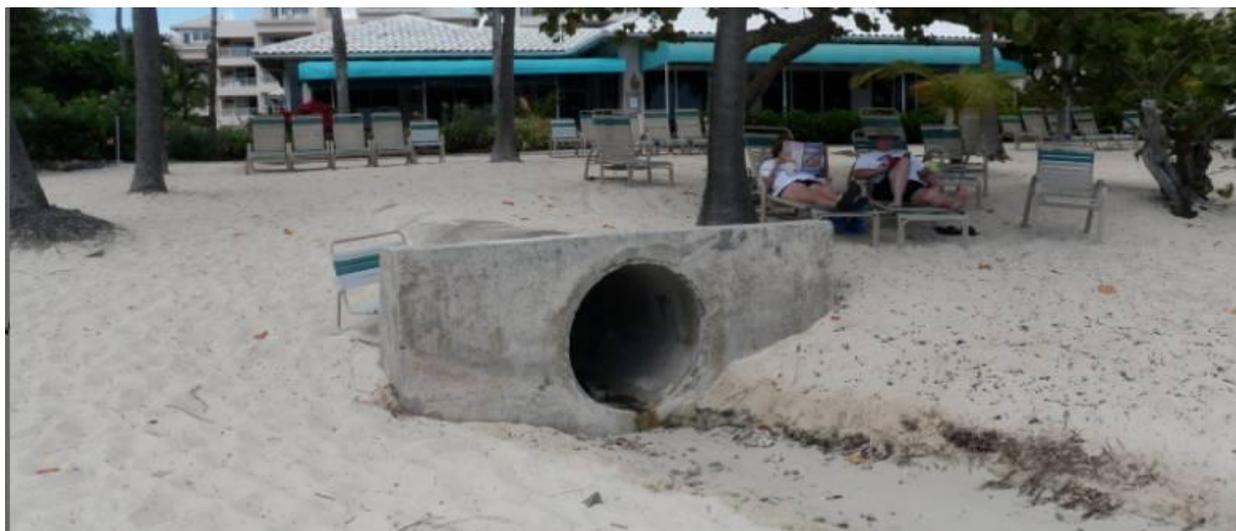
Untreated stormwater runoff from roads, parking lots, and rooftops (excluding cisterns) drains to Cowpet Bay.

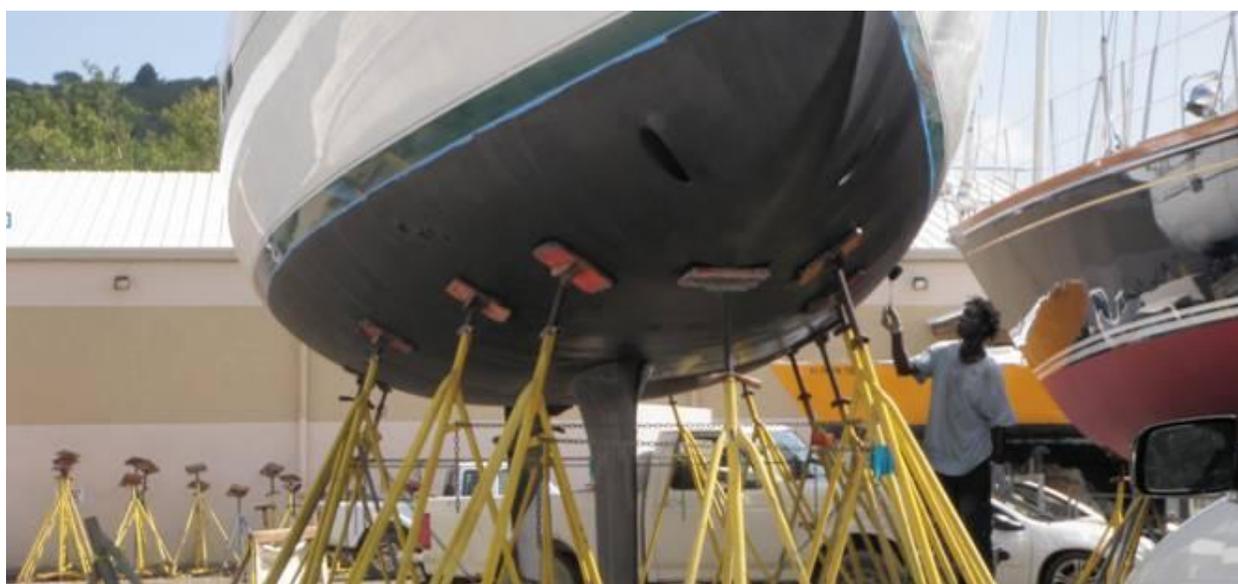
Boatyards along Benner Bay/Marina Lagoon have been linked to high TBT levels in benthic sediment samples.

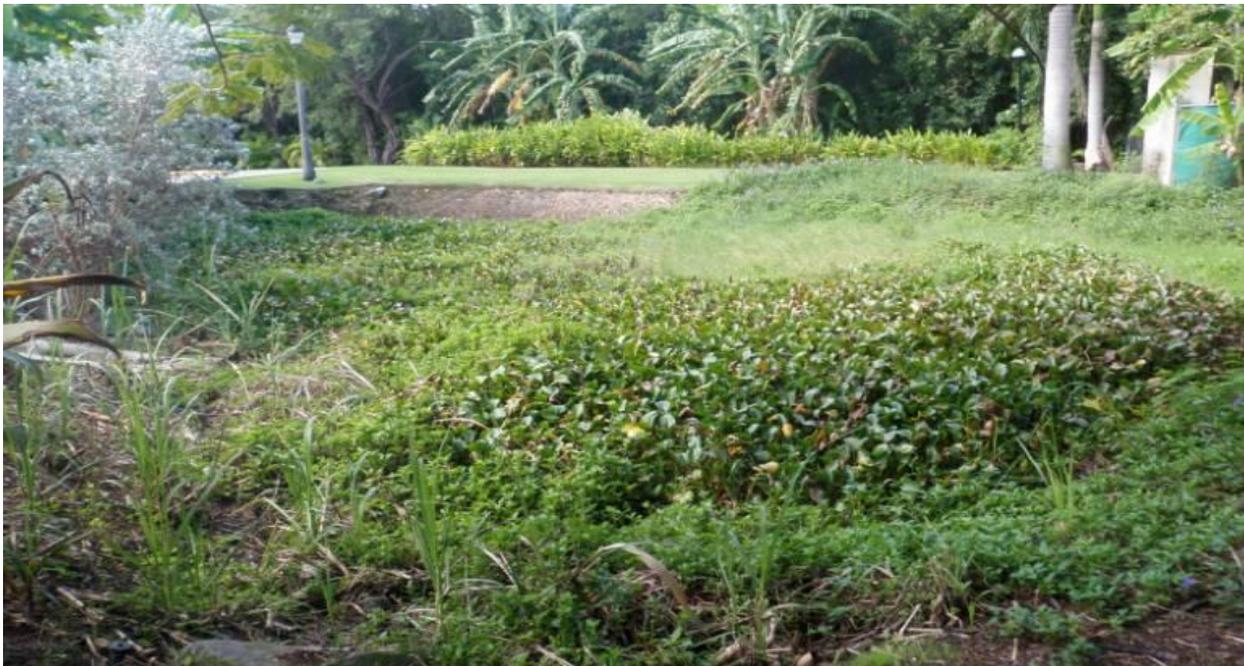
Example of an existing stormwater management facility at the Ritz Carlton.

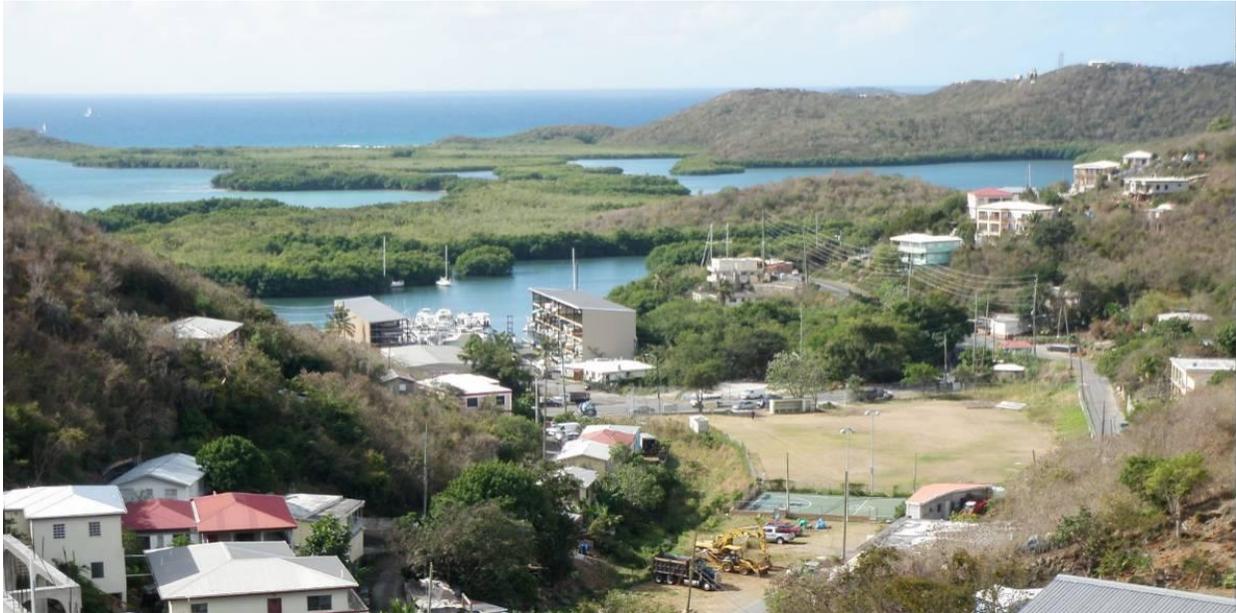
The Nadir gut and adjacent Nadir Community Park is visible from the residential area above.

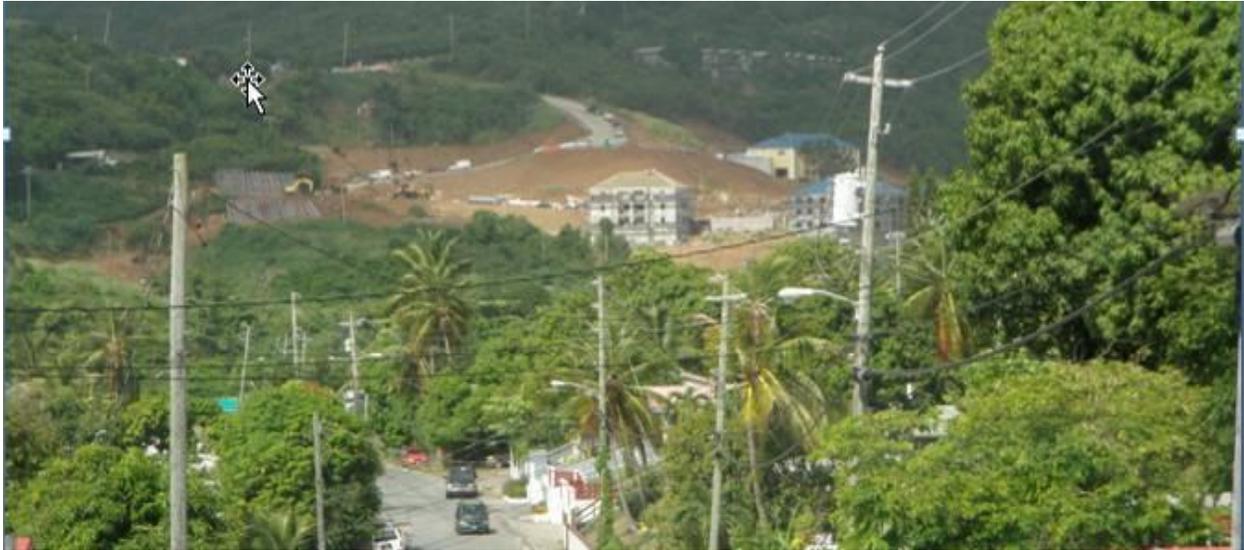
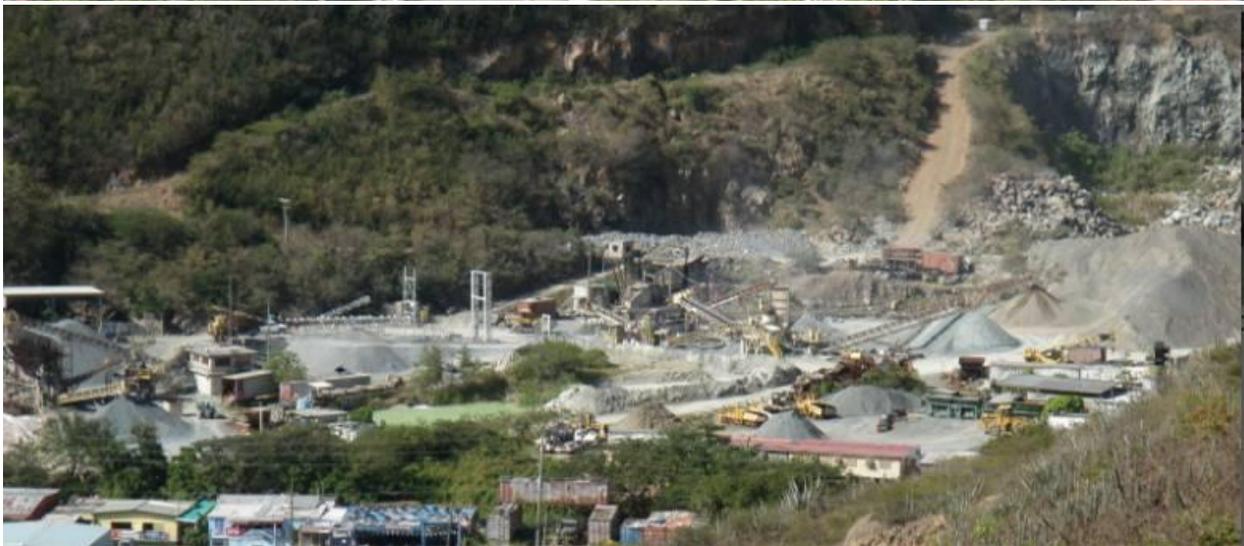
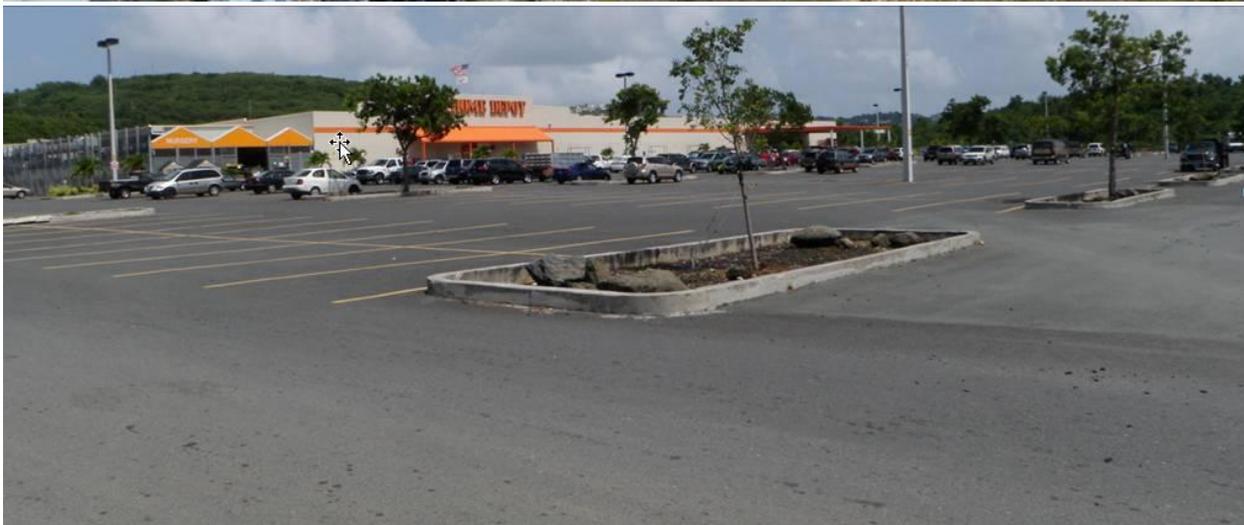
Turpentine Run generates a lot of polluted runoff from new construction (top); industrial uses, and unmanaged impervious cover.

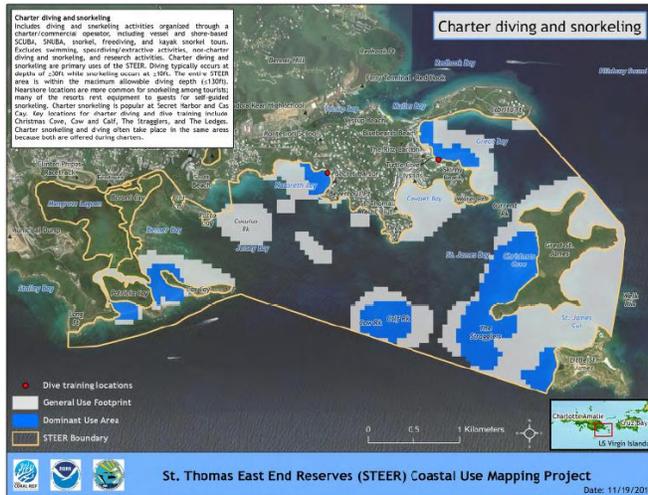
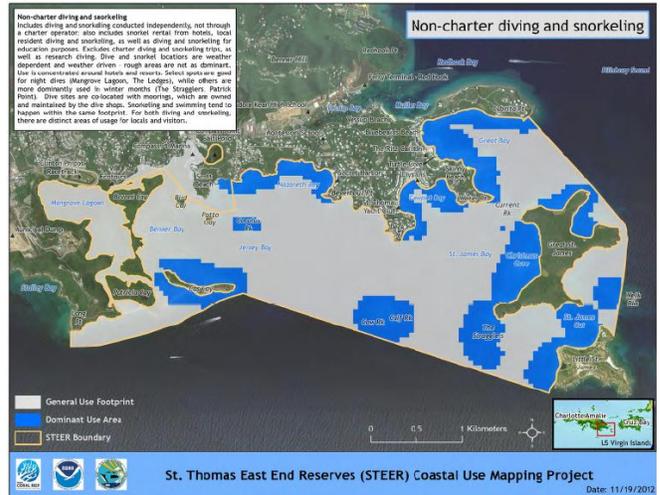
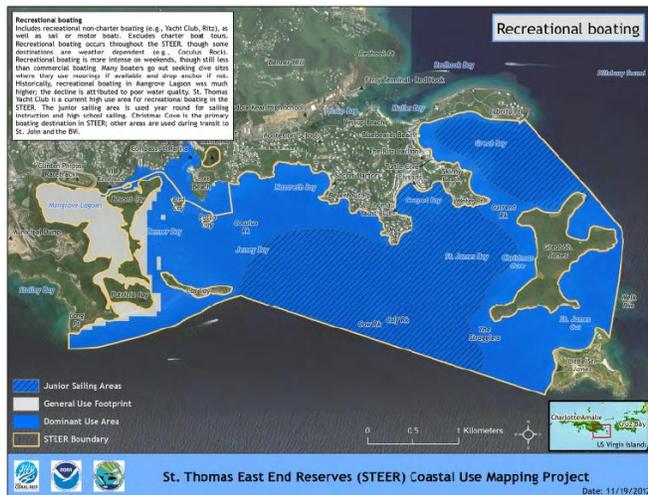
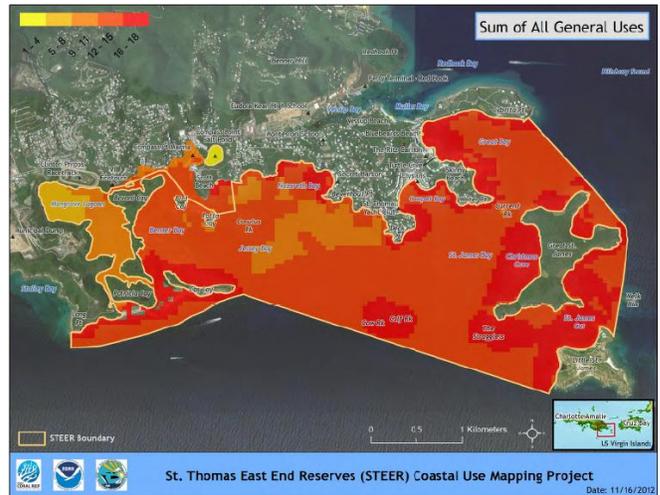
Example maps generated during the 2012 STEER Coastal Use Survey (NOAA) showing general (grey shading) and dominant (blue shading) areas for a variety of uses. The top two maps show charter (left) and non-charter (right) diving and snorkeling, which gives an indication of tourist vs. local resident use. The bottom left shows the recreational boating areas within STEER. The bottom right, is a general “heat map” that combines all the uses surveyed to show where the most commonly used areas are. This map shows the little use of Mangrove Lagoon, which has declined in use from historic levels, reportedly, due to water quality issues.

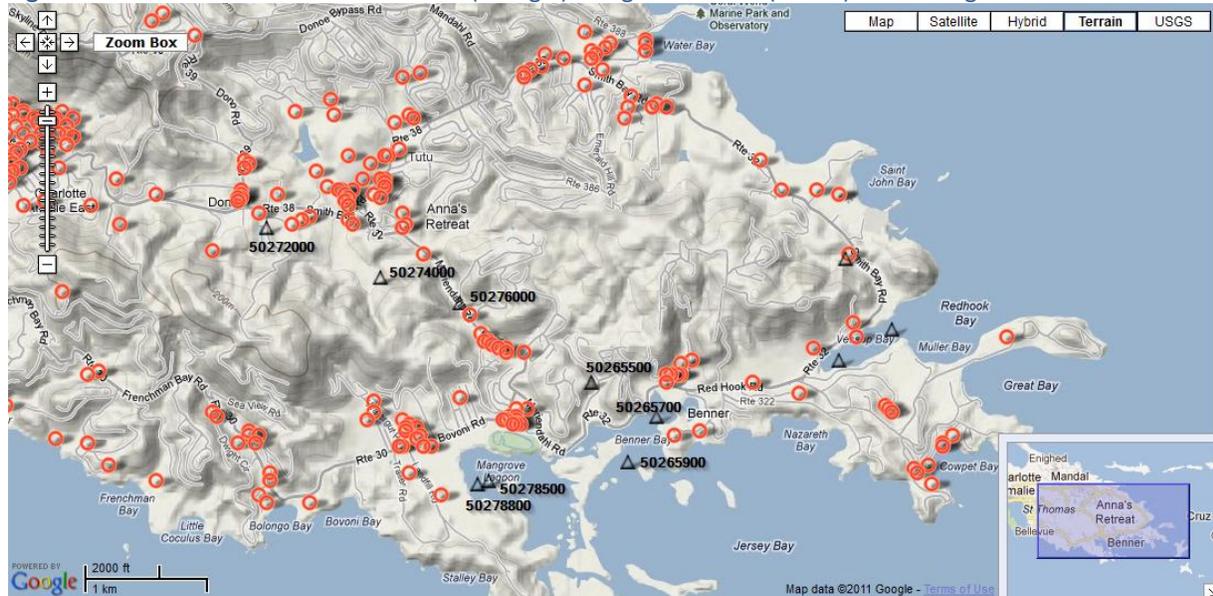
Figure 6. USGS active and inactive surface (triangle) and groundwater (circles) monitoring stations

The USGS Caribbean Water Science Center <http://nwis.waterdata.usgs.gov> maintains flow records for two stream gauges on Turpentine Run. Figure 6 shows the locations of these two stations, as well as other surface and groundwater monitoring stations (active and inactive) where data records are available:
