# Third Year Work Product Coastal Geological Studies

**Preliminary Evaluation - Offshore Reefs  
Recreational Capacity - Beaches and Bluffs  
Effect of Coastal Processes - Waukegan  
and Great Lakes Harbors  
Bluff Recession and Denudation**

A PRELIMINARY EVALUATION  
OF  
LAKE MICHIGAN "REEFS"  
IN ILLINOIS  
AS POTENTIAL BREEDING SITES  
FOR INDIGENOUS FISH SPECIES

Prepared by the  
ILLINOIS STATE GEOLOGICAL SURVEY  
for  
THE ILLINOIS COASTAL ZONE  
MANAGEMENT PROGRAM

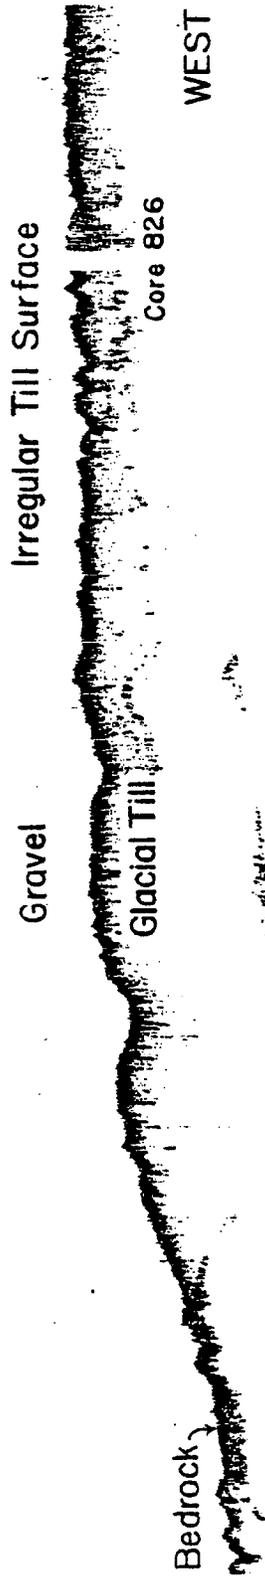
Fig. 10 - Seismic geophysical profile extending due east from Glencoe (Dundee Road). The profile shows a bedrock reef as well as bedrock in the lake floor. The irregular upper surface of the Wadsworth Till covers the area nearest the shore whereas the smooth surfaced lacustrine silt and clay of the Lake Michigan Formation covers the areas near the reef. Fig. 3 shows the profile location. Fig. 4 shows an interpretive geologic cross-section.

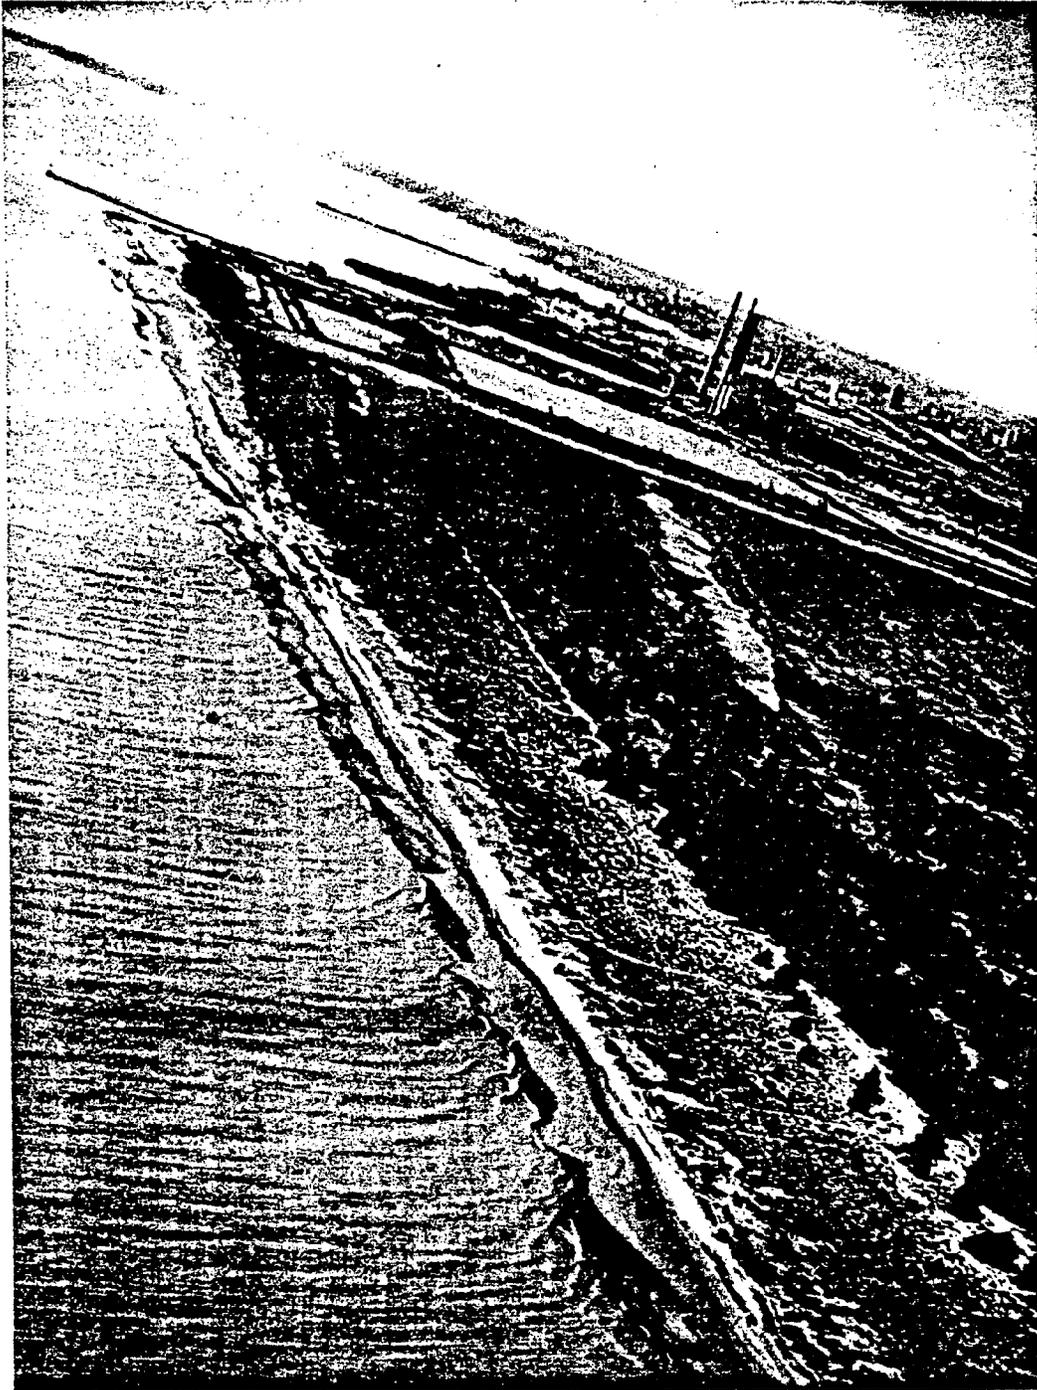
Fig. 2 - This photograph shows the wide stable beach from the Illinois Beach Nature Preserve to Waukegan Harbor. About 75 percent of the shoreline from the Wisconsin state line to the harbor is suitable for heavy recreational beach use. (see Maps 7-10)

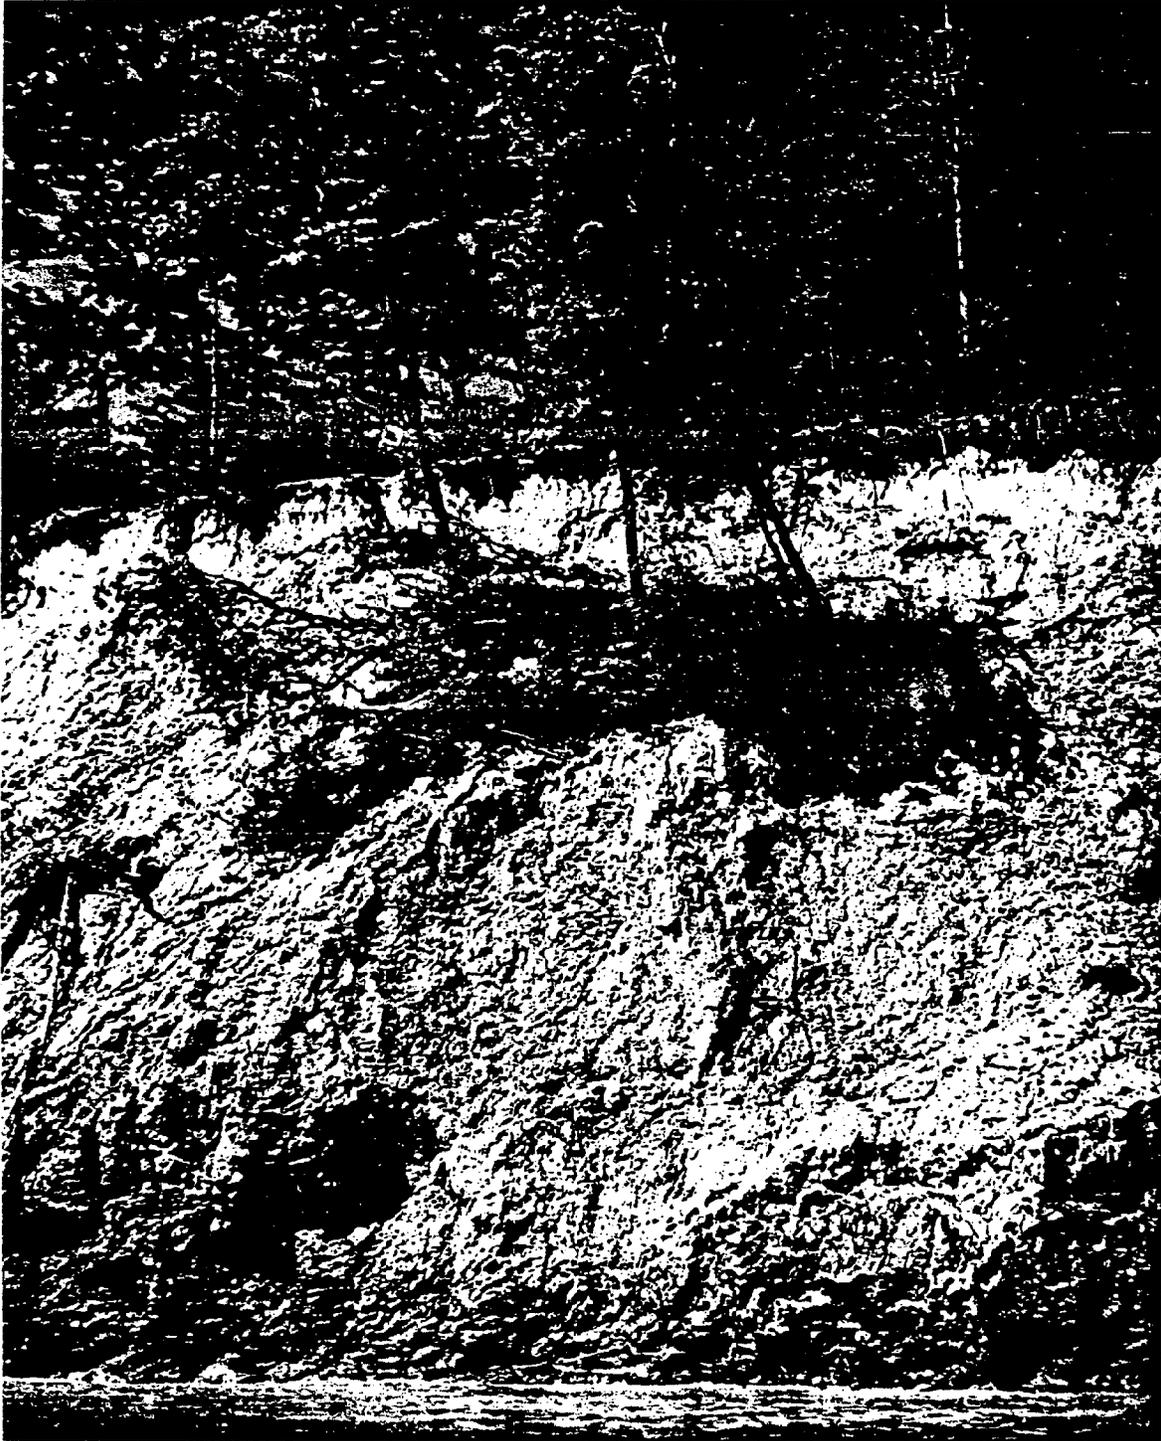
Fig. 5 - The most severely eroding area along the Illinois shore is in south Lake Forest, where over 17 feet of recession has been occurring each year since 1973. In this photo, a large slump block is moving down the bluff face. There is no useable beach. (see Map 20)

4. Bluffs dangerous even for maintenance purposes, are not suitable for any use. The bluff reaches are characterized by oversteepened slopes with numerous seeps, and greater than 30 percent of the bluff face denuded and eroding. These slopes may be either publicly or privately owned, although most are privately owned. Shoreline structures at the base of these bluffs typically are absent or improperly maintained. Bluffline recession rates average about 3.5 feet per year along the Lake Bluff and Lake Forest shore, while along the Highland Park, Glencoe, Winnetka, Kenilworth, and Wilmette shore the erosion rate is 1- to 1.5 feet per year. This category includes the areas of most serious erosion along the Illinois shore of Lake Michigan (Figs. 4 and 5).

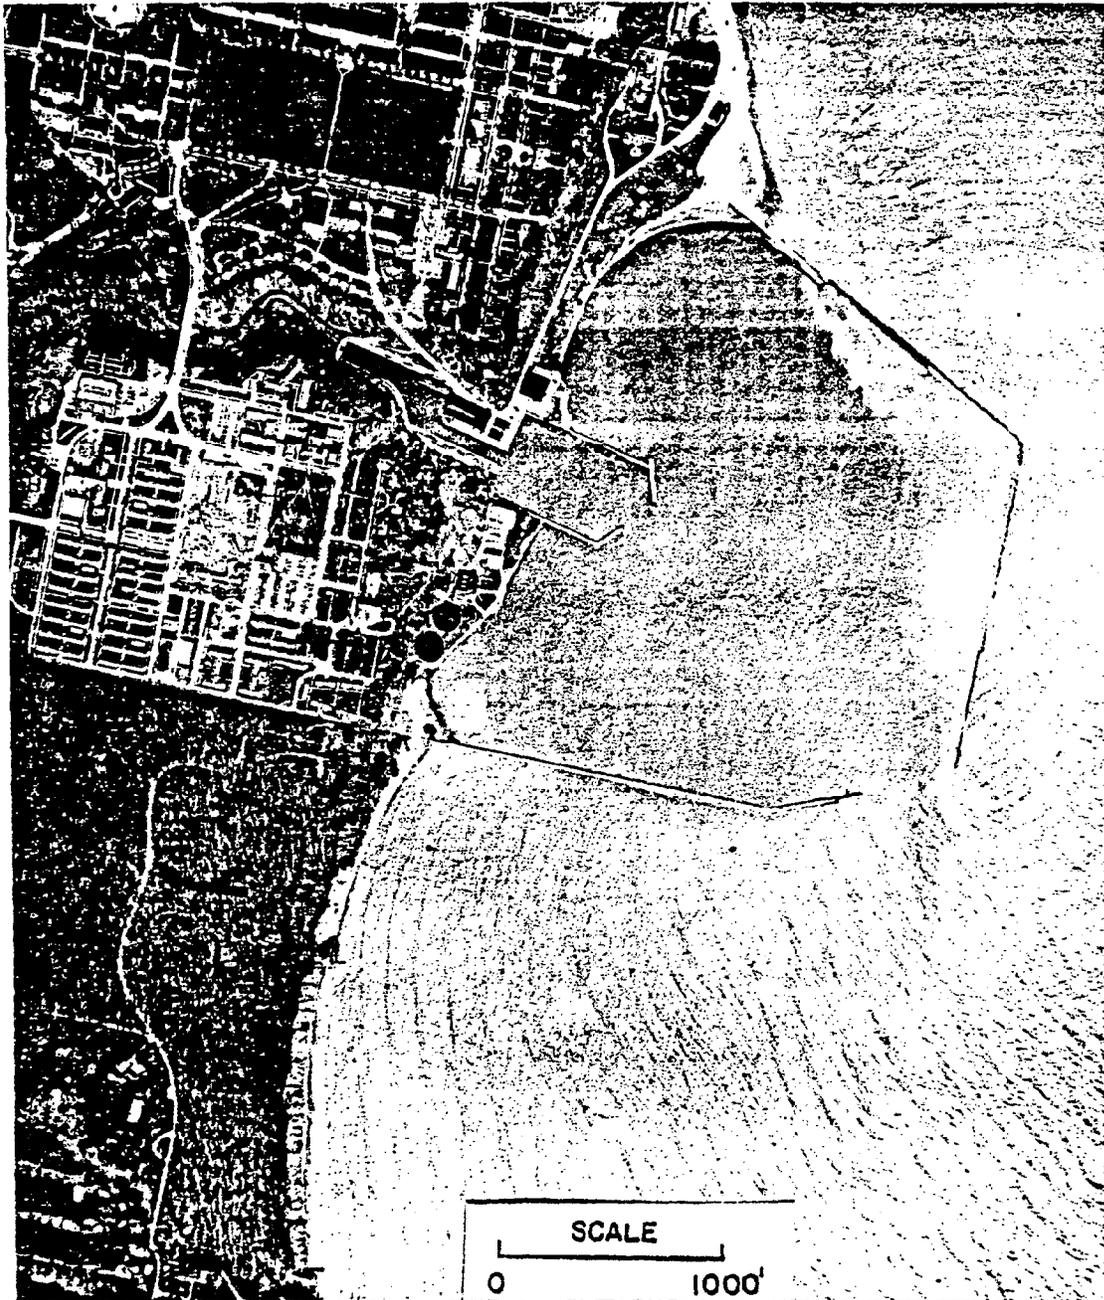
Fig. 7 - Photo Taken in 1958 Showing Jetties at the Great Lakes Naval Training Station and the Adjacent Lakeshore.

This photo shows an excellent example of wave reflection under northeast winds. The unriprapped southern tip of the north jetty reflects waves in an arcuate pattern. The reflected waves then are incorporated into the wave trains moving southwest, adding to their strength and increasing potential for severe erosion. The riprapped portion of the jetty also reflects waves, but much of the energy is absorbed by the revetment. Sediment washed over the jetty appears in suspension along the inner side of the north jetty. The location corresponds with that of exposed sand deposits shown on the photo taken in 1964. The effectiveness of the northern jetty as a breakwater is indicated by the quiet water inside the harbor.
