# ***Ecological Assessment, Classification and Management of Tampa Bay Tidal Creeks***

TAMPA BAY REGIONAL PLANNING COUNCIL 1986

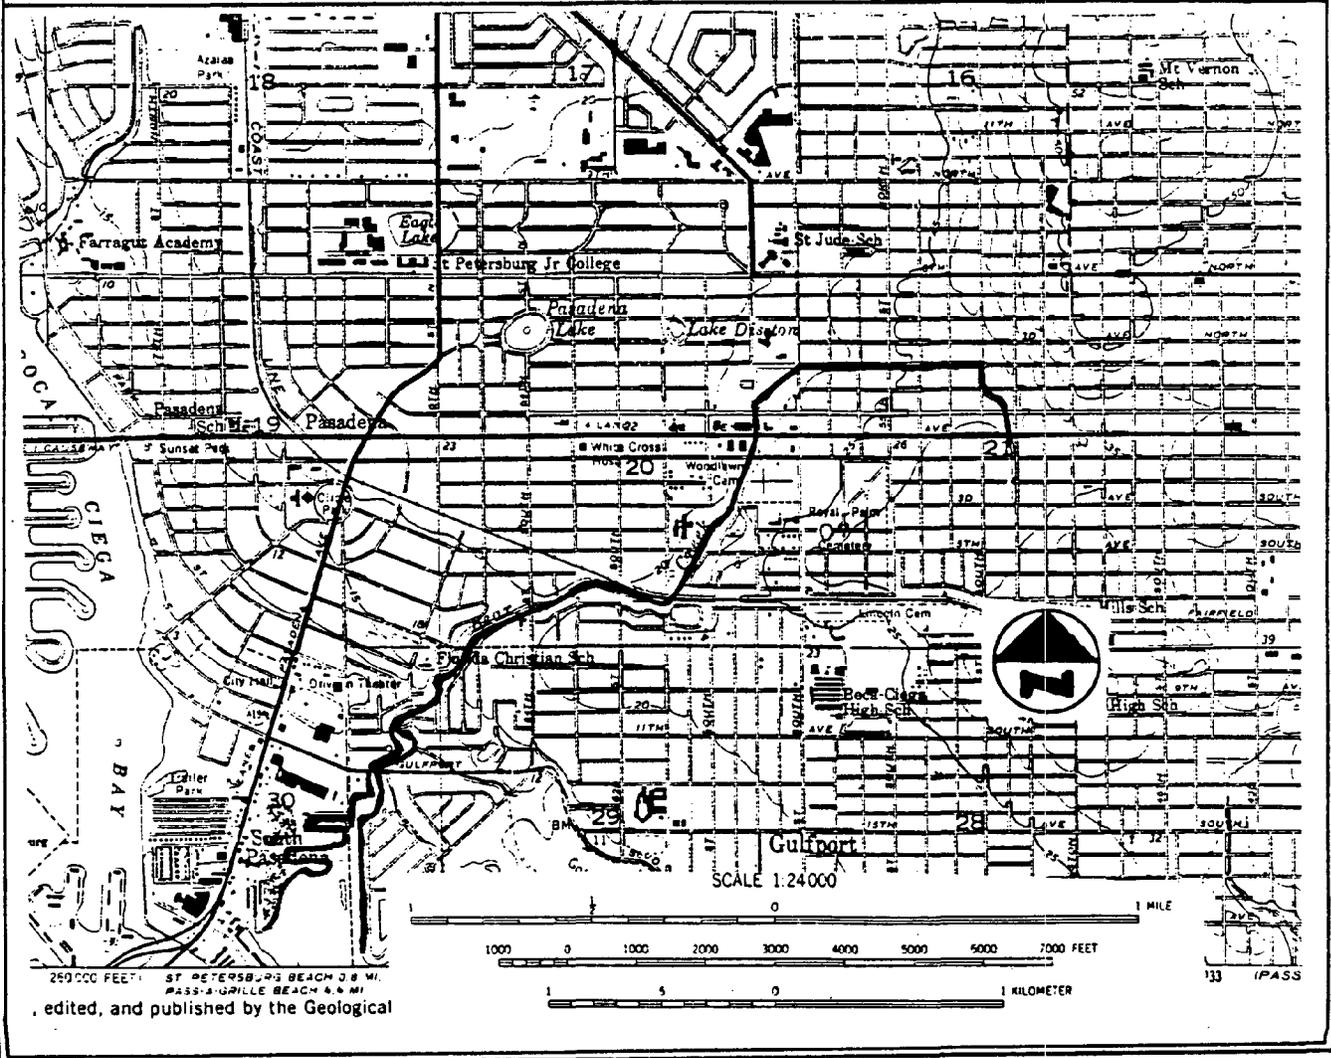
Figure 20.

### Salt Creek

Salt Creek drains the lower southeastern Pinellas County peninsula and flows into Bayboro Harbor, an urbanized embayment (Figure 20). Salt Creek receives the outflow from Lake Maggiore. Between Lake Maggiore and Bayboro Harbor, Salt Creek is approximately 1.5 miles in length.

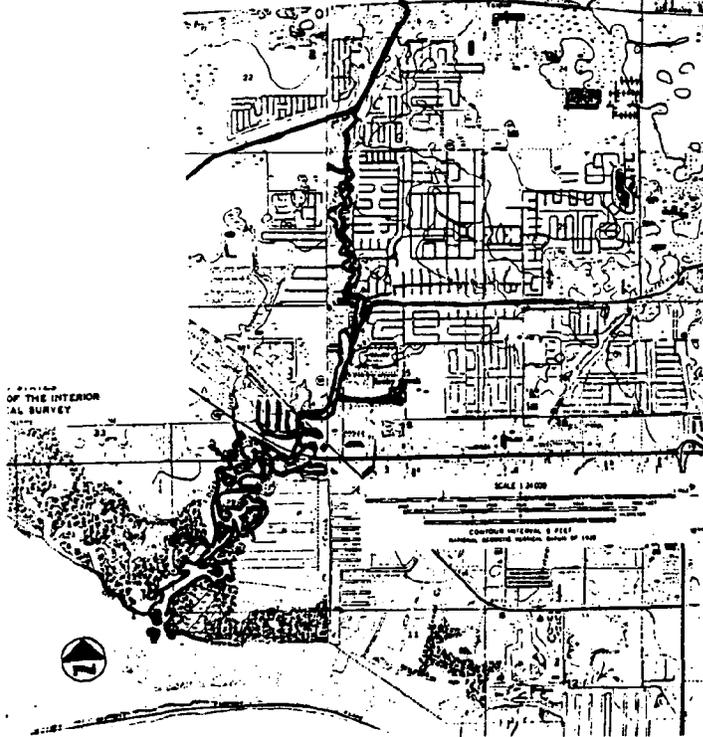
Figure 33.

### Dick Creek

Dick Creek is located between Rocky Creek and Channel "A" and drains southward into Old Tampa Bay in Hillsborough County (Figure 33). Dick Creek shares partial channel alignment with Rocky Creek through the marsh and is approximately 1.6 miles in length.
