Habitat Restoration Study for the Tampa Bay Region

TAMPA BAY REGIONAL PLANNING COUNCIL 1986

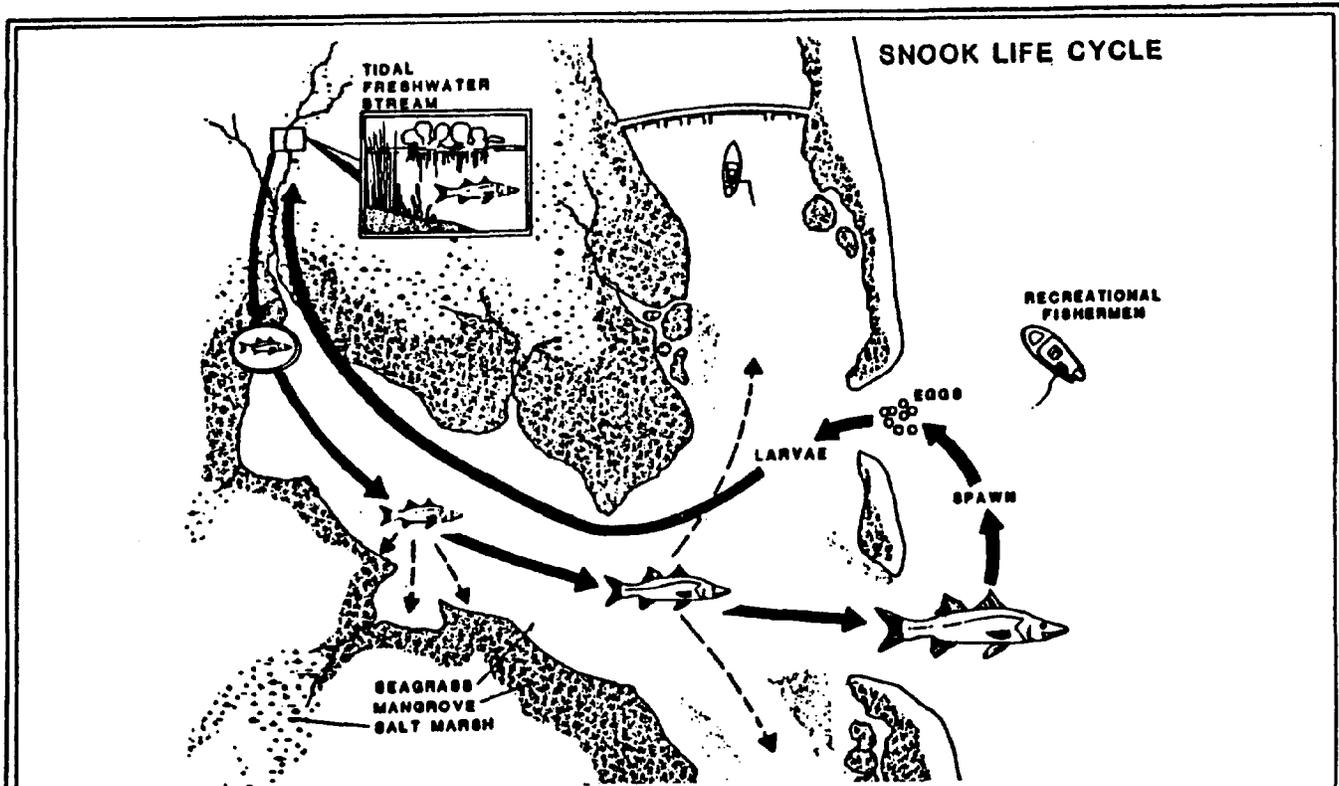
Figure 9 Life cycle of the snook (*Centropomus undecimalis*) (Lewis et al. 1985)

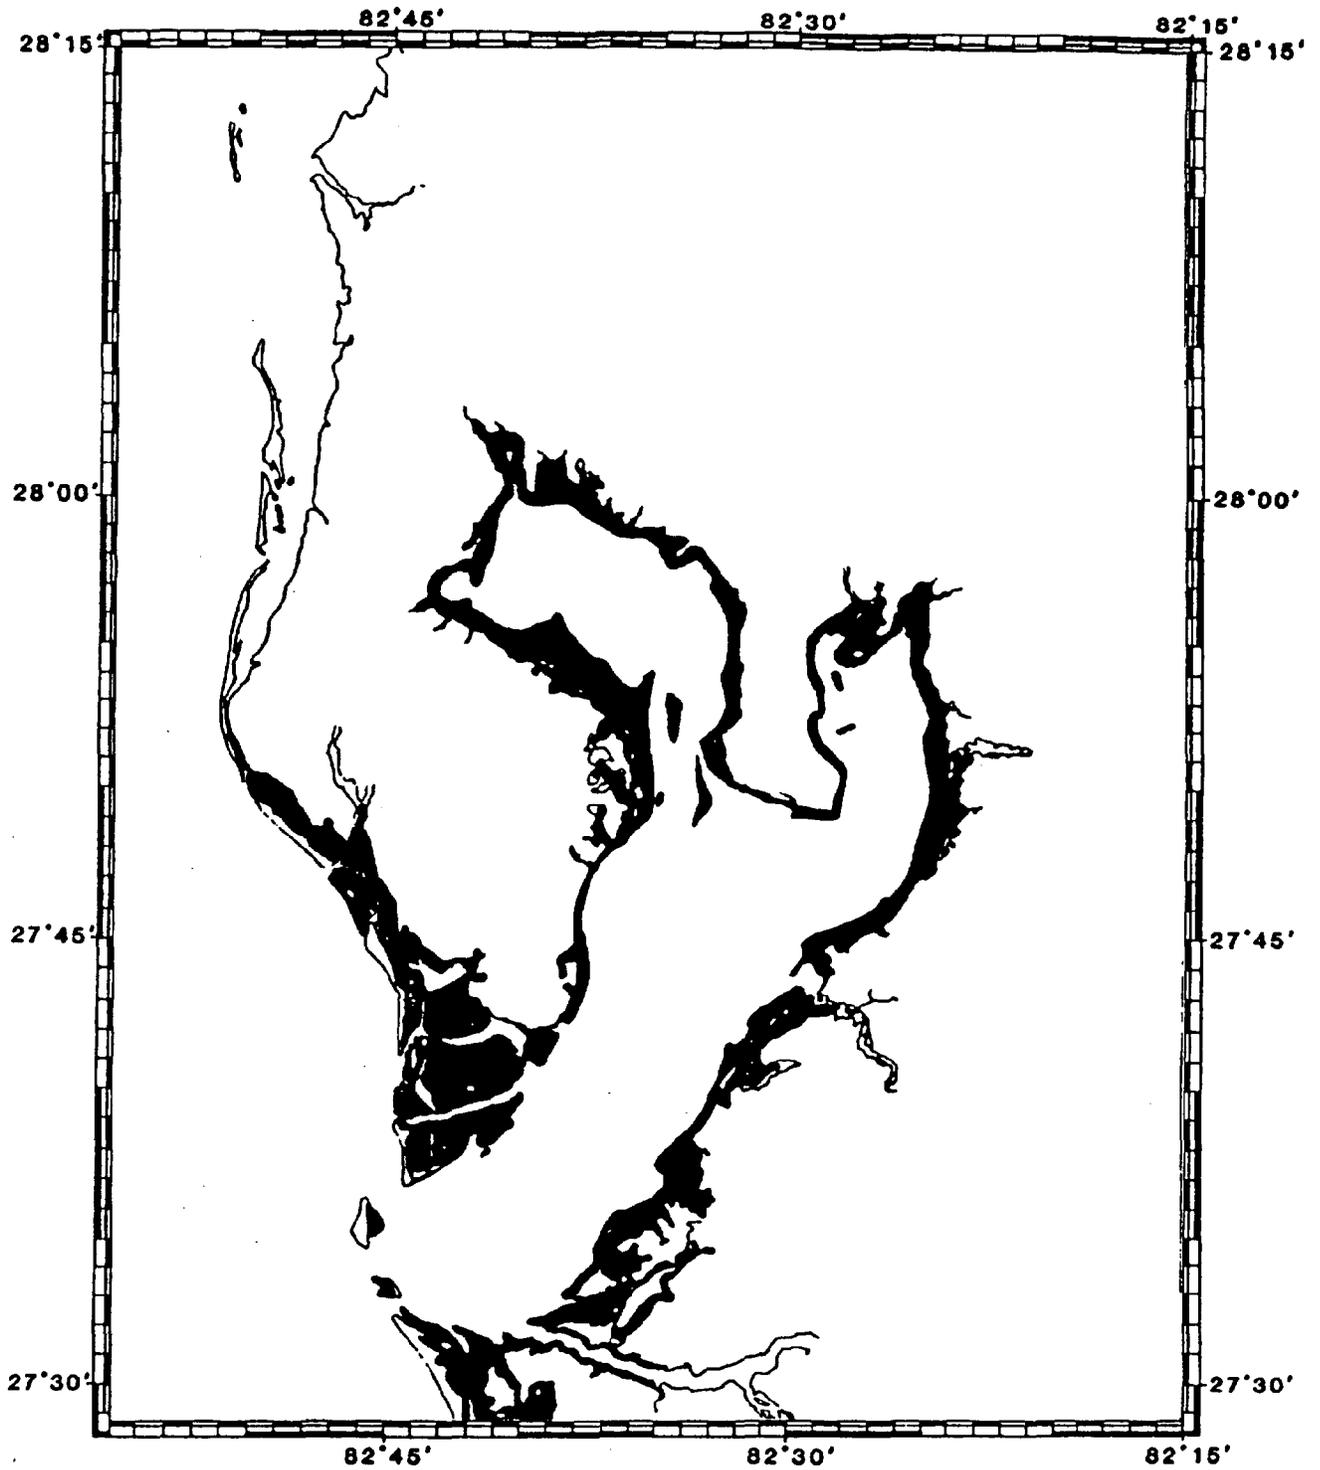
Figure 15 Estimated extent of seagrass meadows in Tampa Bay - 1879
(Lewis et al. 1985)

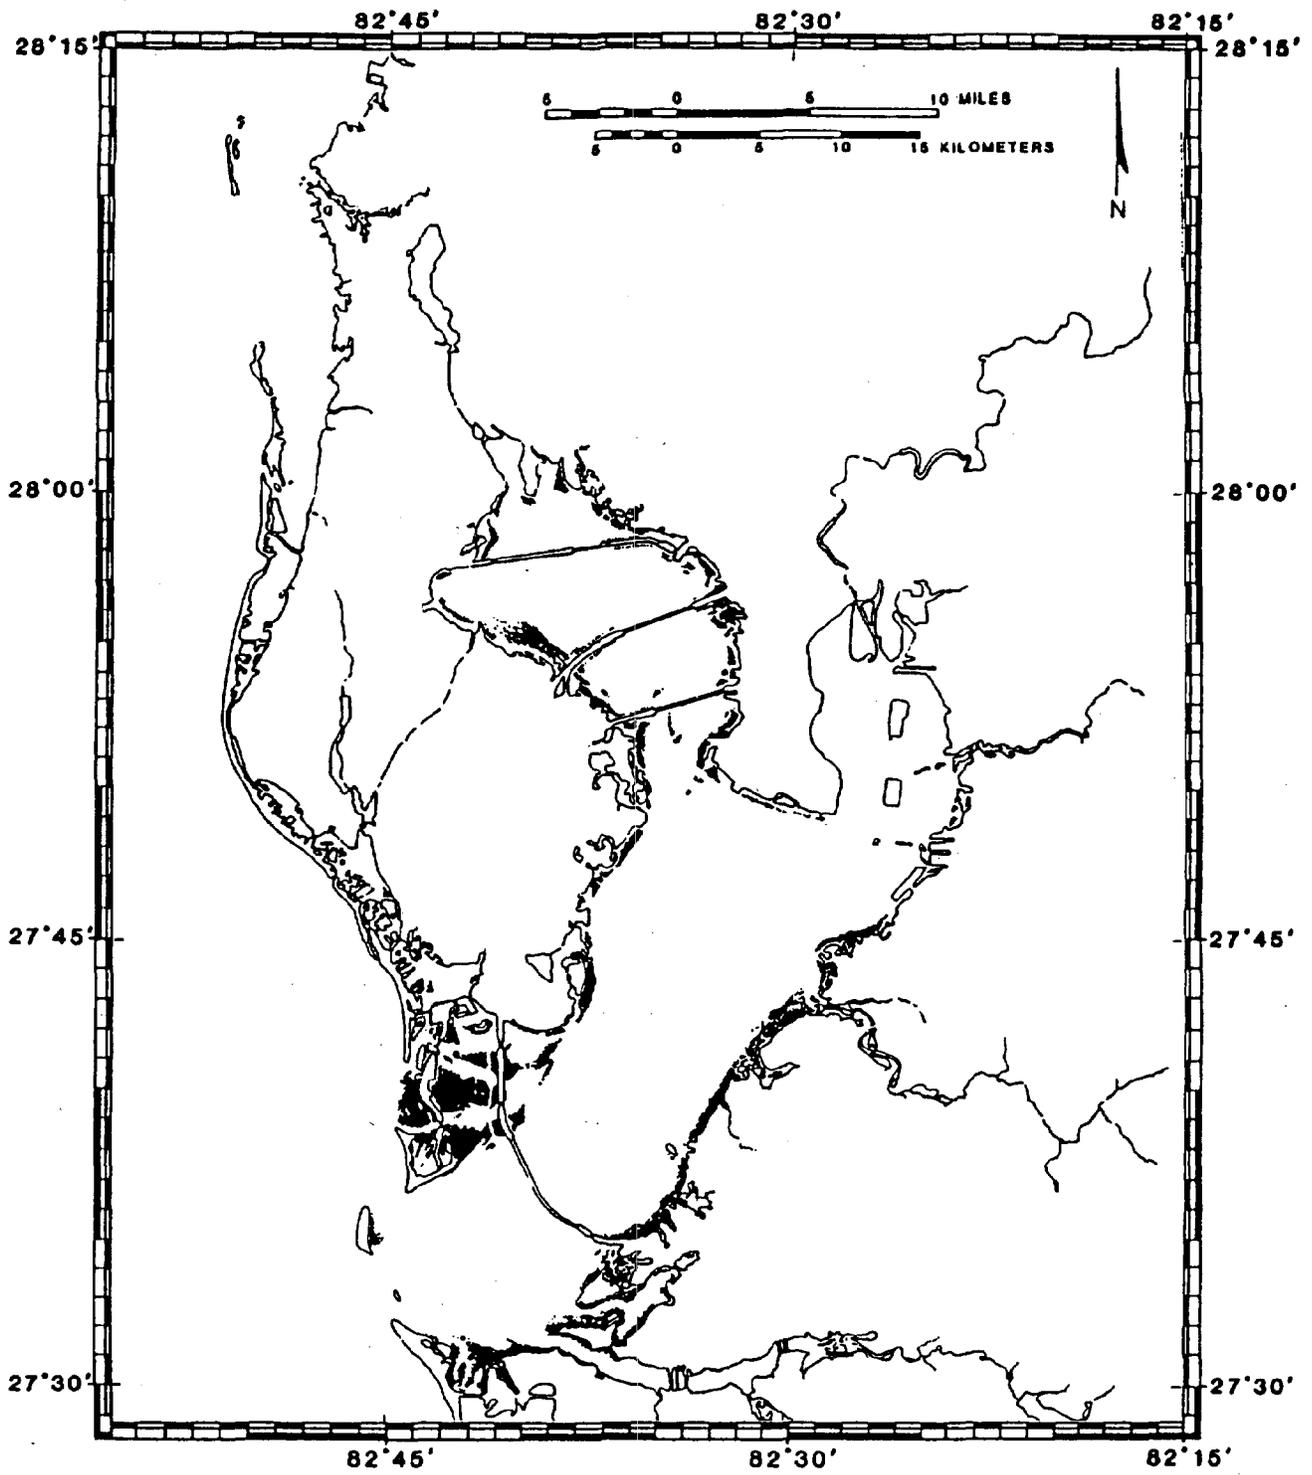
Figure 16 Estimated extent of seagrass meadows in Tampa Bay - 1982
(Lewis et al. 1985)

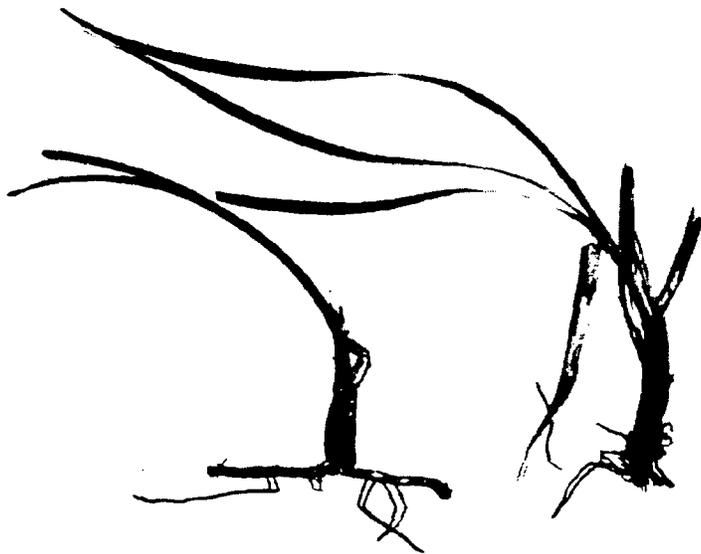
Thalassia testudinum (Turtle Grass)

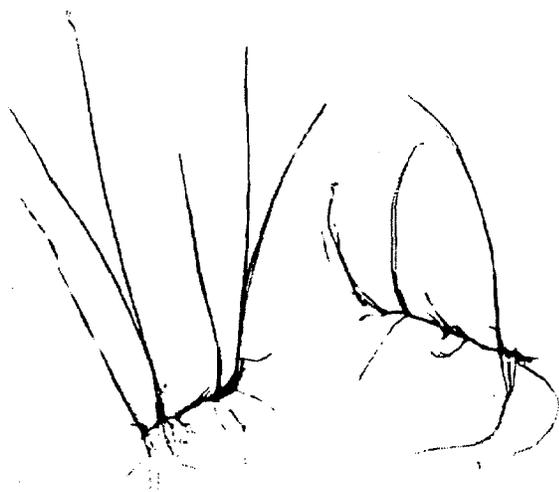
Halodule wrightii (Shoal Grass)

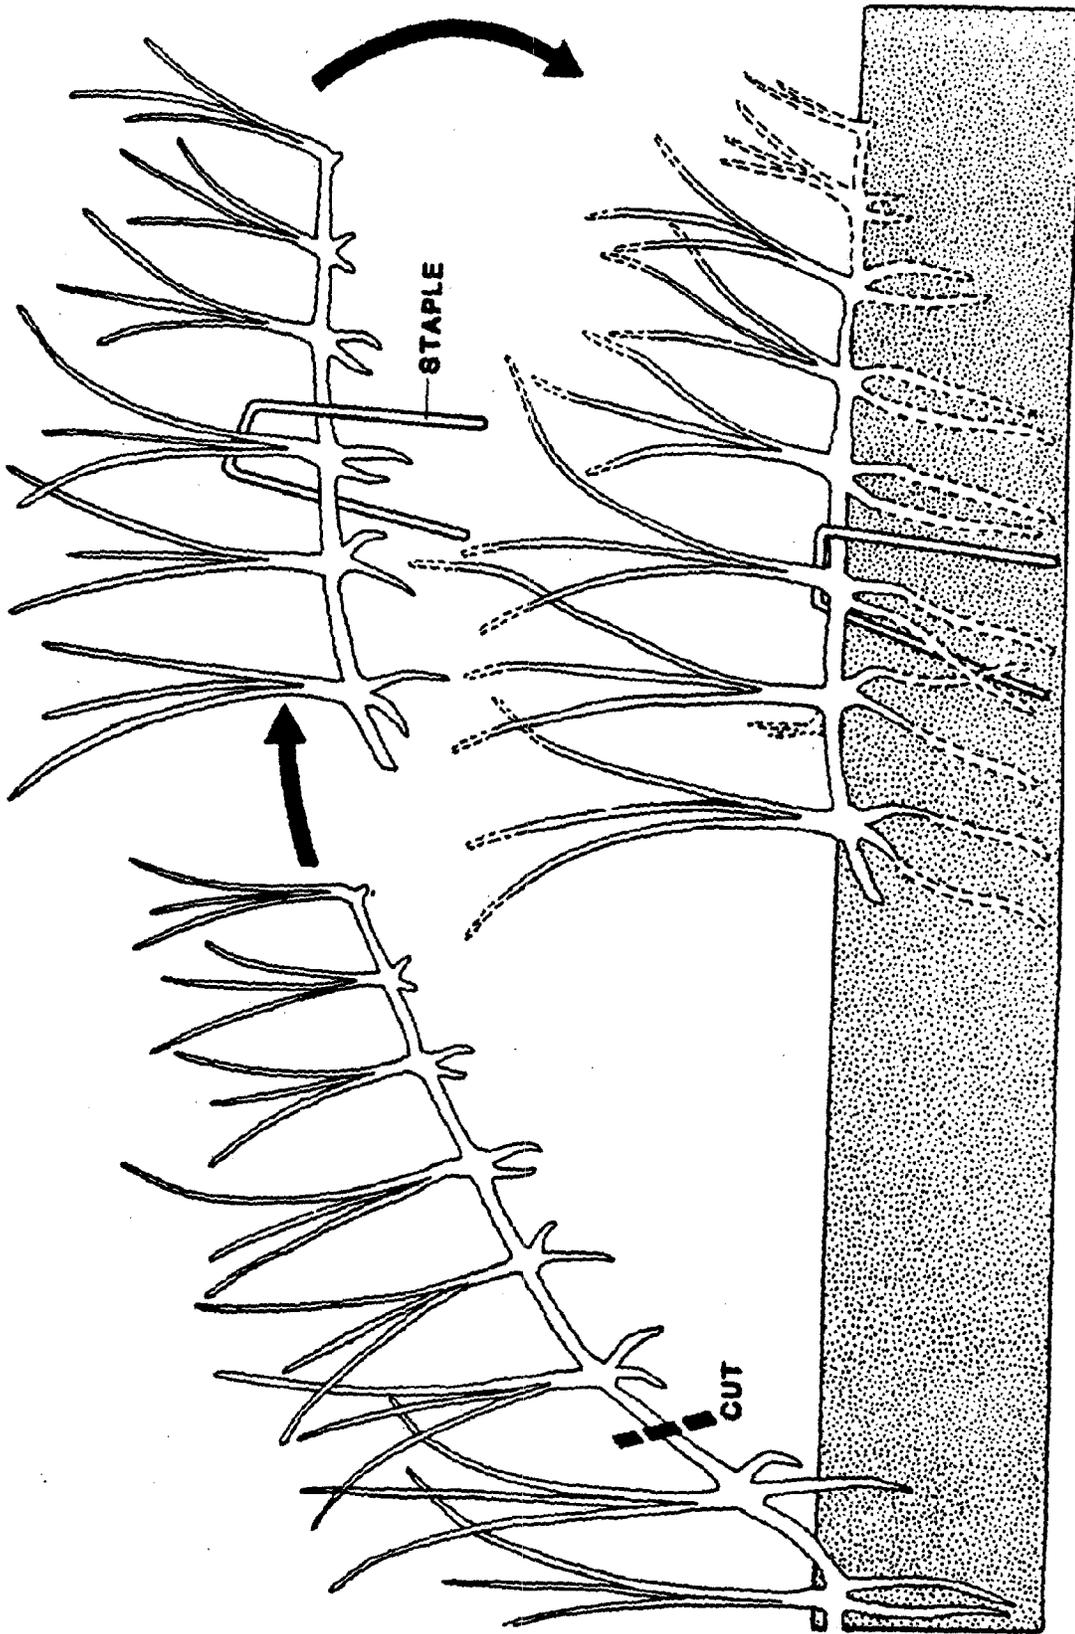
Figure 30 Transplantation of *Halodule* Sprig for Habitat Restoration
(Adapted from Derrenbacker and Lewis, 1981)

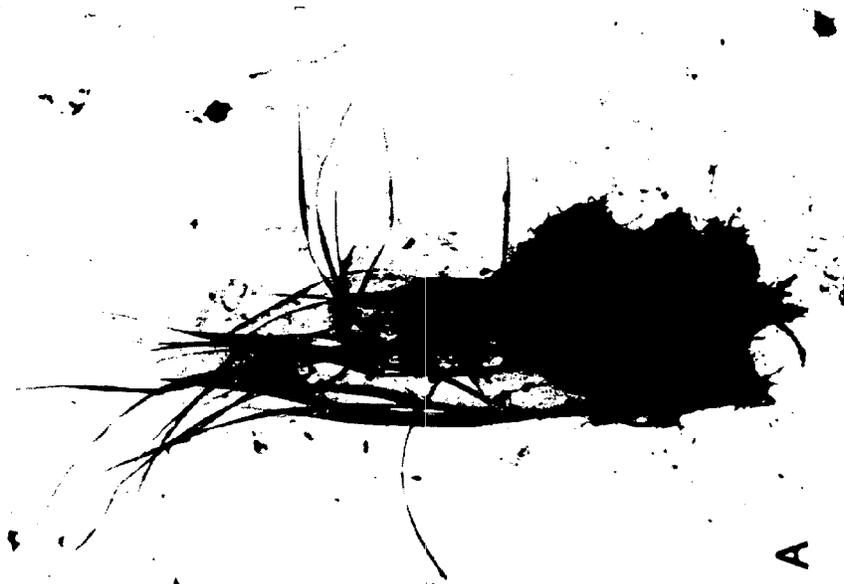
Figure 34
Spartina alterniflora plug (A) and sprig (B) used in habitat restoration projects.
(Hoffman et al. 1985)

Figure 34 illustrates a plug and sprig used in habitat restoration projects.

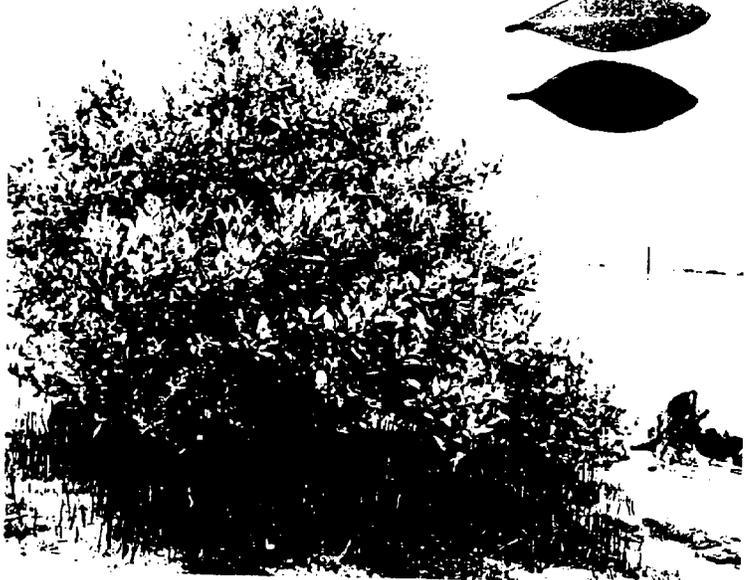
Avicennia germinans
(black mangrove)

Figure 36
Mangroves of Tampa Bay
(Adapted from Darovec
et al. 1975)

mangle and L. racemosa have been reported as far north as Cedar Key on the west coast of Florida (Rehm, 1976), and north of Ponce de Leon Inlet on the east coast; these northern extremes lie at approximately 29°10'N Lat. (Teas, 1977) (Figure 35). A. germinans has been found as far north as 30°N Lat. on the east coast (Savage, 1972) and it also occurs as scattered shrubs along the islands of the Gulf coast states to Mexico (Odum et al. 1982 in CSA, 1986). Figure 36 identifies the three common mangrove species in Tampa Bay.

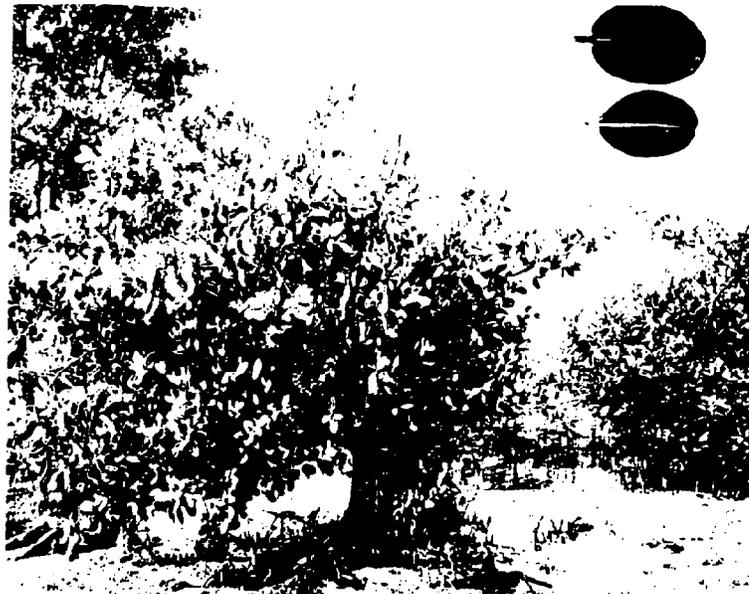
Laguncularia racemosa
(white mangrove)

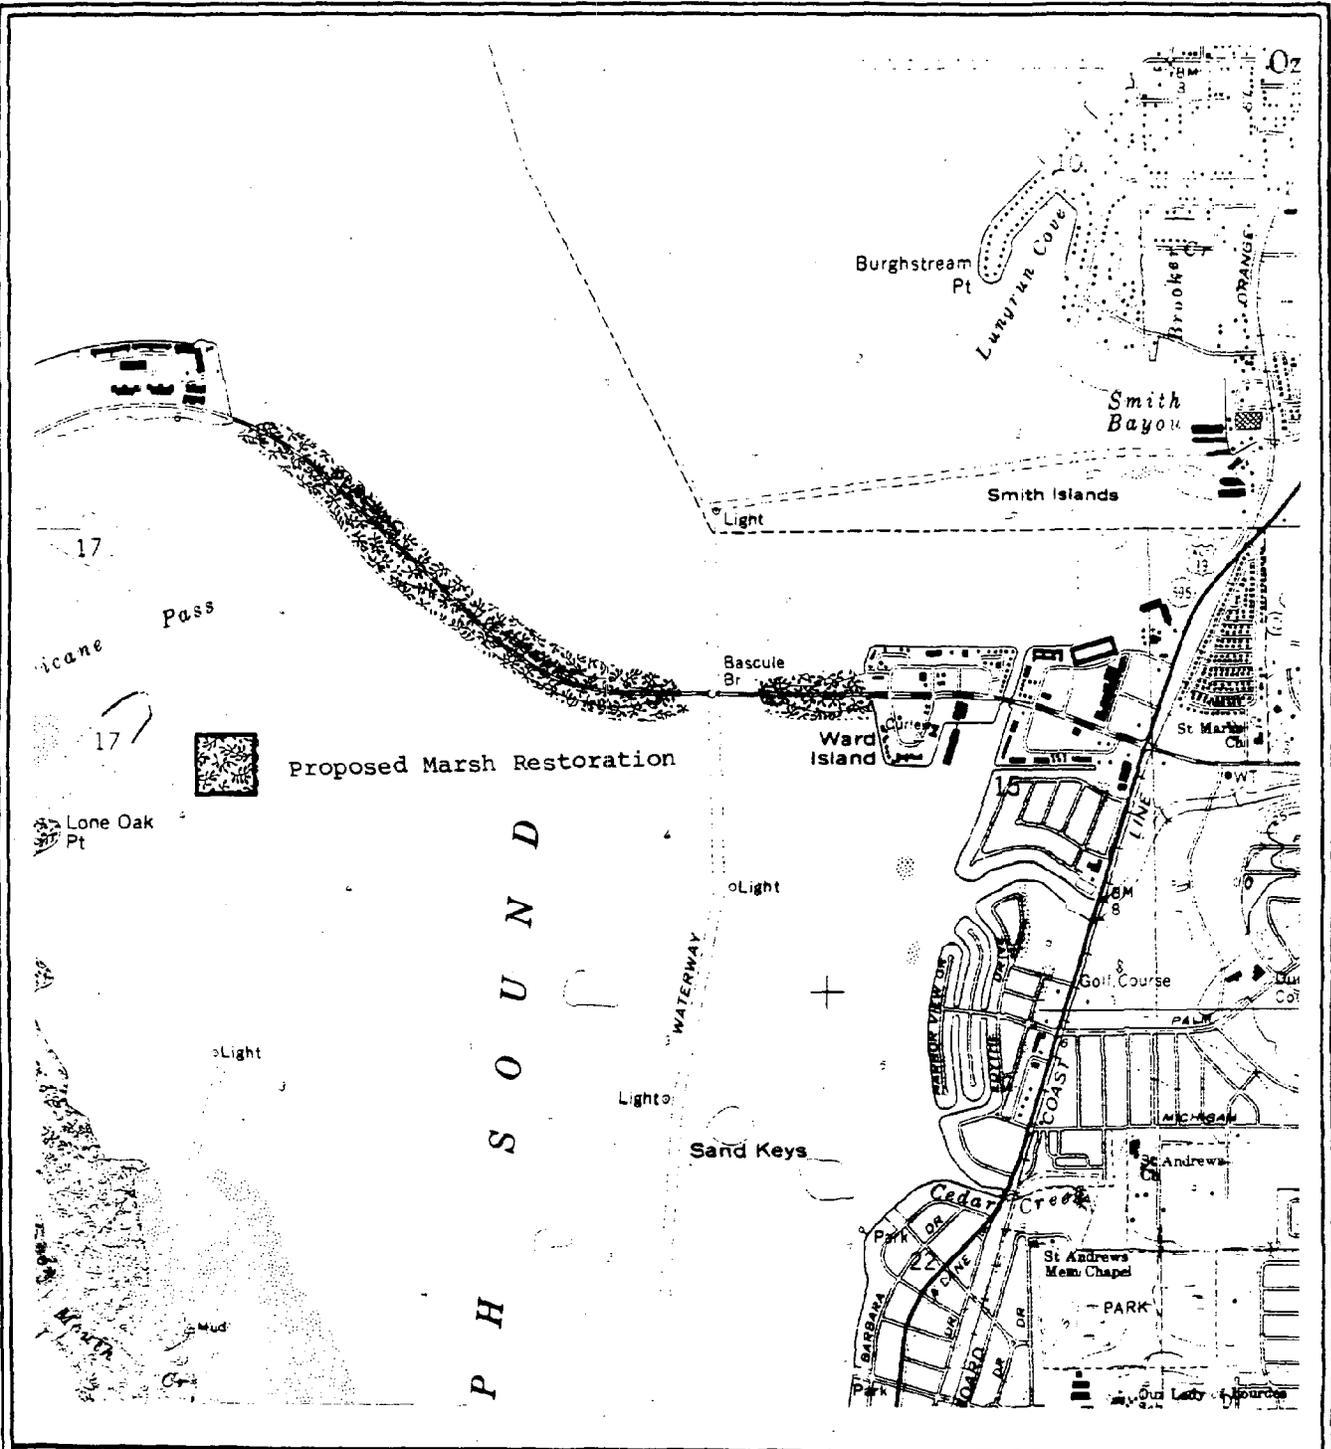
Figure 50
 Dunedin Causeway Restoration Site

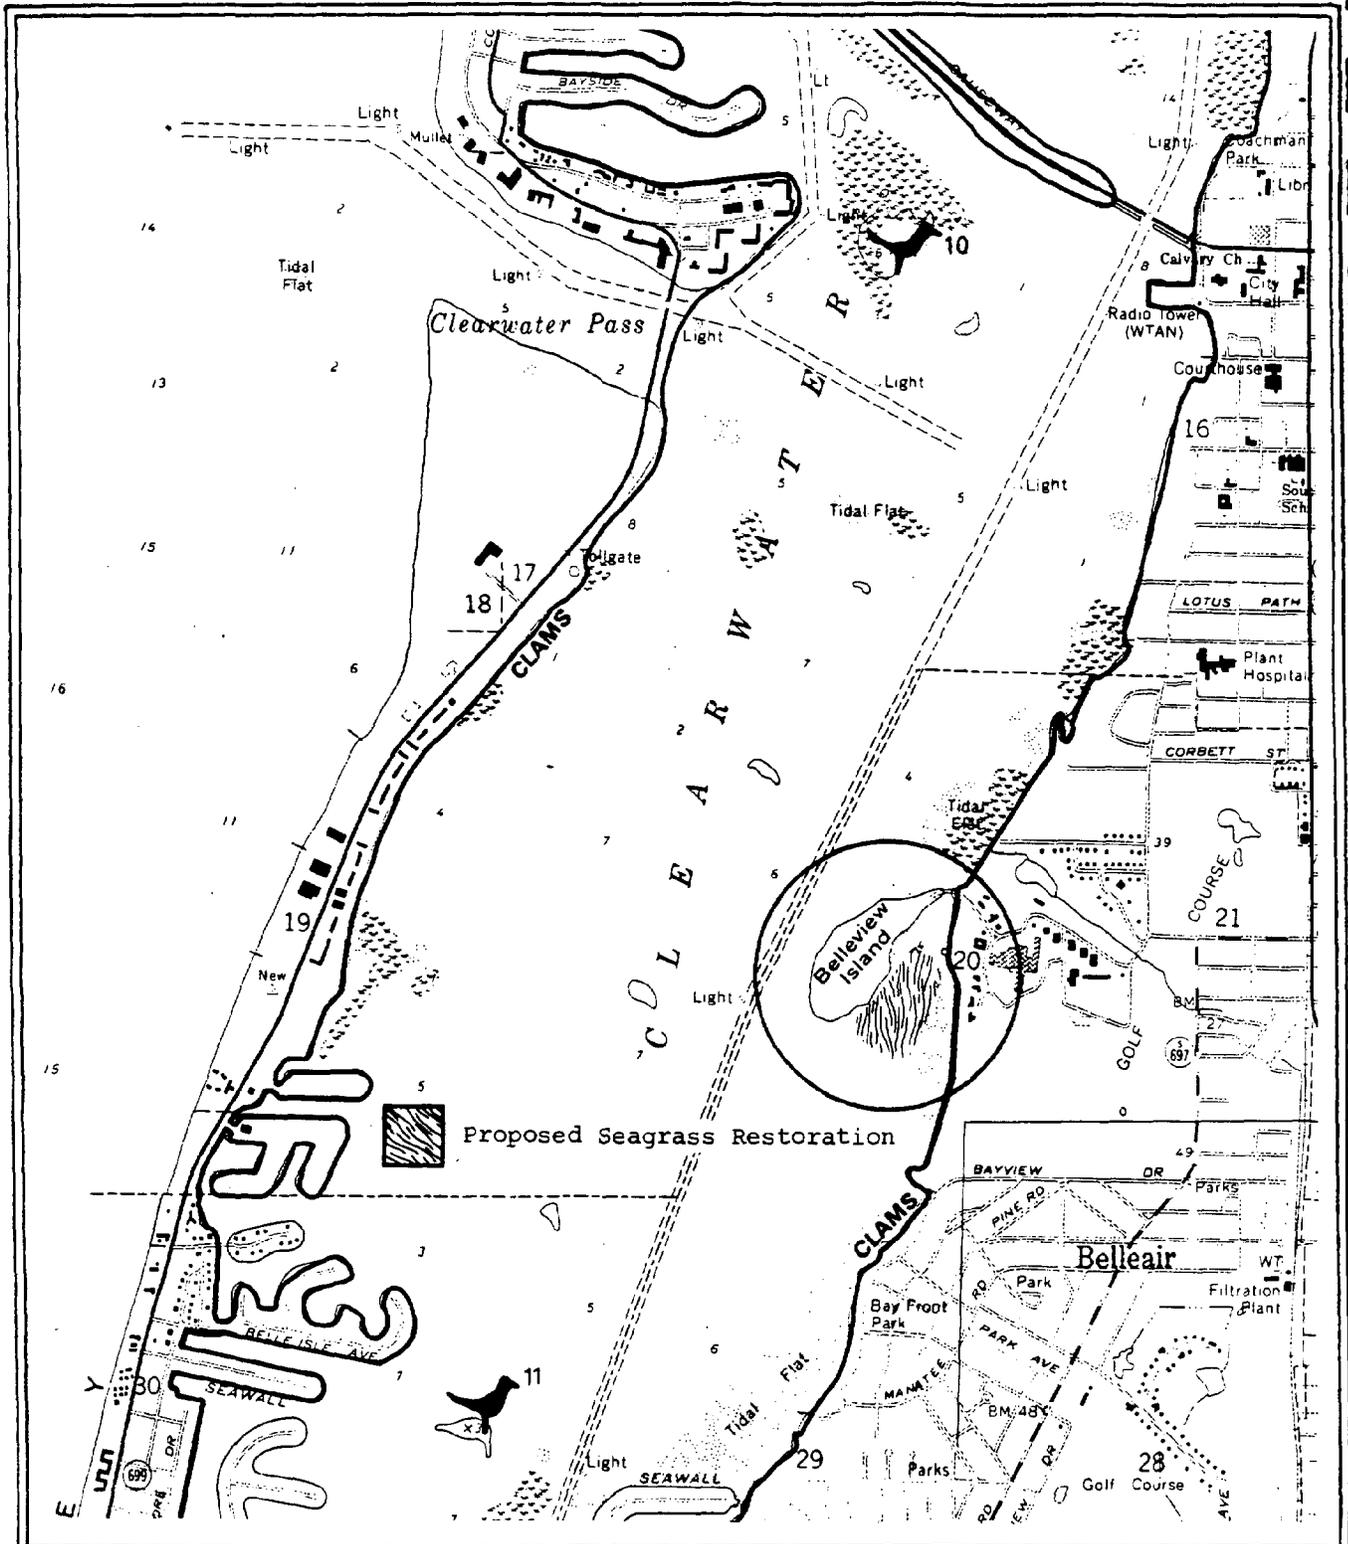
Figure 51
 Belleview Island Restoration Site

Restoration Plan: The shallow subtidal area on the southeastern side of Belleview Island can be planted with Halodule wrightii seagrass (Figure 51). Proper planting elevation should be determined from adjacent beds. H. wrightii sprigs are recommended to be planted on two-foot centers with the total acreage calculated from the available area occurring at proper elevation.

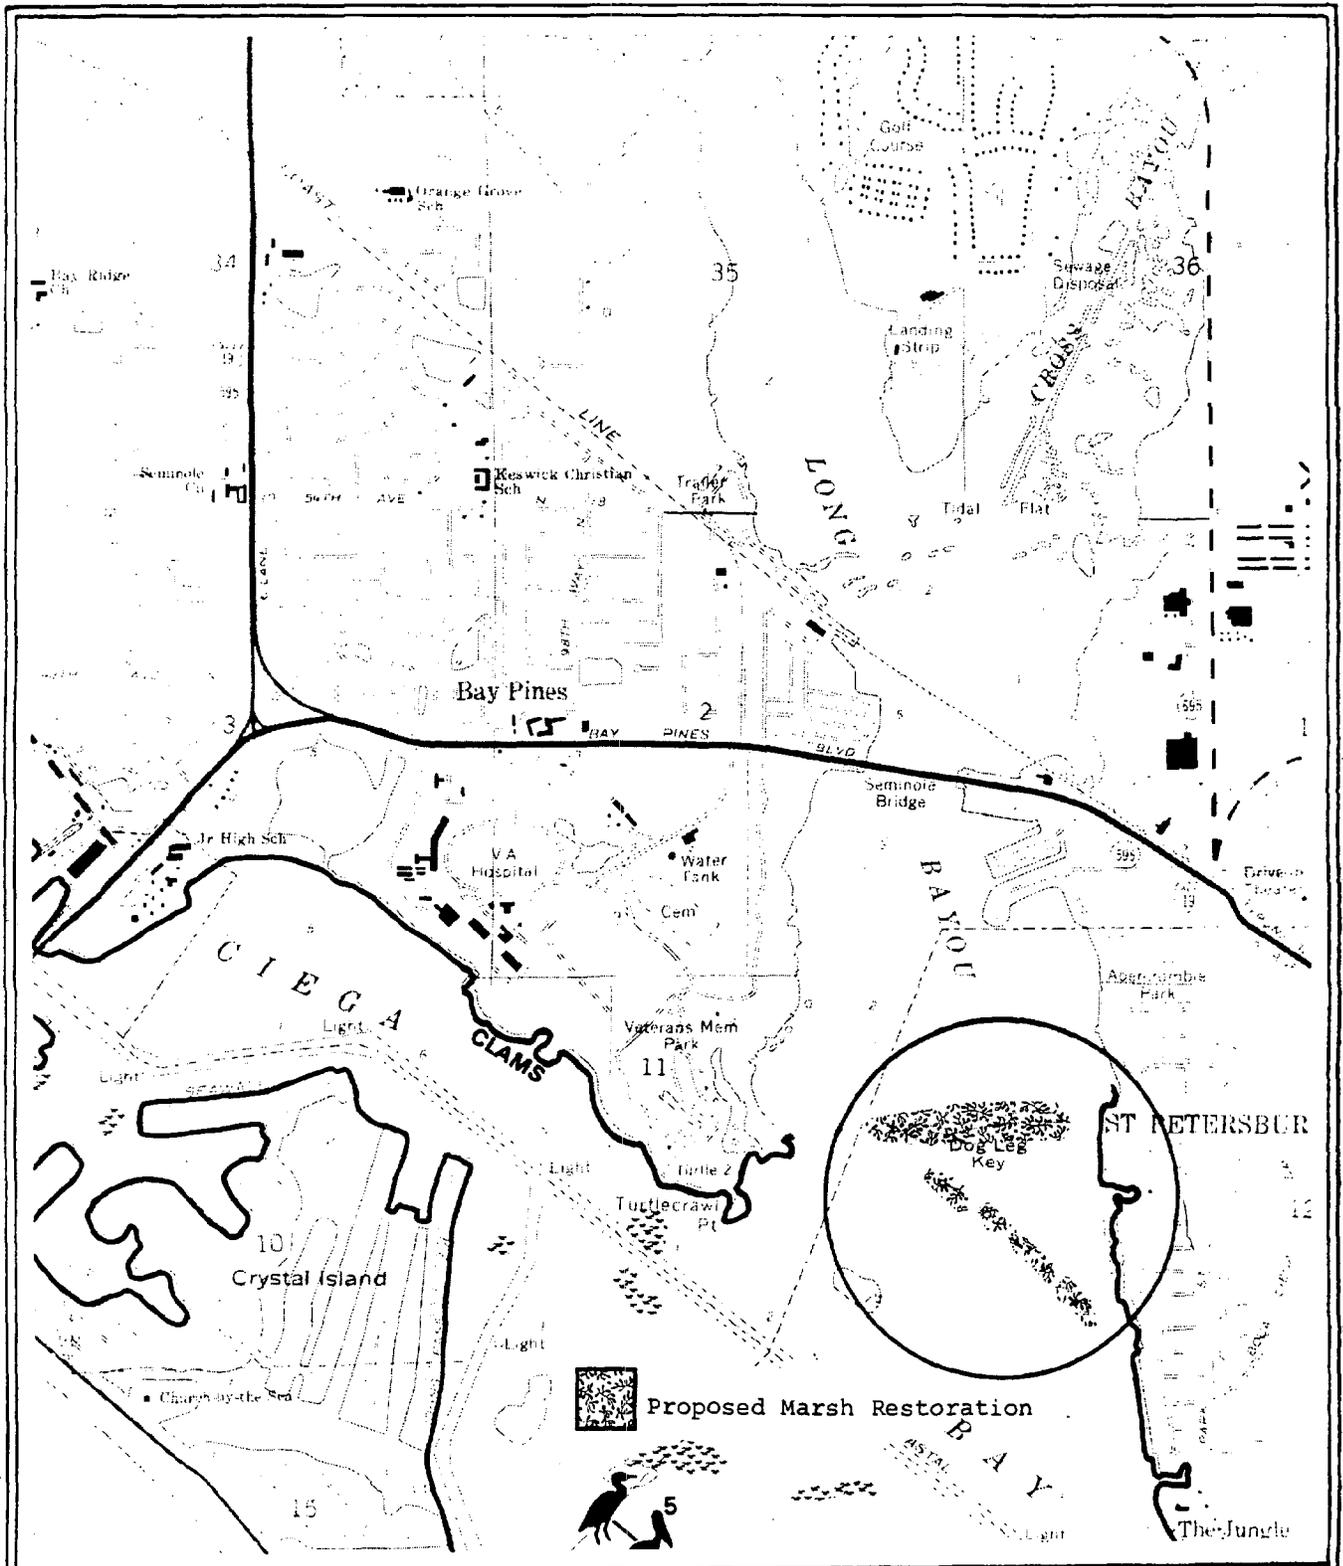
Figure 53
Dog Leg Key Restoration Site

Restoration Plan: It is recommended that the perimeter of Dog Leg Key and the smaller adjacent spoil islands be planted with smooth cordgrass (Figure 53). Cordgrass can be planted on a maximum of three-foot centers in three rows within the intertidal zone of each of the islands. Due to its close proximity to the Long Bayou boat channel, it may be necessary to increase planting densities (sprigs or plugs on two-foot centers in four rows) or establish a wave dampening barrier just off shore. Dog Leg Key is not utilized actively by the public, but if properly marked, may provide an ideal location for boaters and fishermen to identify with restoration sites.

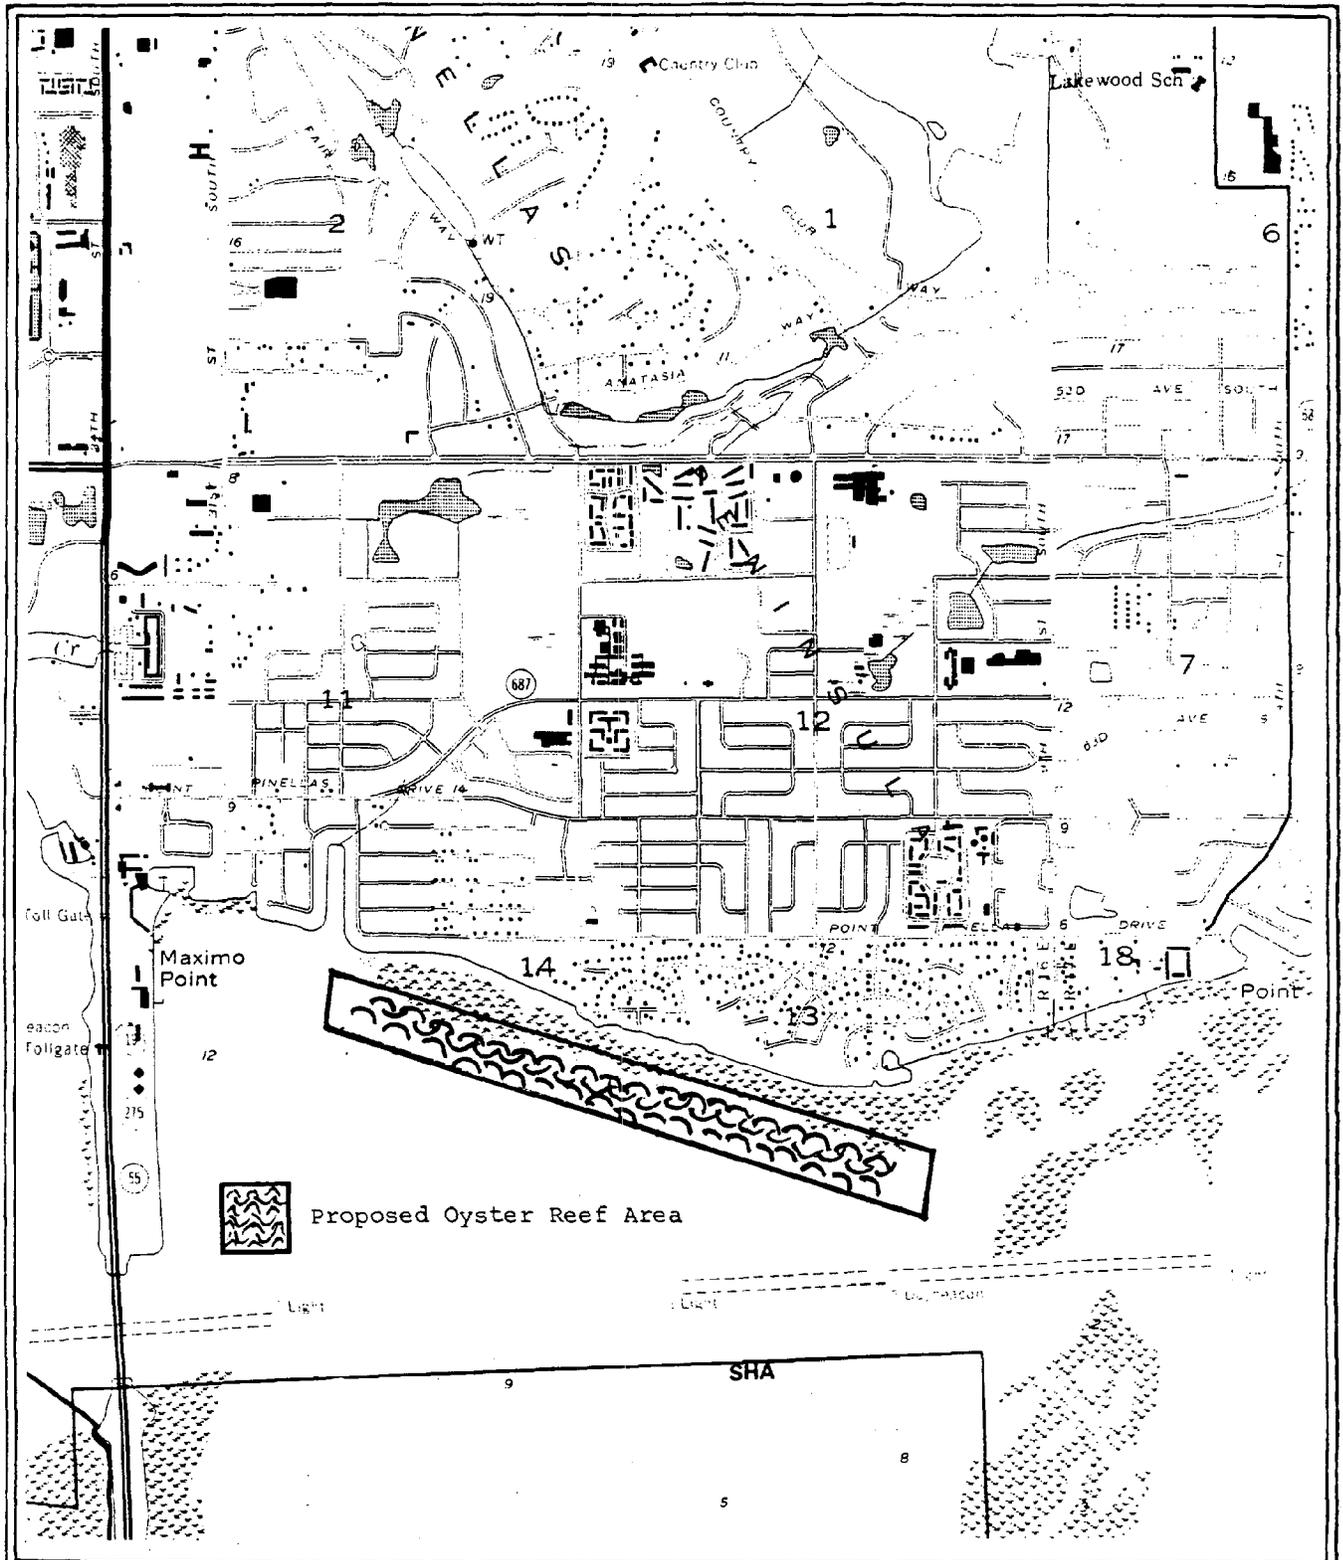
Figure 60
 Pinellas Point Subtidal
 Restoration Site

Site Description: Pinellas Point is located at the southern tip of Pinellas County east of the Skyway approach. Figure 60 identifies the location of Site 15 and adjacent areas.

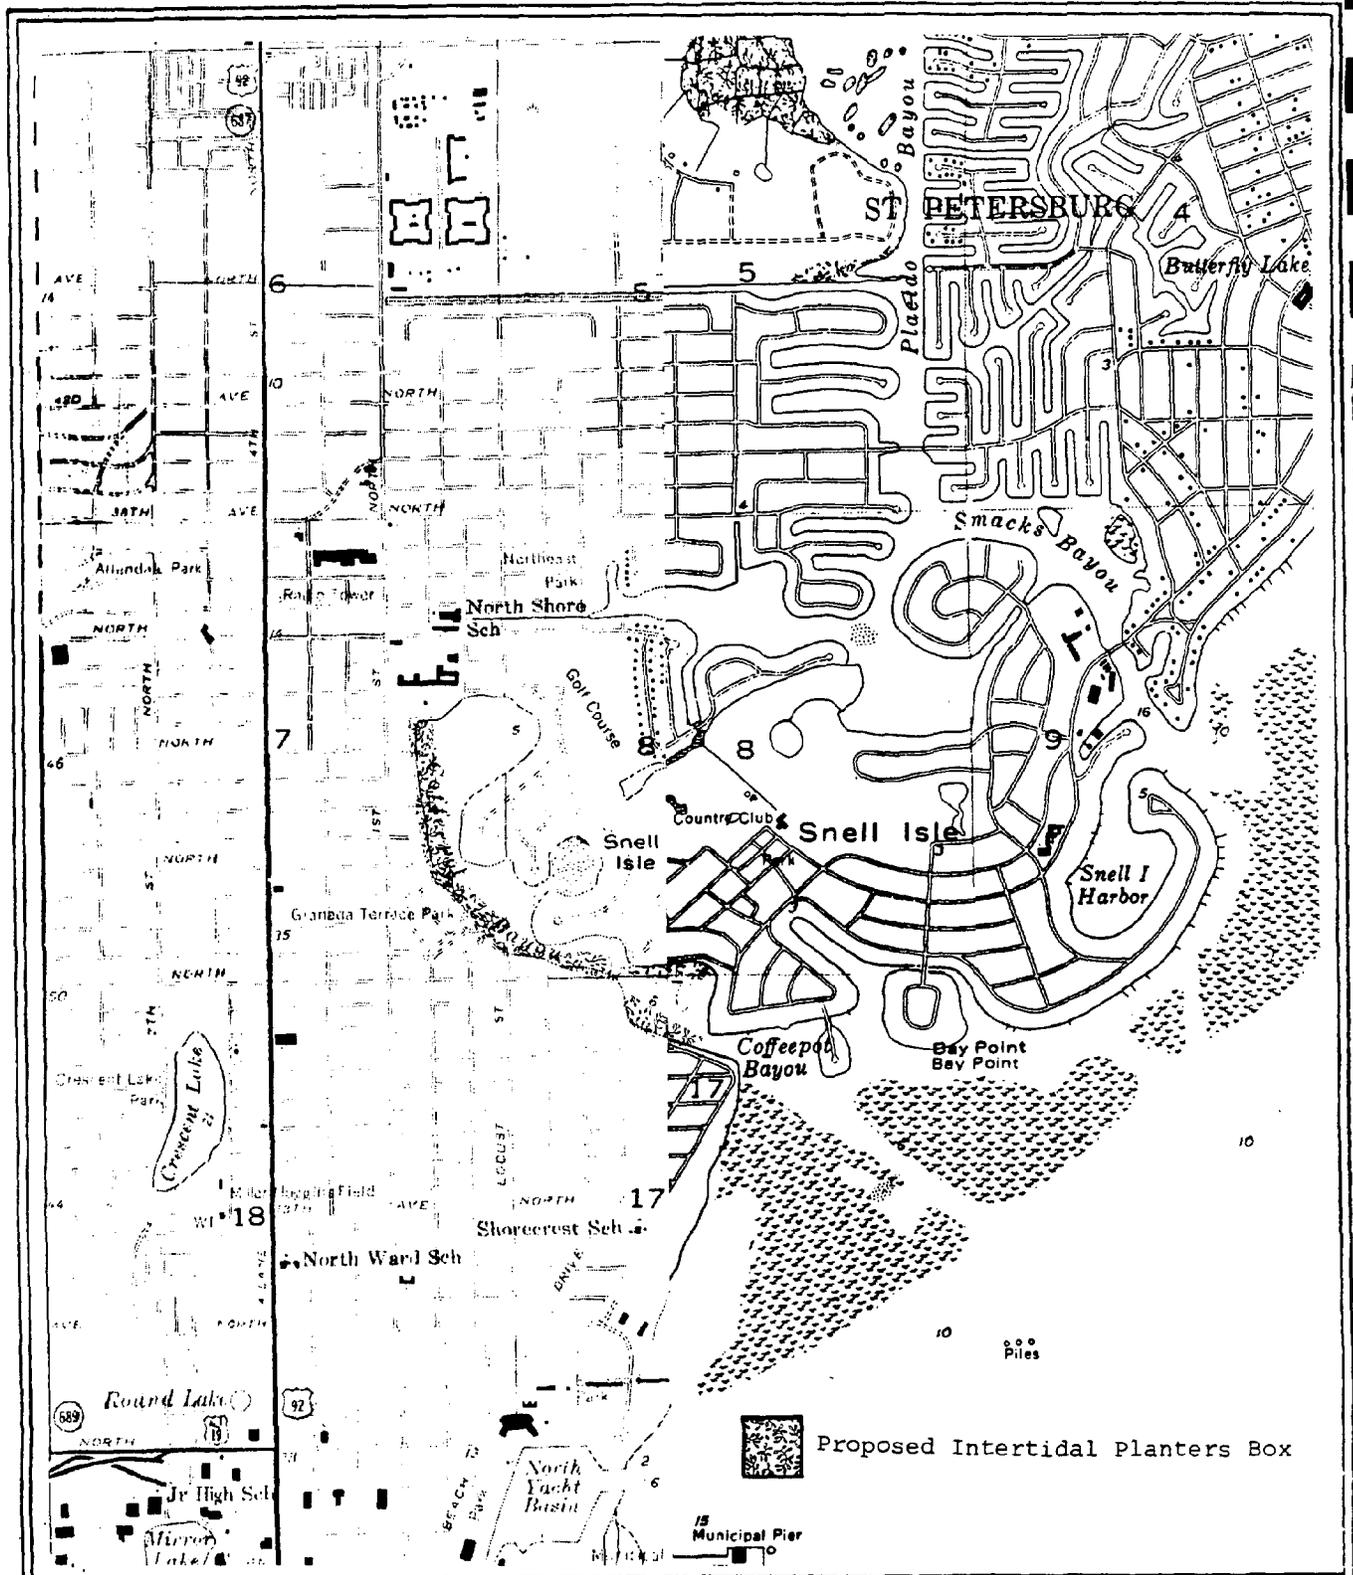
Figure 63
Coffee Pot Bayou Restoration Site

Restoration Plan: There is approximately 1.4 linear miles available for littoral shelf creation along Coffee Pot and Brightwaters Boulevards (Figure 63). The construction of the littoral shelf within a planters box

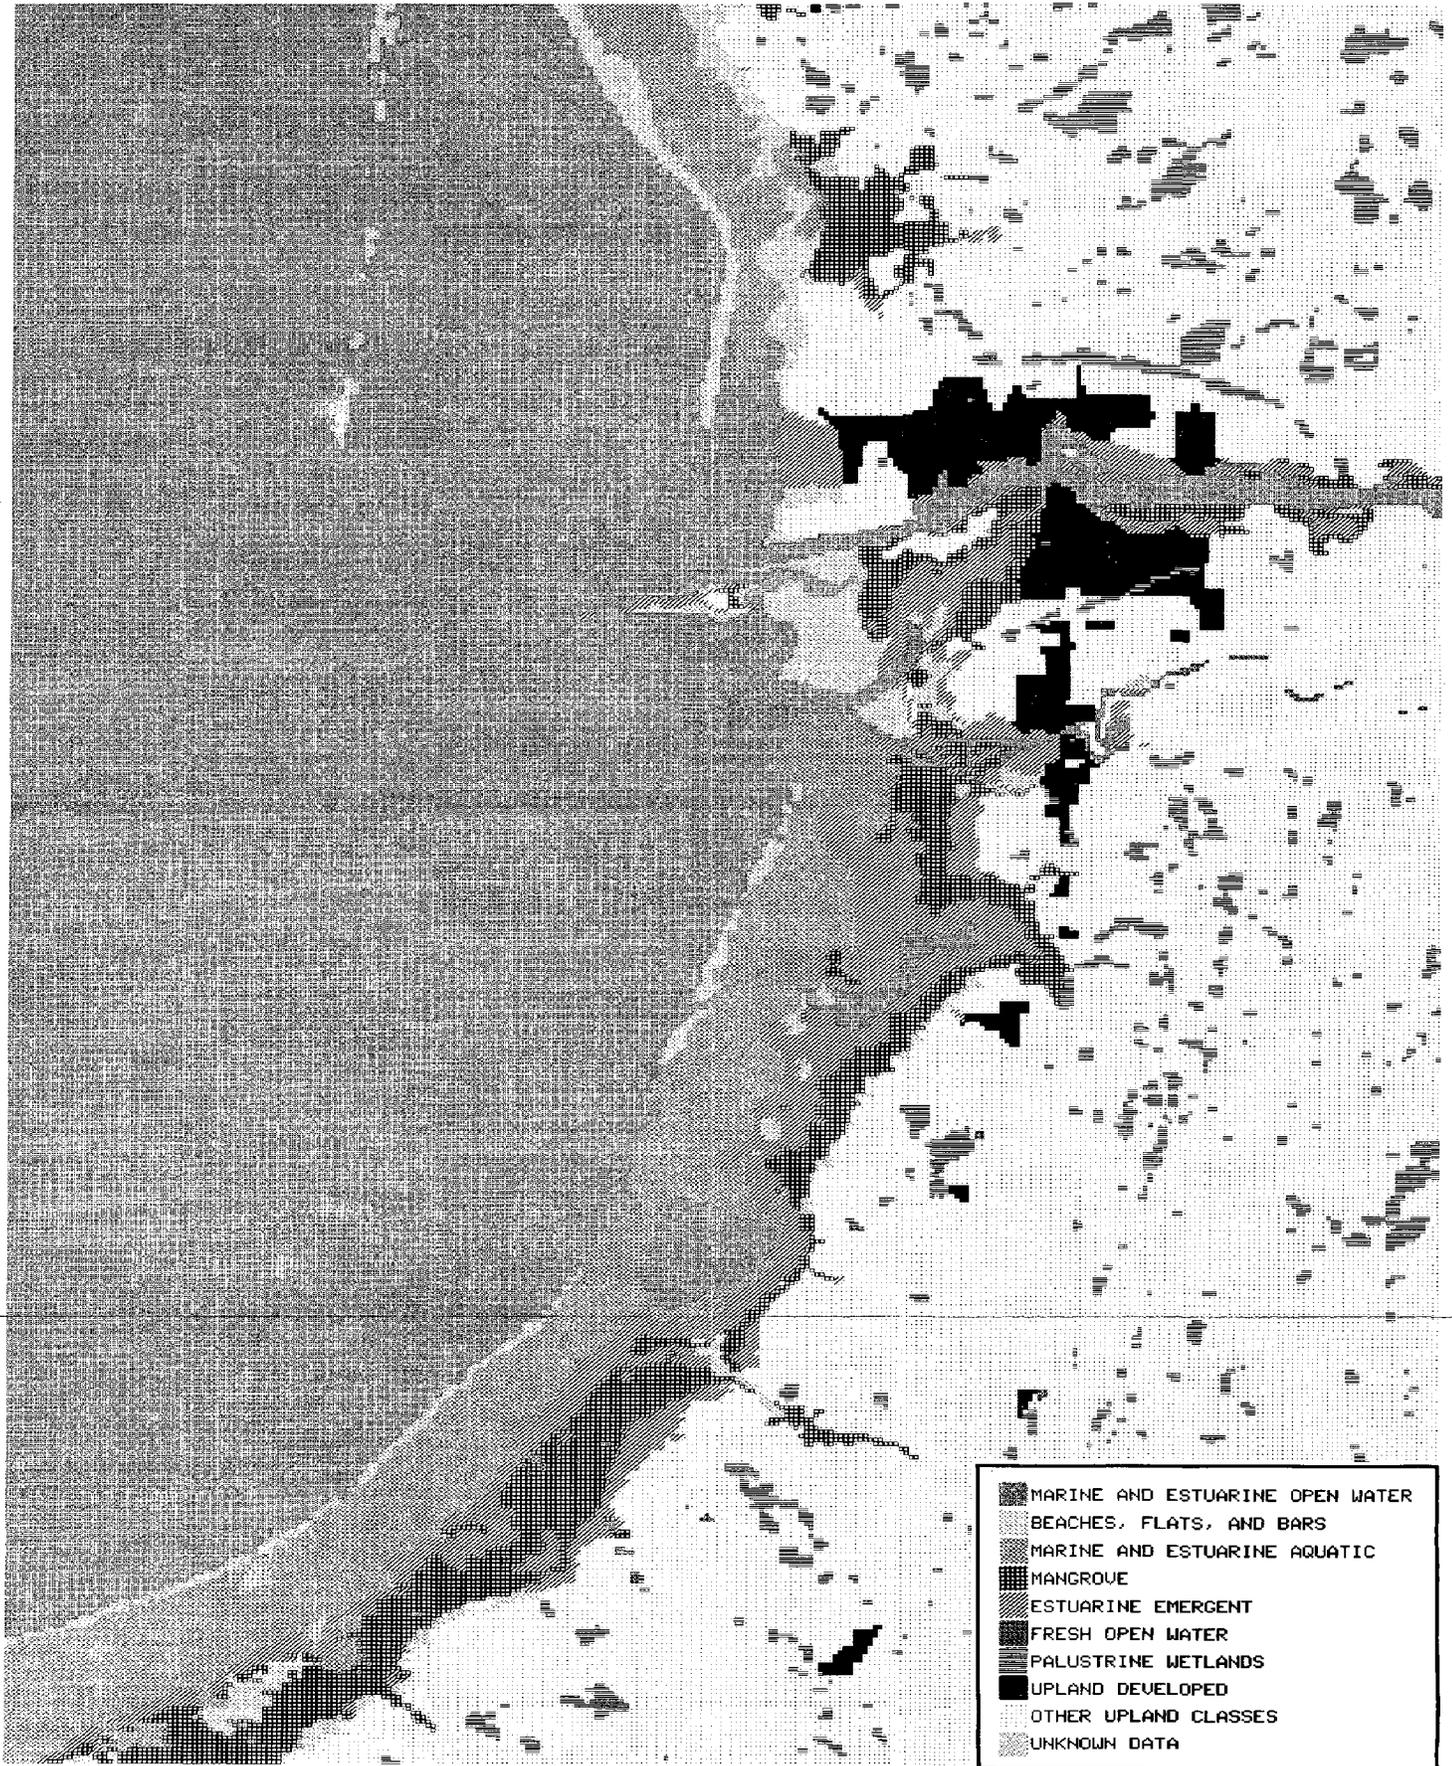
Figure 85 Wetland Inventory of the Alafia River Area - 1957

Review of the 1957 (Figure 85) and 1982 (Figure 86) wetland inventory, and the trend analysis (Figure 87) for Spoil Disposal Islands 2-D and 3-D show the placement of the islands in open estuarine waters of Hillsborough Bay. Scattered small spoil islands are identified on the 1957 inventory in a linear orientation adjacent to the shipping channel. The 1982 inventory reflects the increase in open water filling with the creation of 2D and 3D spoil islands from dredging operations into the Port Redwing/Big Bend facility, and expansion of spoil islands at the mouth of the Alafia River. A large emergent estuarine marsh identified in the 1957 inventory at the mouth of the Alafia River is colonized by mangroves in the 1982 wetland inventory analysis. A large quantity of seagrass coverage noted in the 1957 inventory has been lost in the area by 1982.
