Habitat Restoration Study for the Tampa Bay Region

TAMPA BAY REGIONAL PLANNING COUNCIL 1986

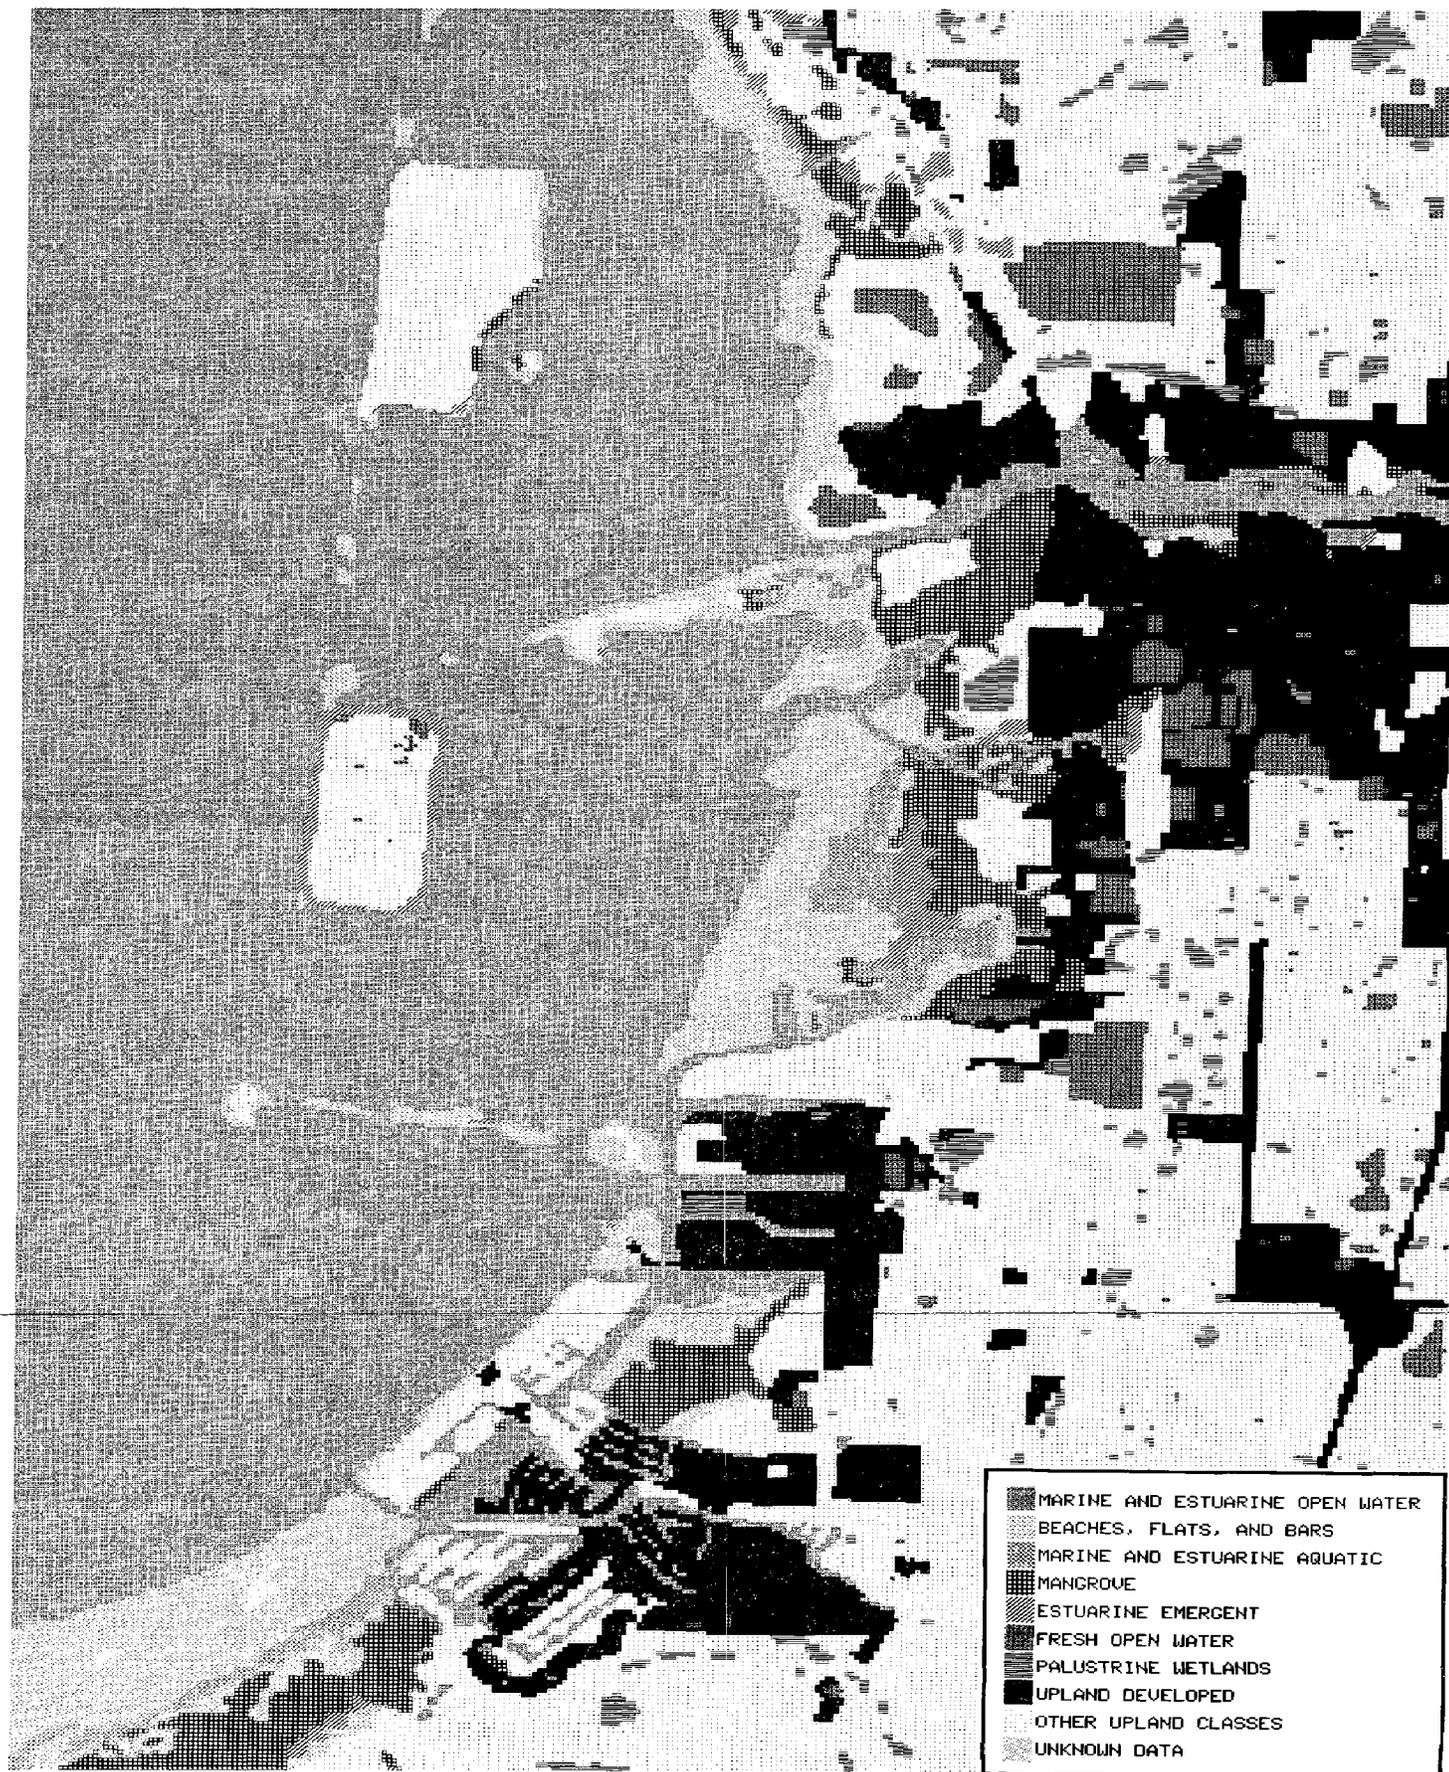
Figure 86 Wetland Inventory of the Alafia River Area - 1982

Review of the 1957 (Figure 85) and 1982 (Figure 86) wetland inventory, and the trend analysis (Figure 87) for Spoil Disposal Islands 2-D and 3-D show the placement of the islands in open estuarine waters of Hillsborough Bay. Scattered small spoil islands are identified on the 1957 inventory in a linear orientation adjacent to the shipping channel. The 1982 inventory reflects the increase in open water filling with the creation of 2D and 3D spoil islands from dredging operations into the Port Redwing/Big Bend facility, and expansion of spoil islands at the mouth of the Alafia River. A large emergent estuarine marsh identified in the 1957 inventory at the mouth of the Alafia River is colonized by mangroves in the 1982 wetland inventory analysis. A large quantity of seagrass coverage noted in the 1957 inventory has been lost in the area by 1982.

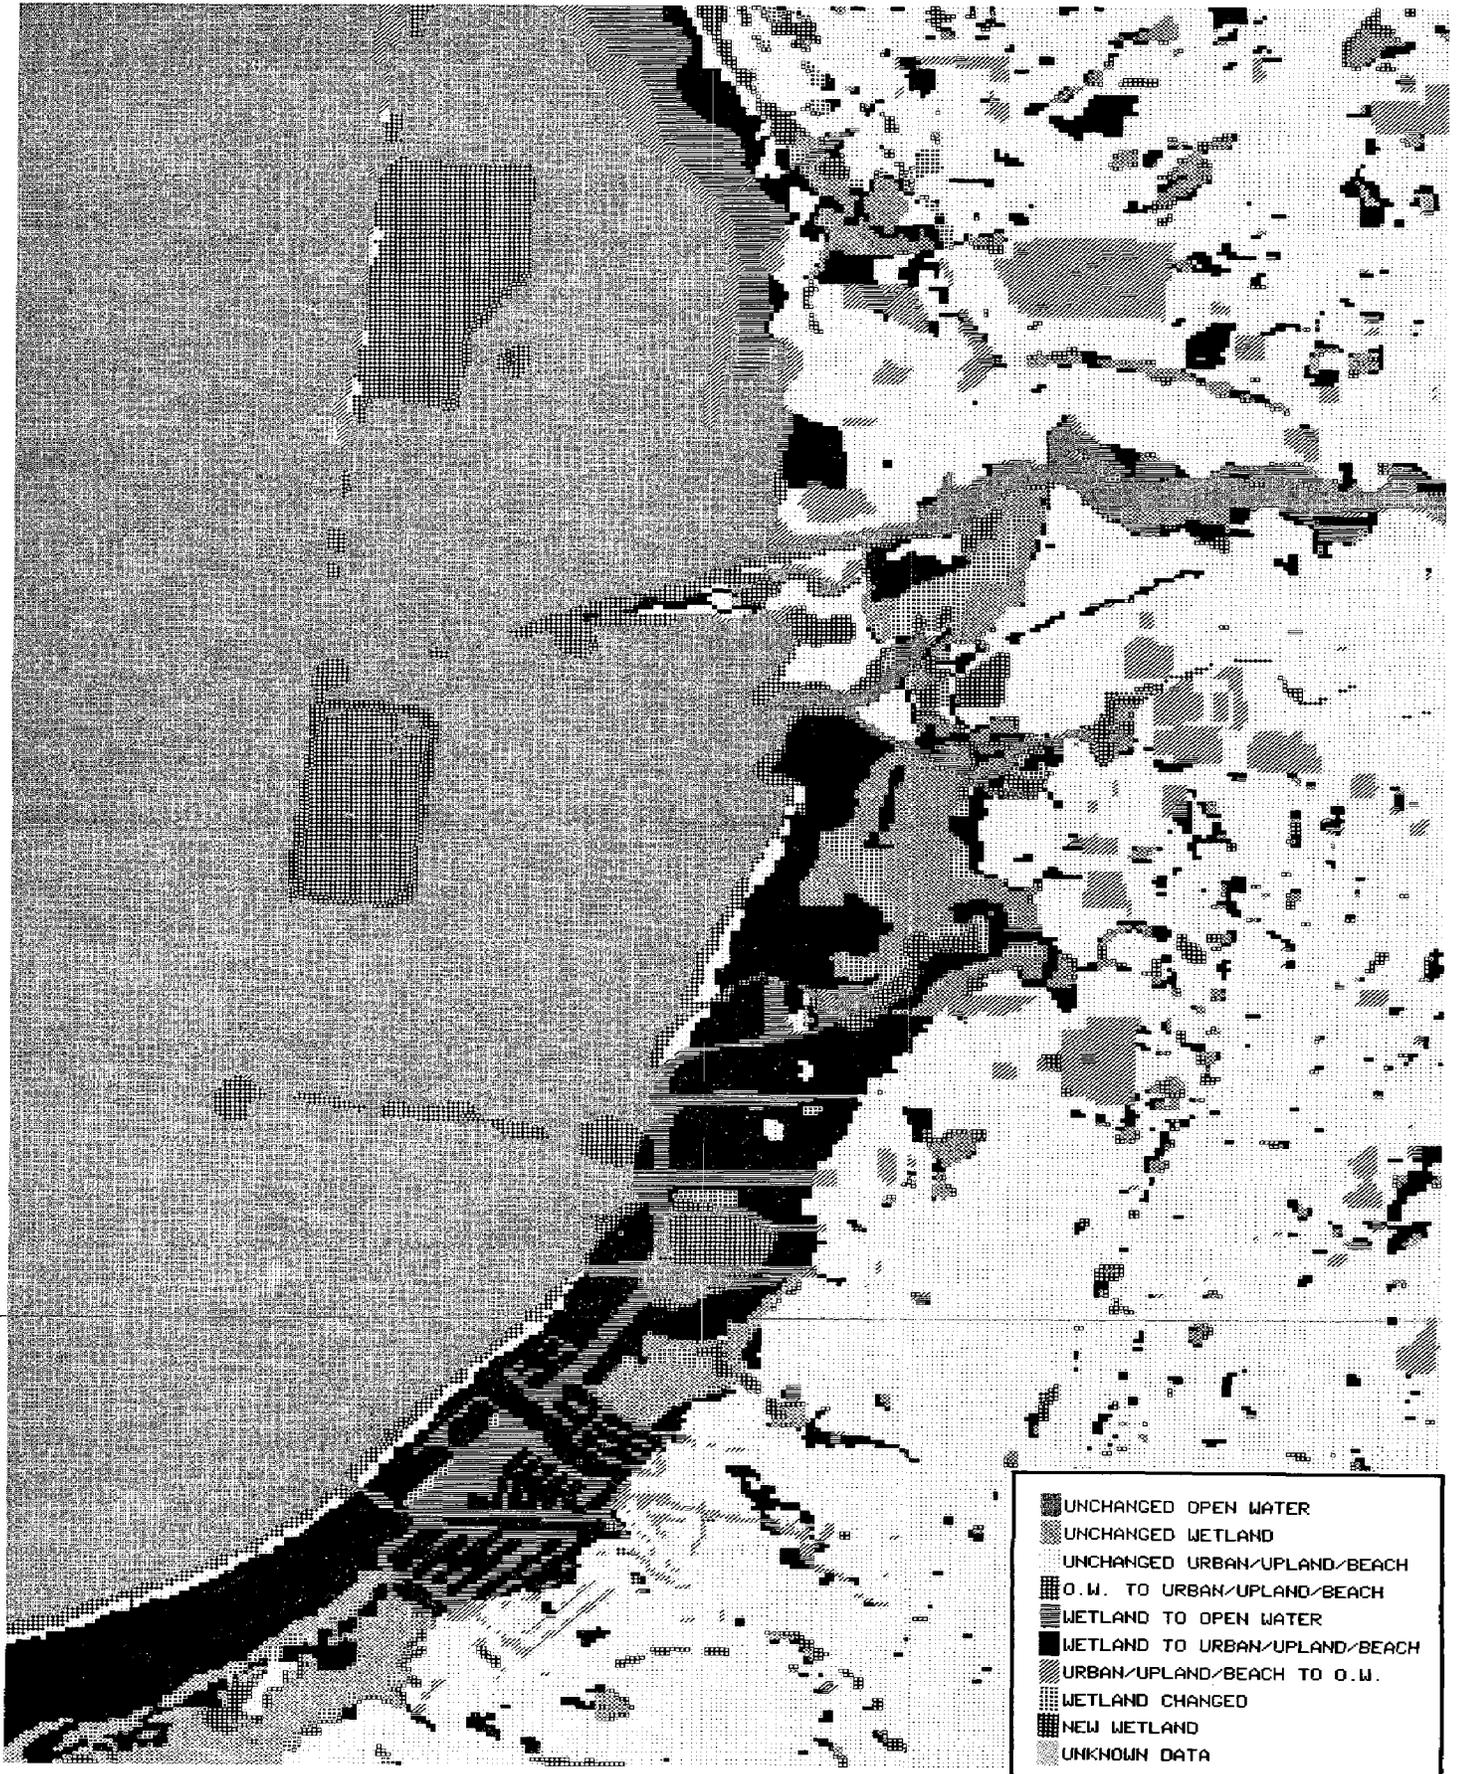
Figure 87 Wetland Trend Analysis of the Alafia River Area

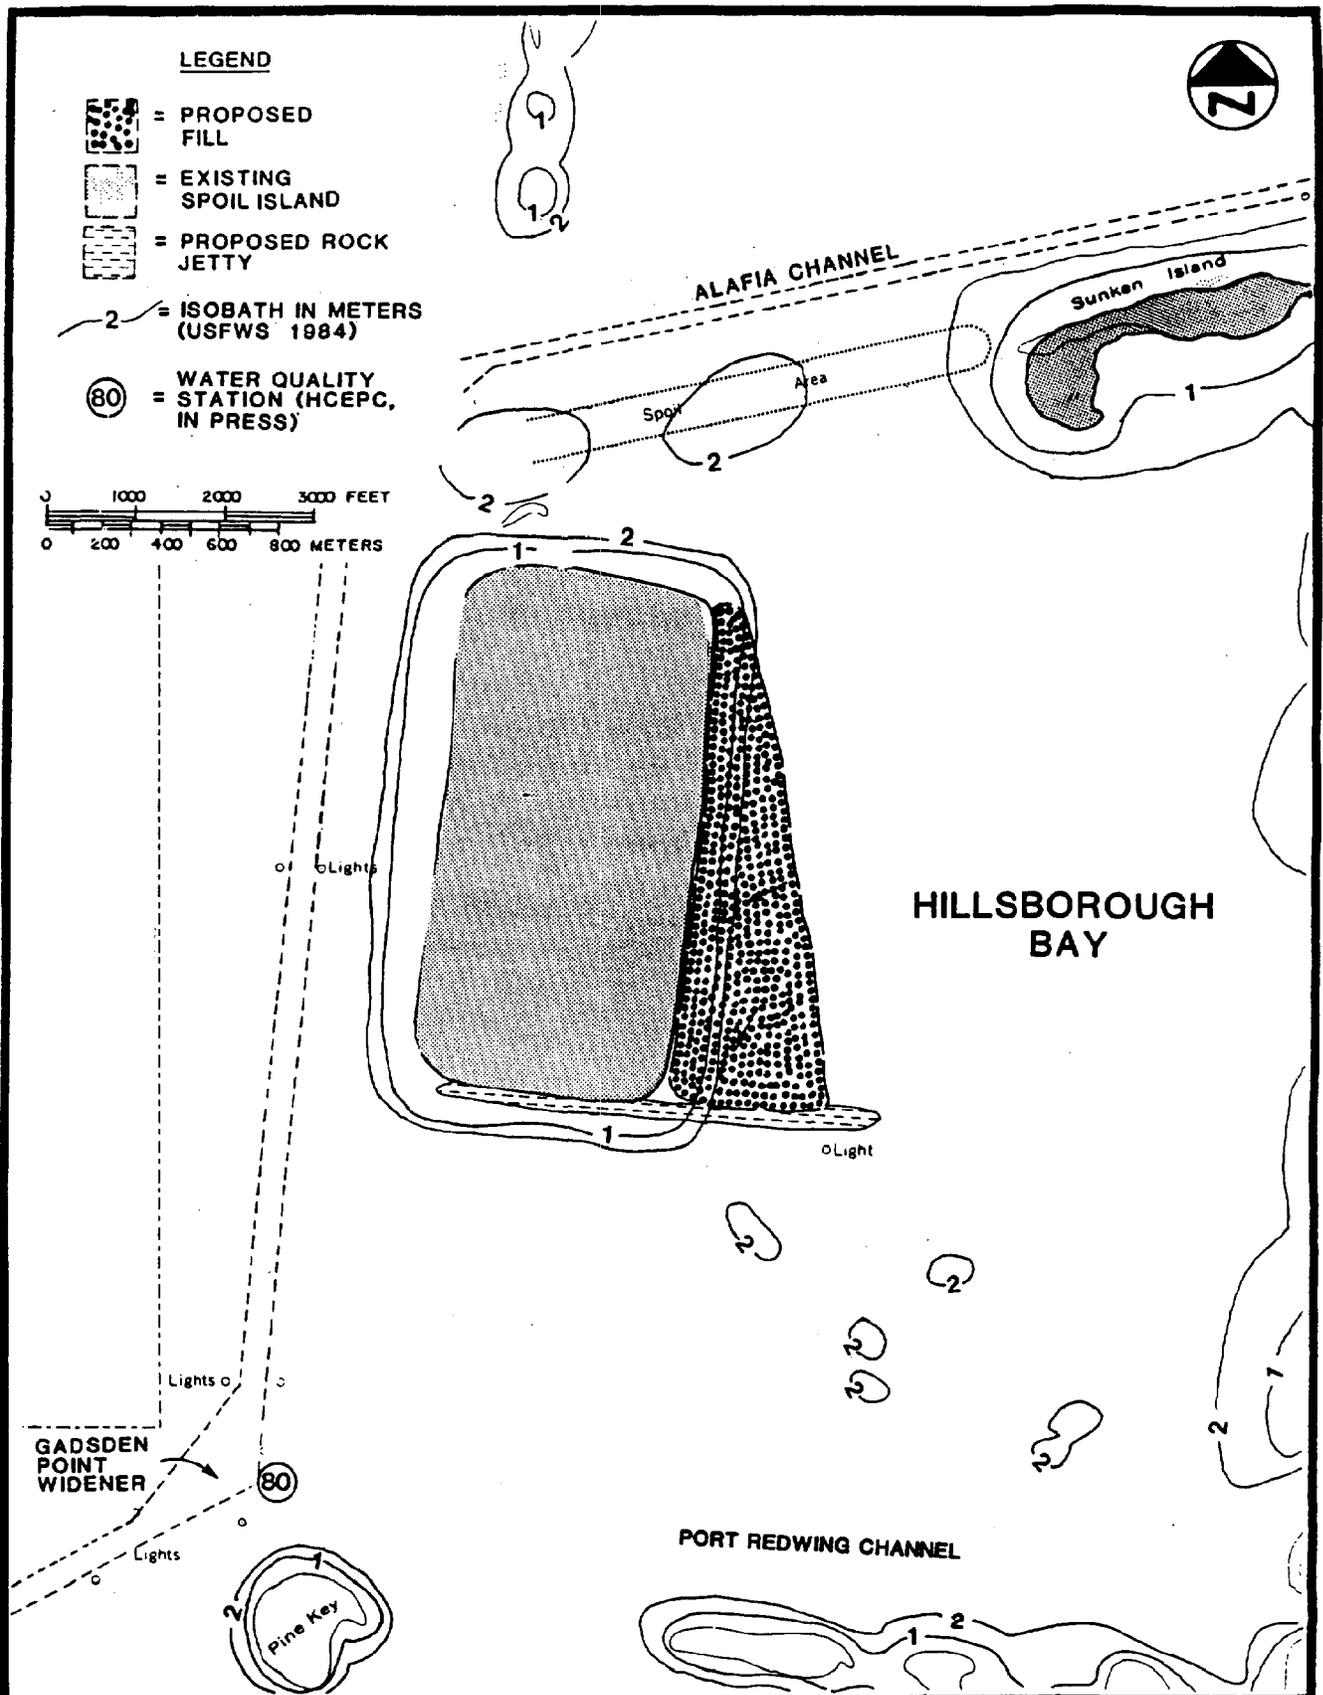
Figure 89 Spoil Island 3-D restoration site (CSA, 1986)

Site Description: Spoil Island 3-D is located in Hillsborough Bay south of the Alafia River, and north of the channel to Port Redwing (Figure 89). The diked island is approximately 150 ha in size. The island, constructed largely of sand and fine shell, was built in 1981 by the USACE for spoil containment as a part of the Tampa Harbor deepening project. No vegetation has been planted on the island, which is eroding rapidly (Lewis and Paul, 1984). Observations by CSA (1986) indicate that the entire island base is eroded at the southwest corner, forming a 6-m cliff from the eroded dike. The eastern shoreline, however, has a 6- to 10-m shelf between the dike base and the MHW line (Figure 89). This area has become vegetated with grasses [e.g., *P. vaginatum* and *Ipomea pes-caprae* (railroad vine)]. The interior of the island is only partially vegetated with grasses and low shrubs.

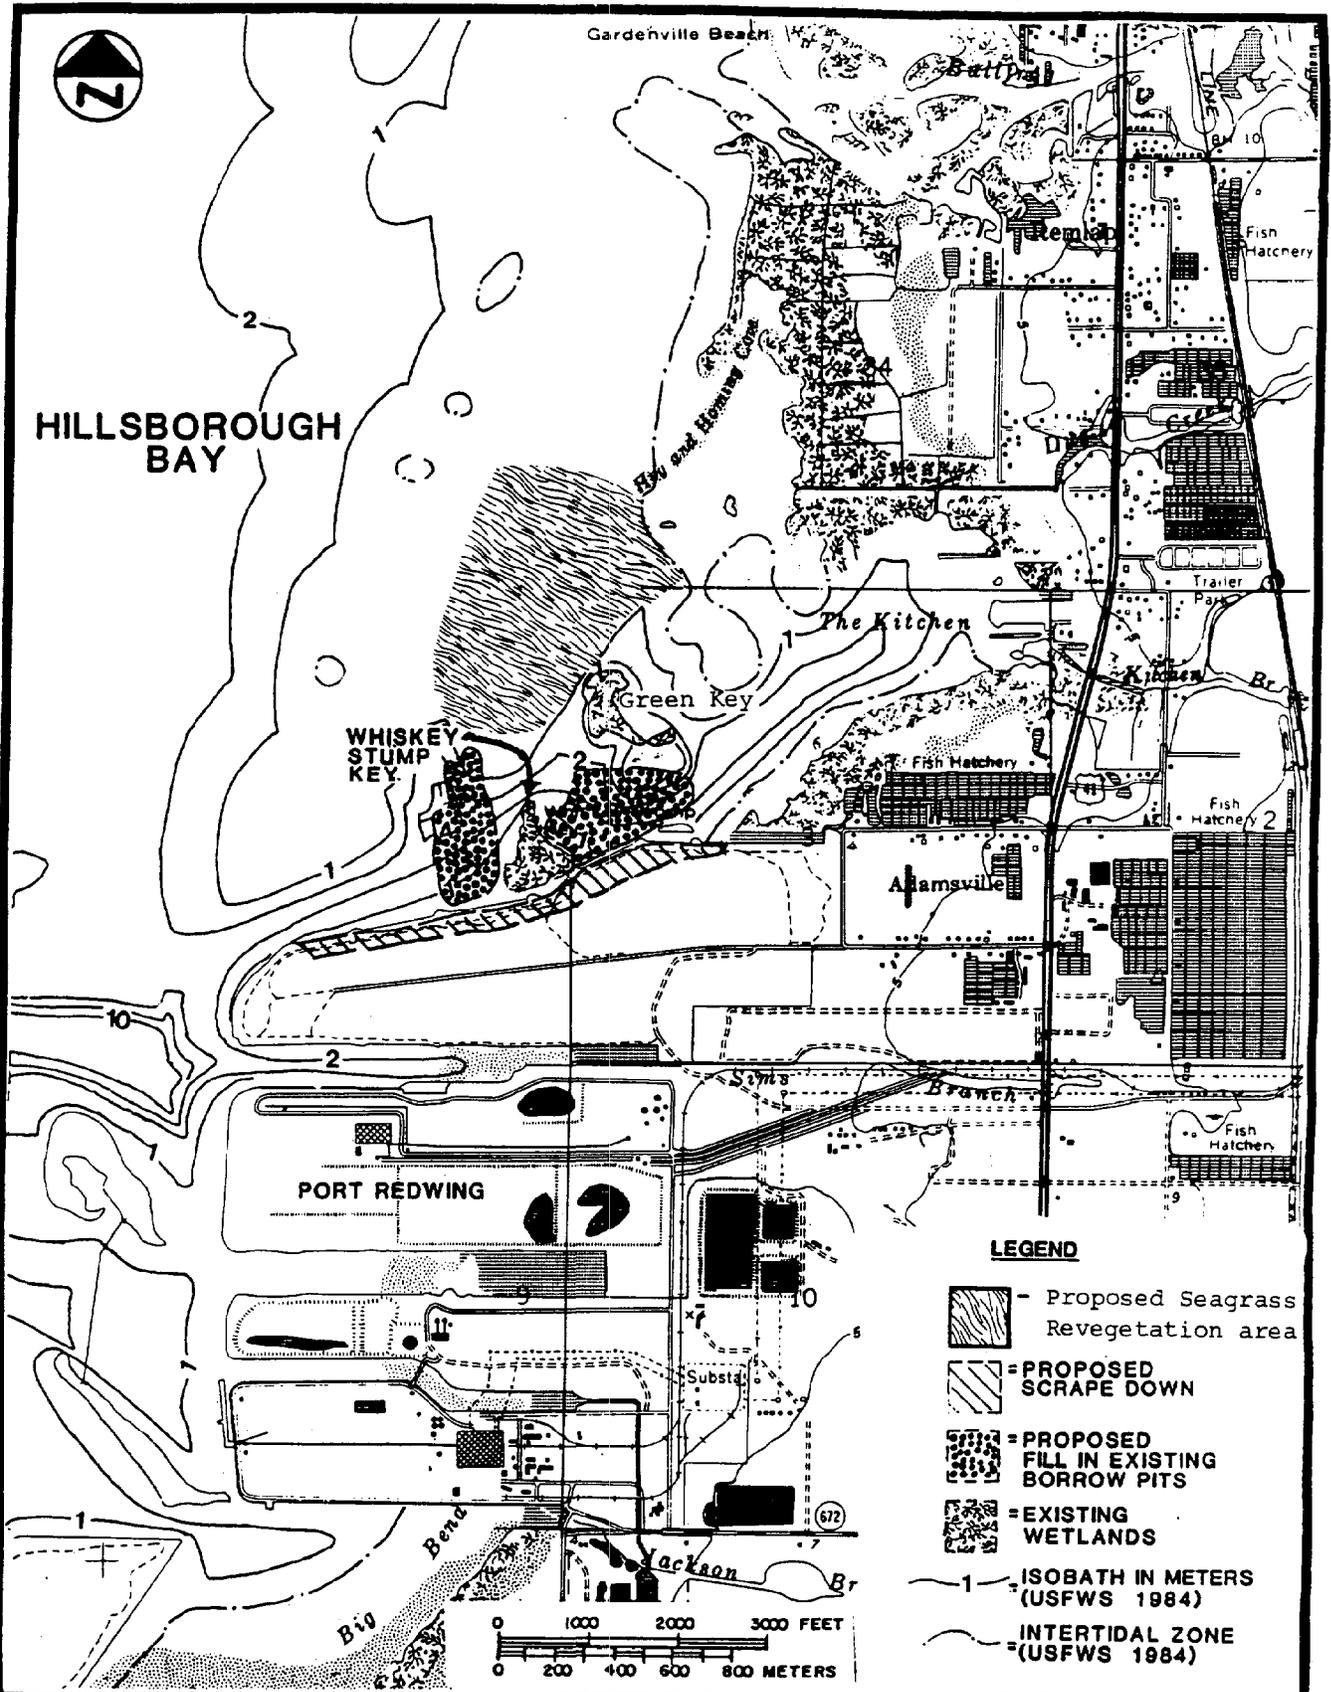
Figure 90 Port Redwing restoration site (Adapted from CSA, 1986)

Site Description: Port Redwing is located within Hillsborough County, south of Bullfrog Creek and north of Apollo Beach (Figure 90). The recent (9 March 1984) Big Bend Study by the TPA for the Coastal Energy Impact Program describes in detail the area around Port Redwing (NUS Corporation et al. 1984 in CSA, 1986). The areas of concern for this study are the northern shoreline of Port Redwing and two old dredge cuts north of the port in the vicinity of Whiskey Stump Key and Green Key (two natural islands which are currently National Audubon Society Sanctuaries). The northern shoreline of Port Redwing currently has a 6- to 15-m fringe of S. alterniflora and mangroves (predominantly A. germinans). Green Key is a low-lying mangrove island. Whiskey Stump Key has slightly higher elevation

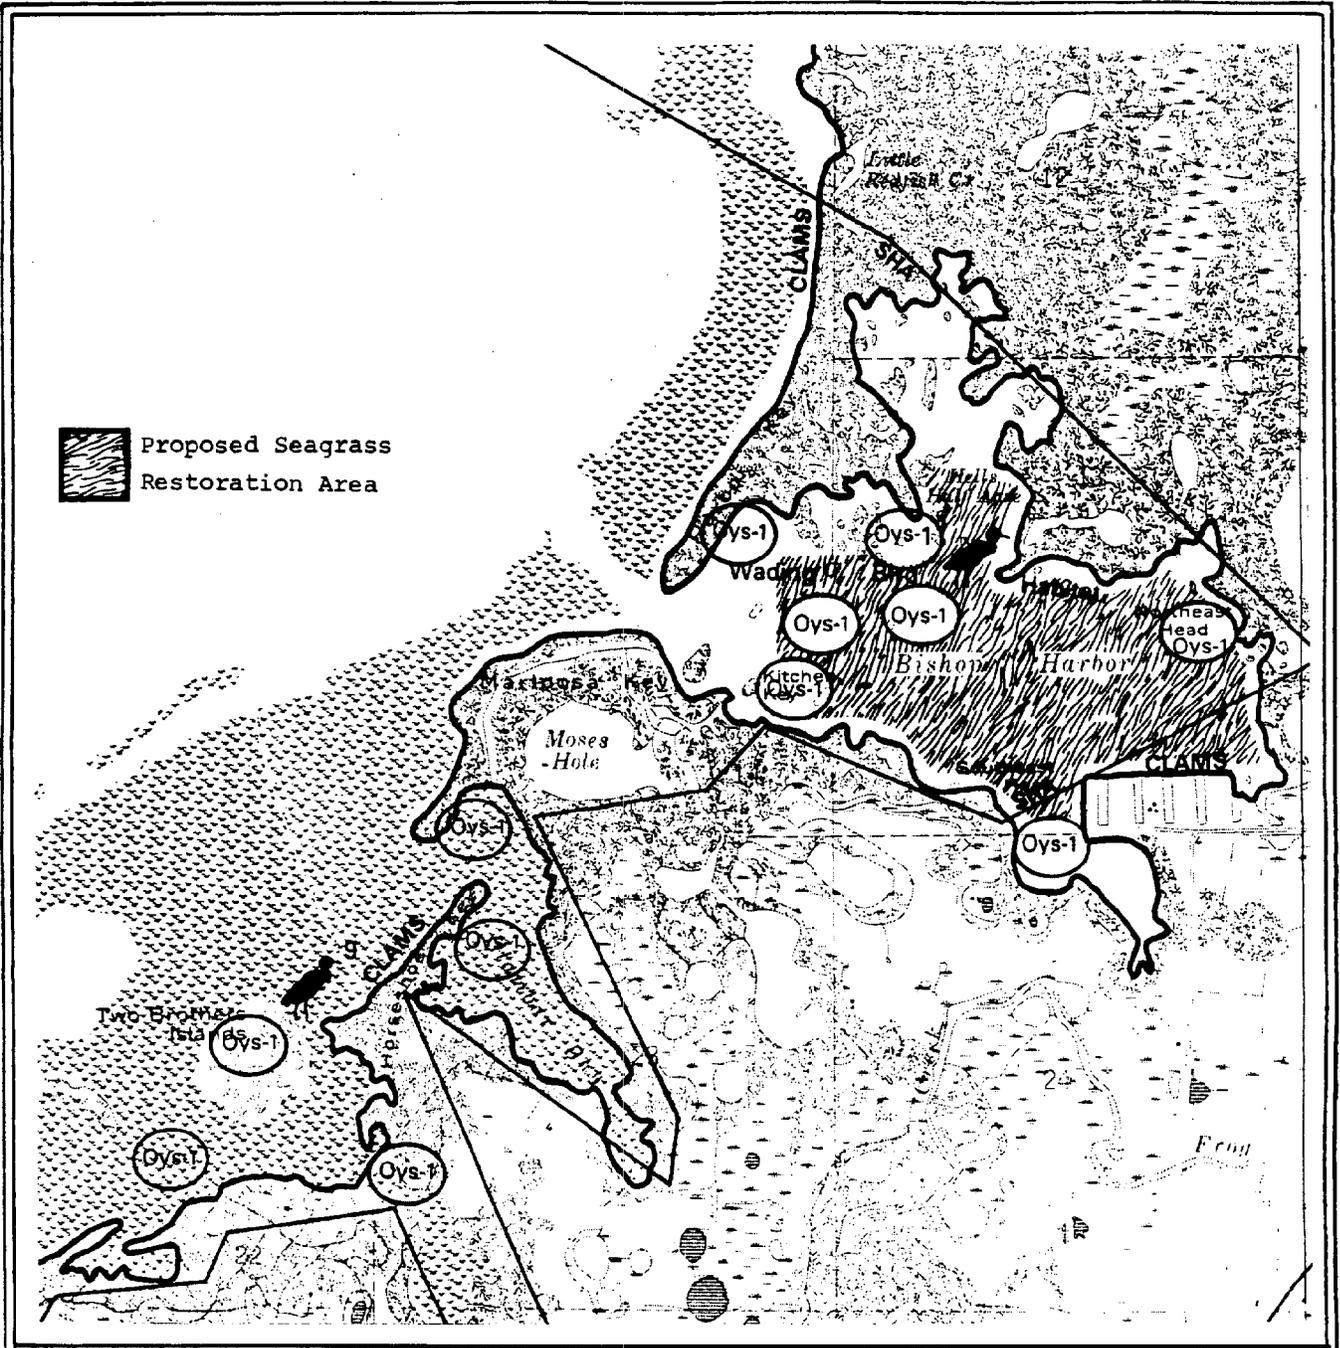
Figure 98

Site Description: Bishop Harbor is located south of Port Manatee and northeast of the Skyway Bridge causeway, in Manatee County (Figure 98). The area is a small embayment of Tampa Bay, containing extensive oyster bars and mangrove islands, contiguous with Terra Ceia Bay to the south.

Periodic releases of toxic ammonia and agricultural runoff have destroyed approximately 70 acres of seagrass vegetation in Bishop Harbor. Approximately 30% of the seagrass coverage has returned naturally (Lewis, personal communication, 1986).

Bishop's Harbor Restoration Site

Restoration Plan: Water quality in Bishop Harbor is expected to increase with engineering improvements to the phosphate processing plant's treatment facility and rerouting the drainage ditches. Seagrass planting is recommended to enhance natural establishment into the area (Figure 98).
