ANNETTE ISLANDS STREAM INVENTORY

Potential Salmon Production Summary

Prepared for the
Metlakatla Indian Community

Evelyn D. Biggs
Fisheries Management Biologist

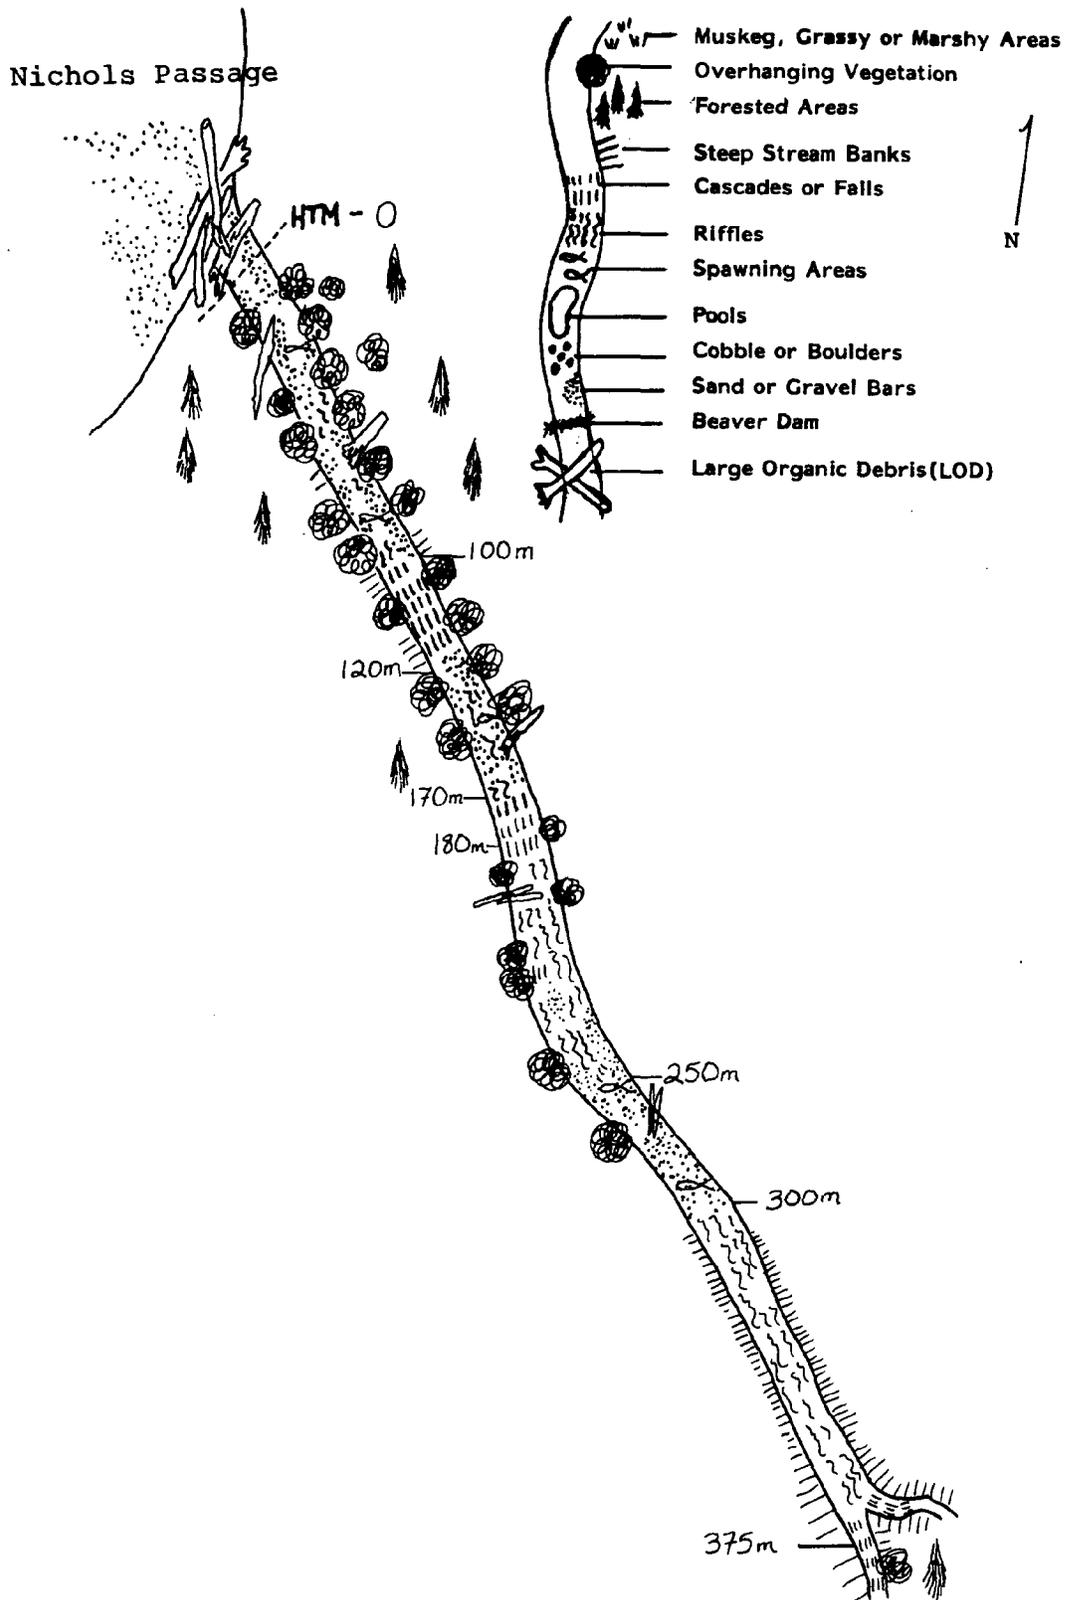
Figure 2. ANVIL MOUNTAIN CREEK

Anvil Mountain Creek potentially produces approximately 165 pinks, and 25 chum that will return to Annette Island vicinity, using an emergent fry survival rate of 10% egg-fry due to the fair to good quality gravels present.

ANVIL MOUNTAIN CREEK

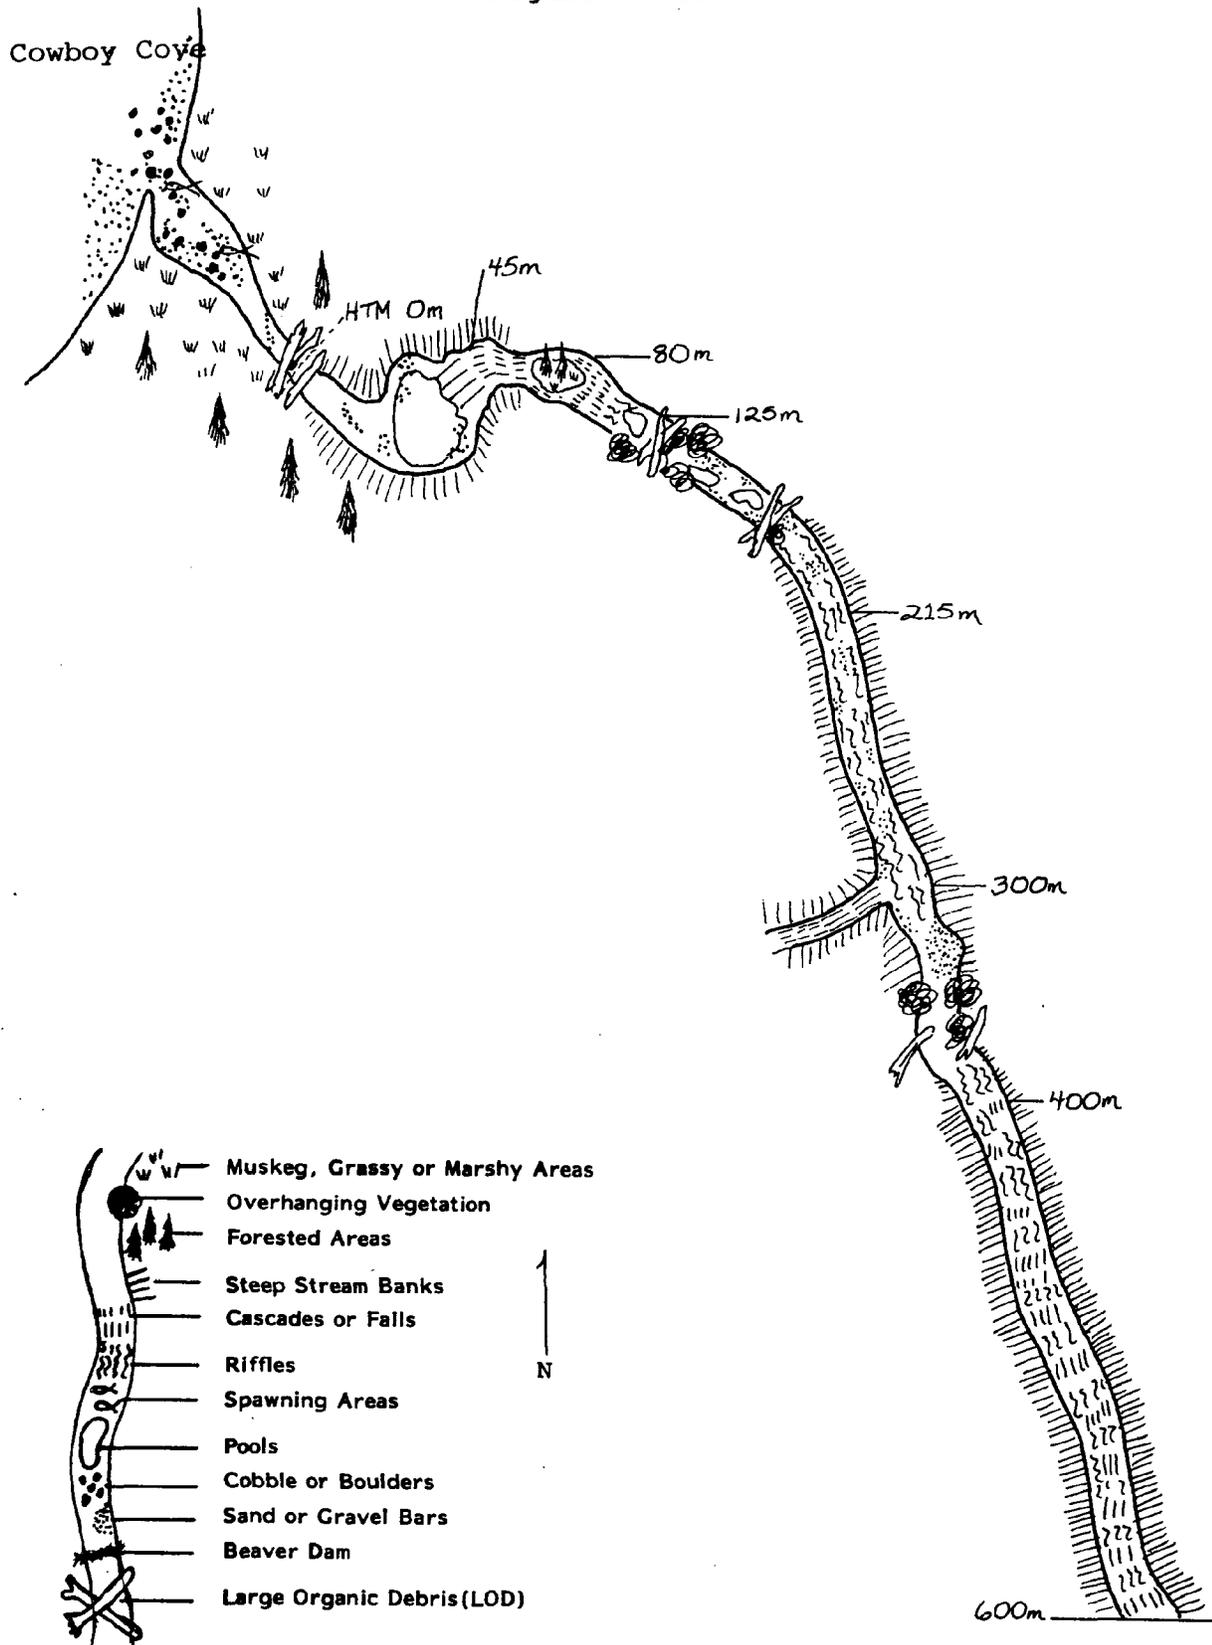
Figure 3. COWBOY CREEK

Due to poor gravel quality, only a 1.2% egg-fry survival rate is assumed: only 21 pinks, and 2 chums are expected to return given the recommended escapement numbers.

COWBOY CREEK

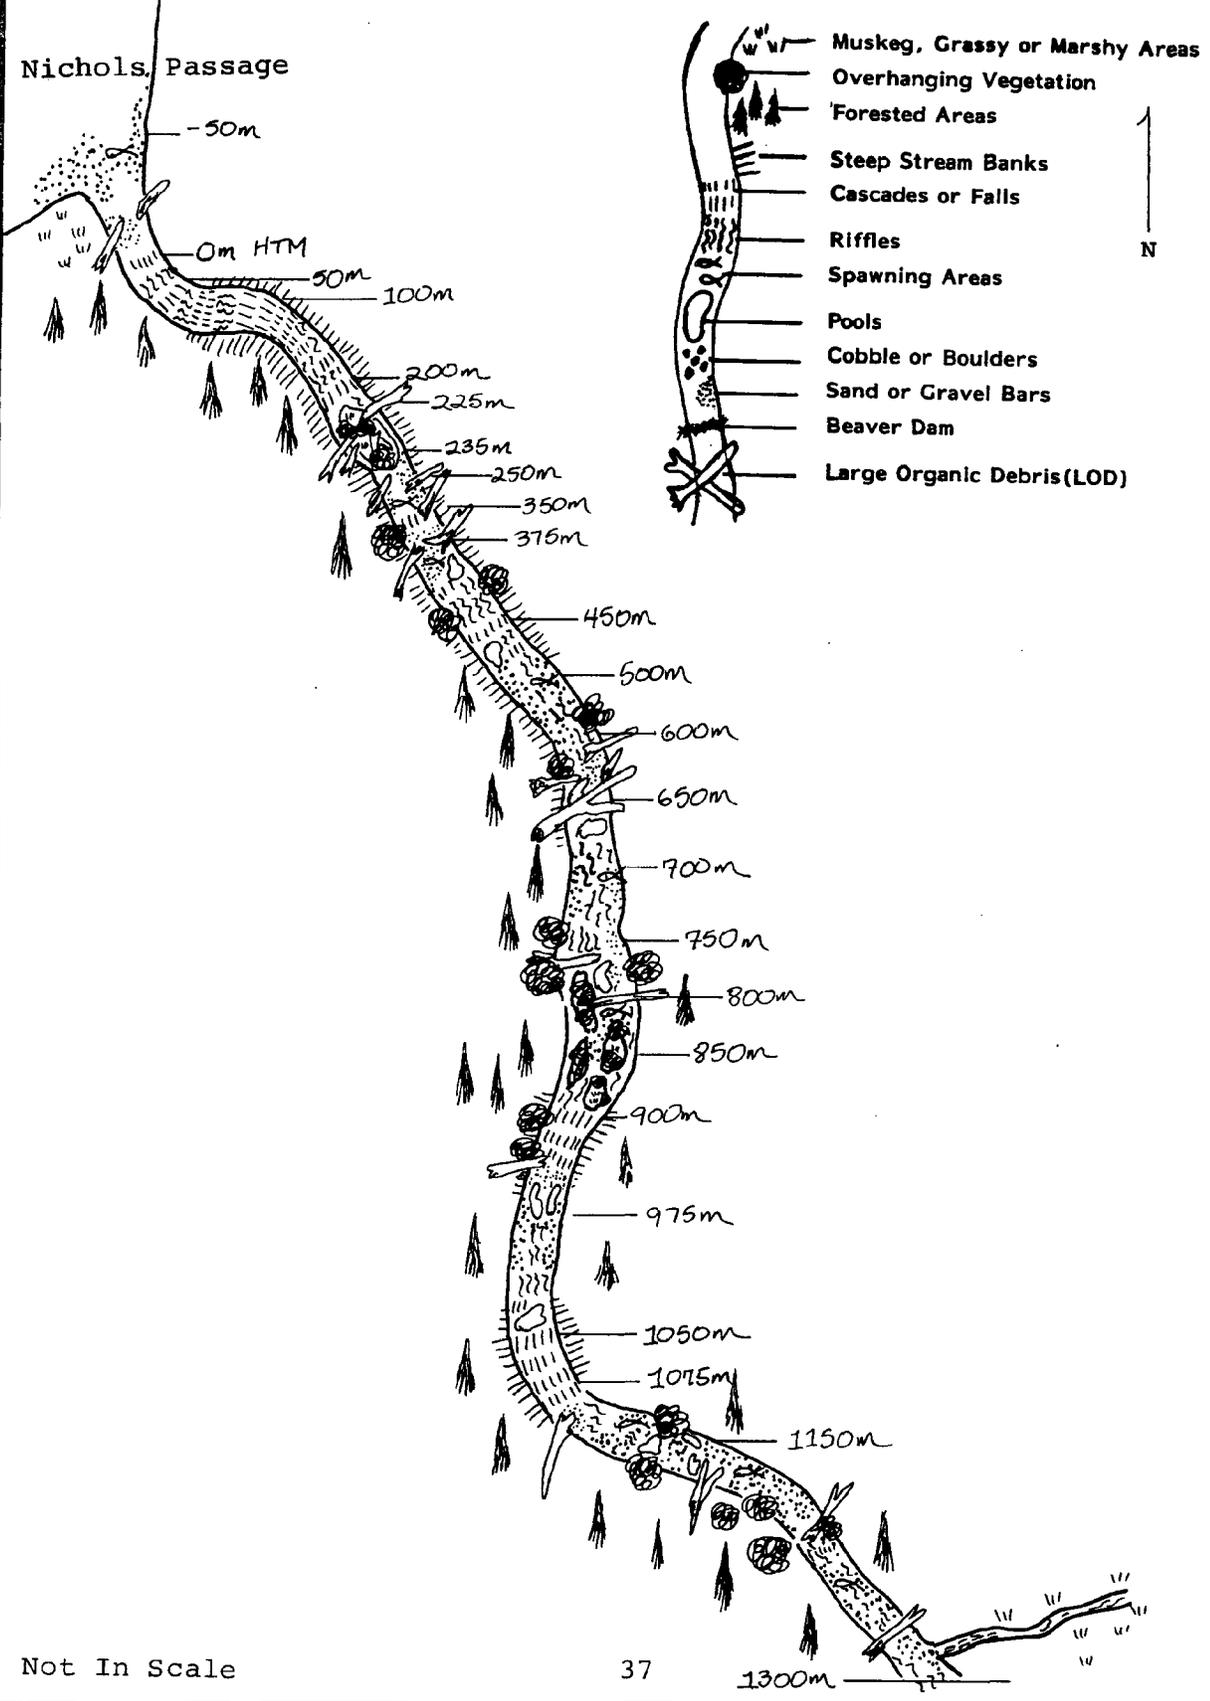
Figure 4. NICHOLS PASSAGE CREEK II - Section 1

With the poor gravel quality, a 1.2% egg-fry survival rate is assumed. With the recommended escapements, approximately 500 pinks, 21 chums, and 8 coho could return to Annette Island from this creek.

NICHOLS PASSAGE CREEK II

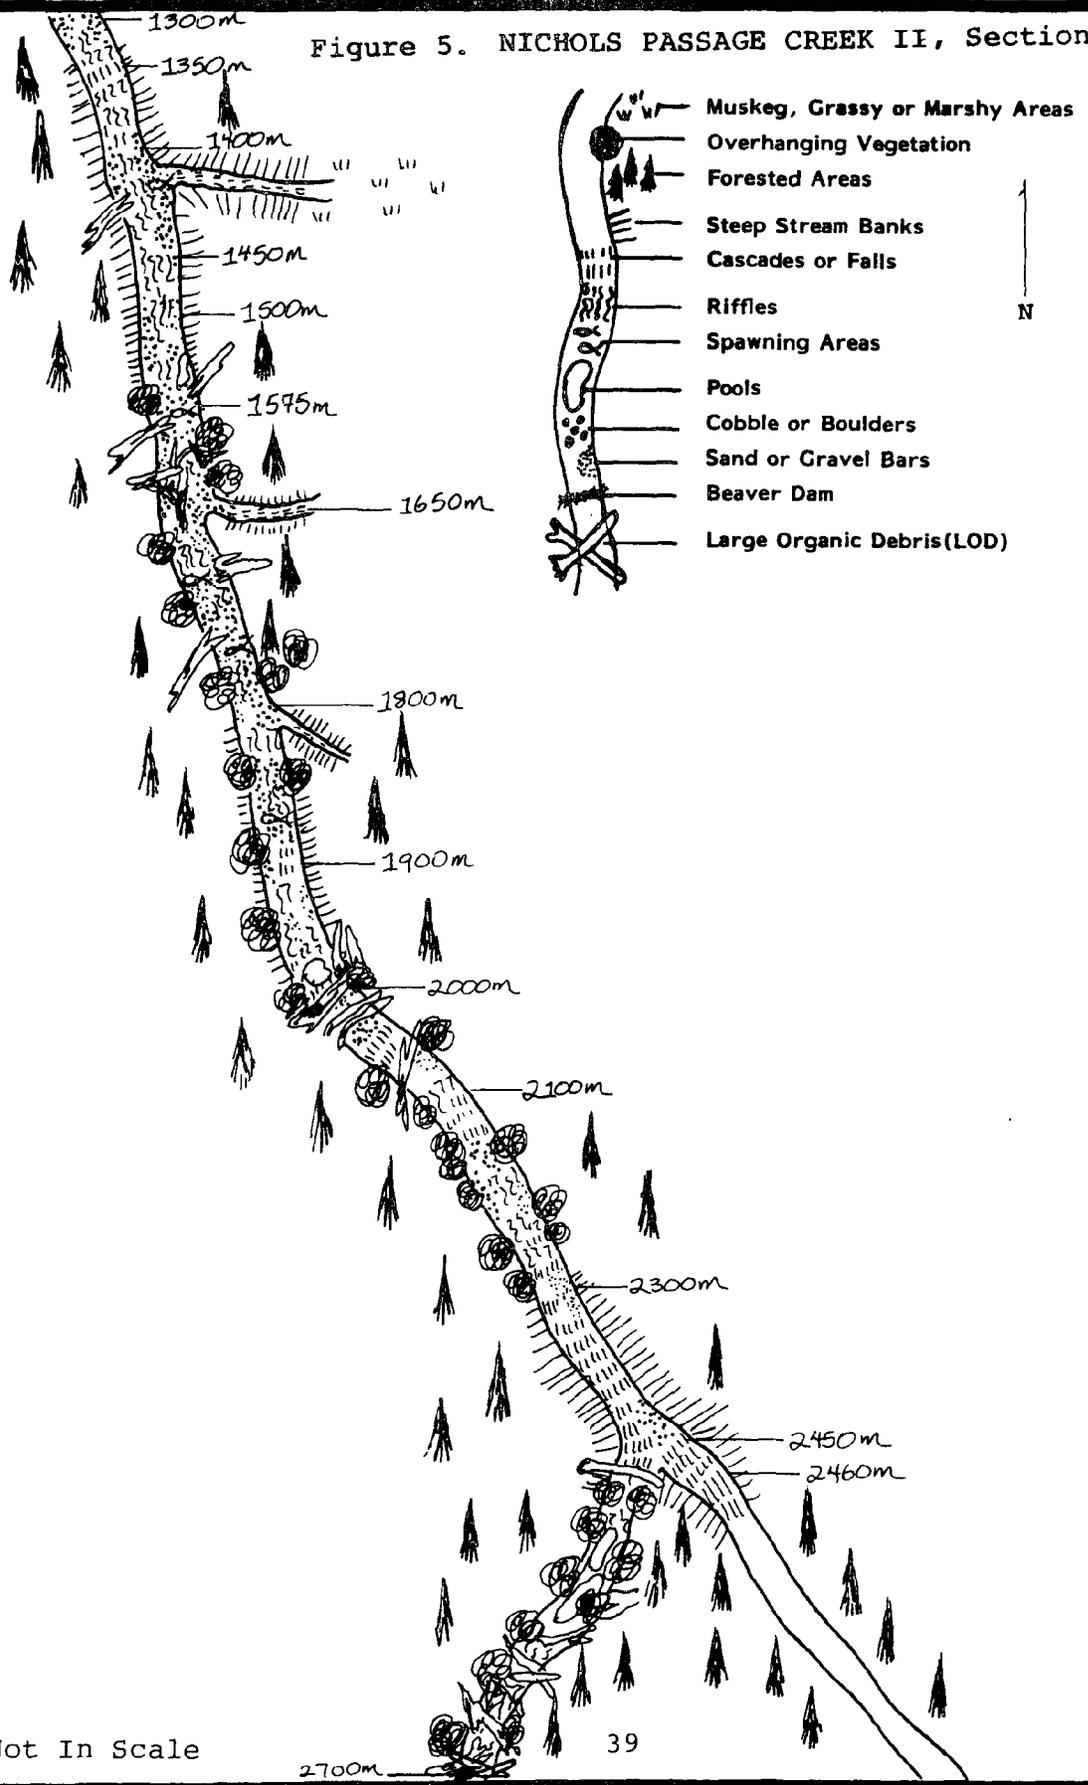
Figure 5. NICHOLS PASSAGE CREEK II, Section 2

Upper half of creek is bordered by old growth timber with little to no understory.

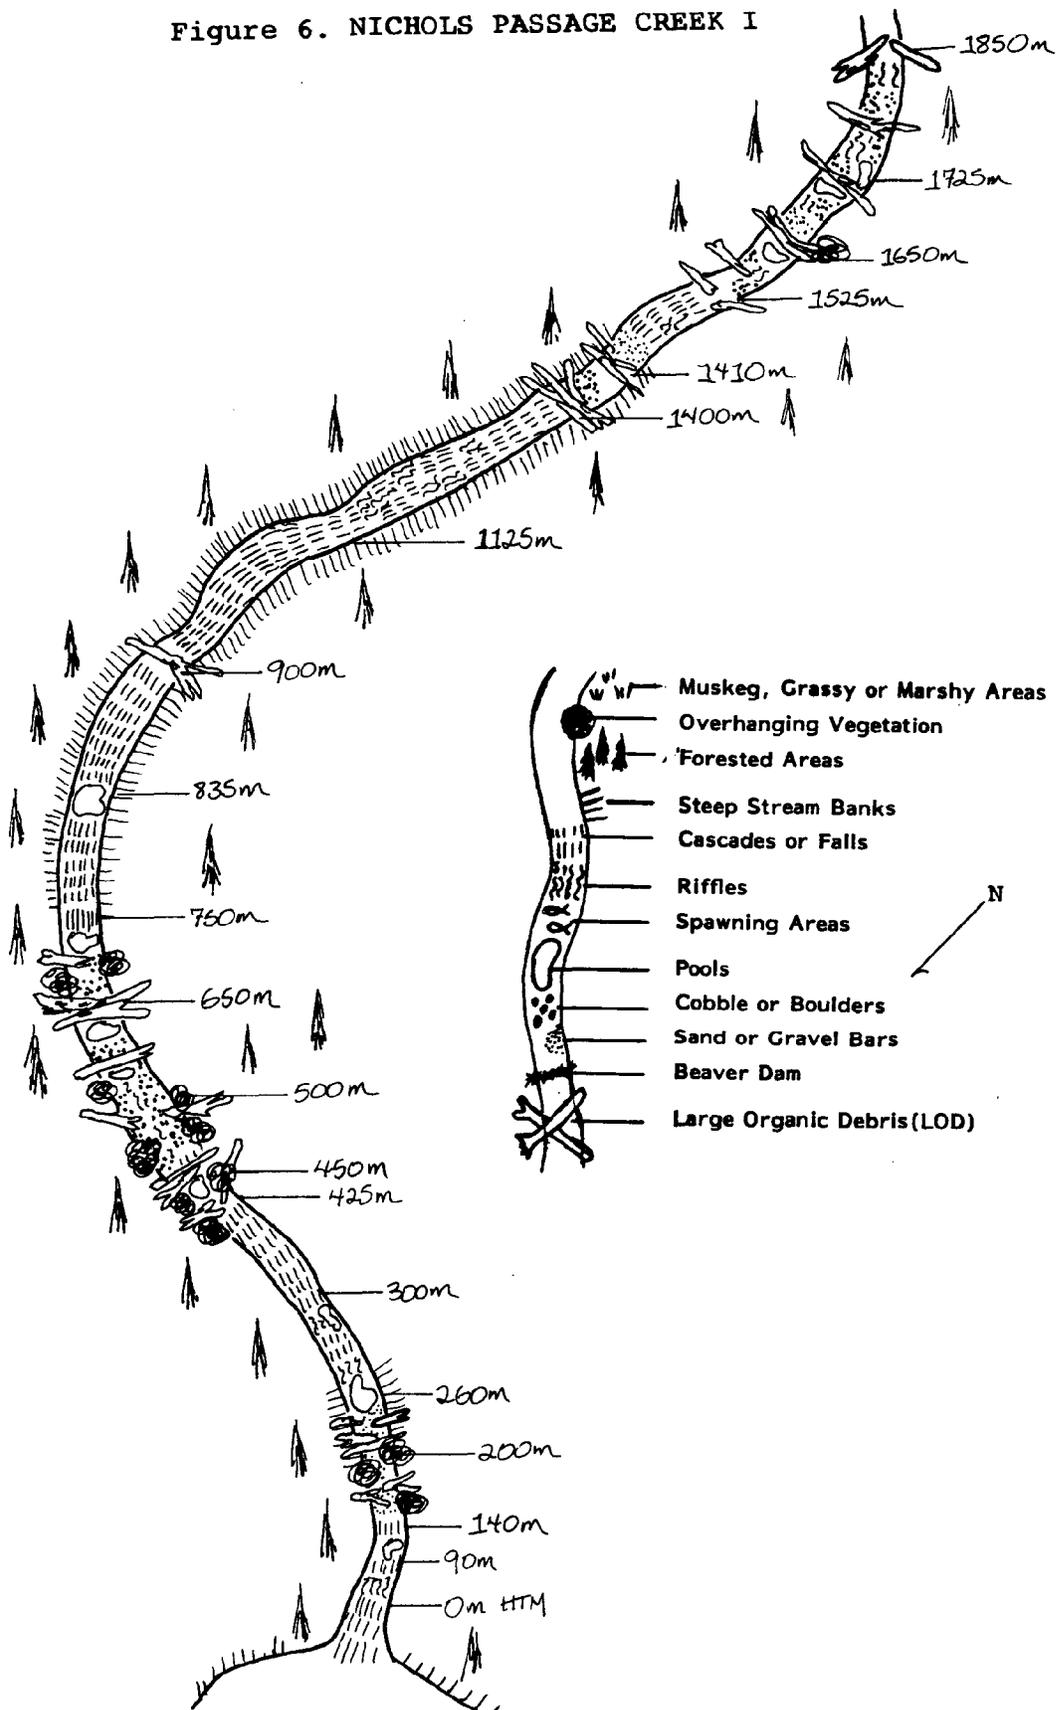
Figure 6. NICHOLS PASSAGE CREEK I

Due to the fair quality gravels, a 10% egg-fry survival rate is assumed and approximately 28 adult coho could be expected to return to Annette Island from this creek.

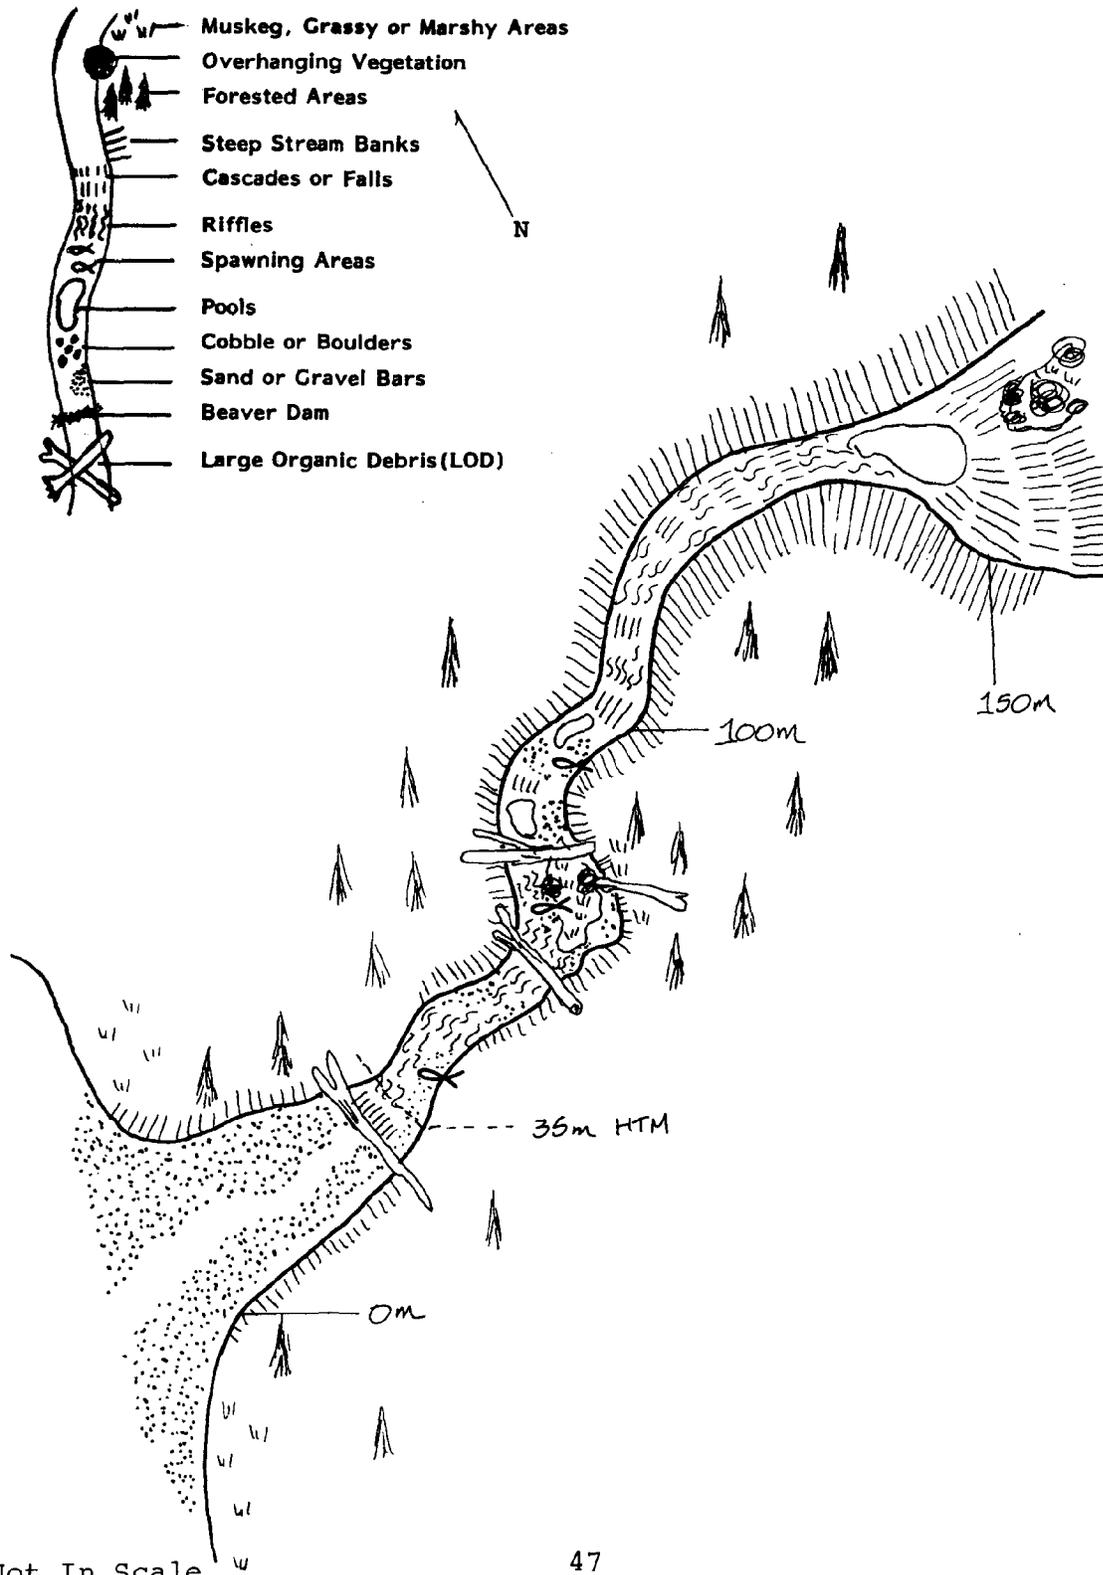
Figure 7. JAPAN CREEK II

The gravels are angular, and the creek flashy, therefore, only a 1.2% egg-fry survival rate is assumed. Therefore, approximately 30 pinks would return to Annette Island from this creek.

JAPAN CREEK II

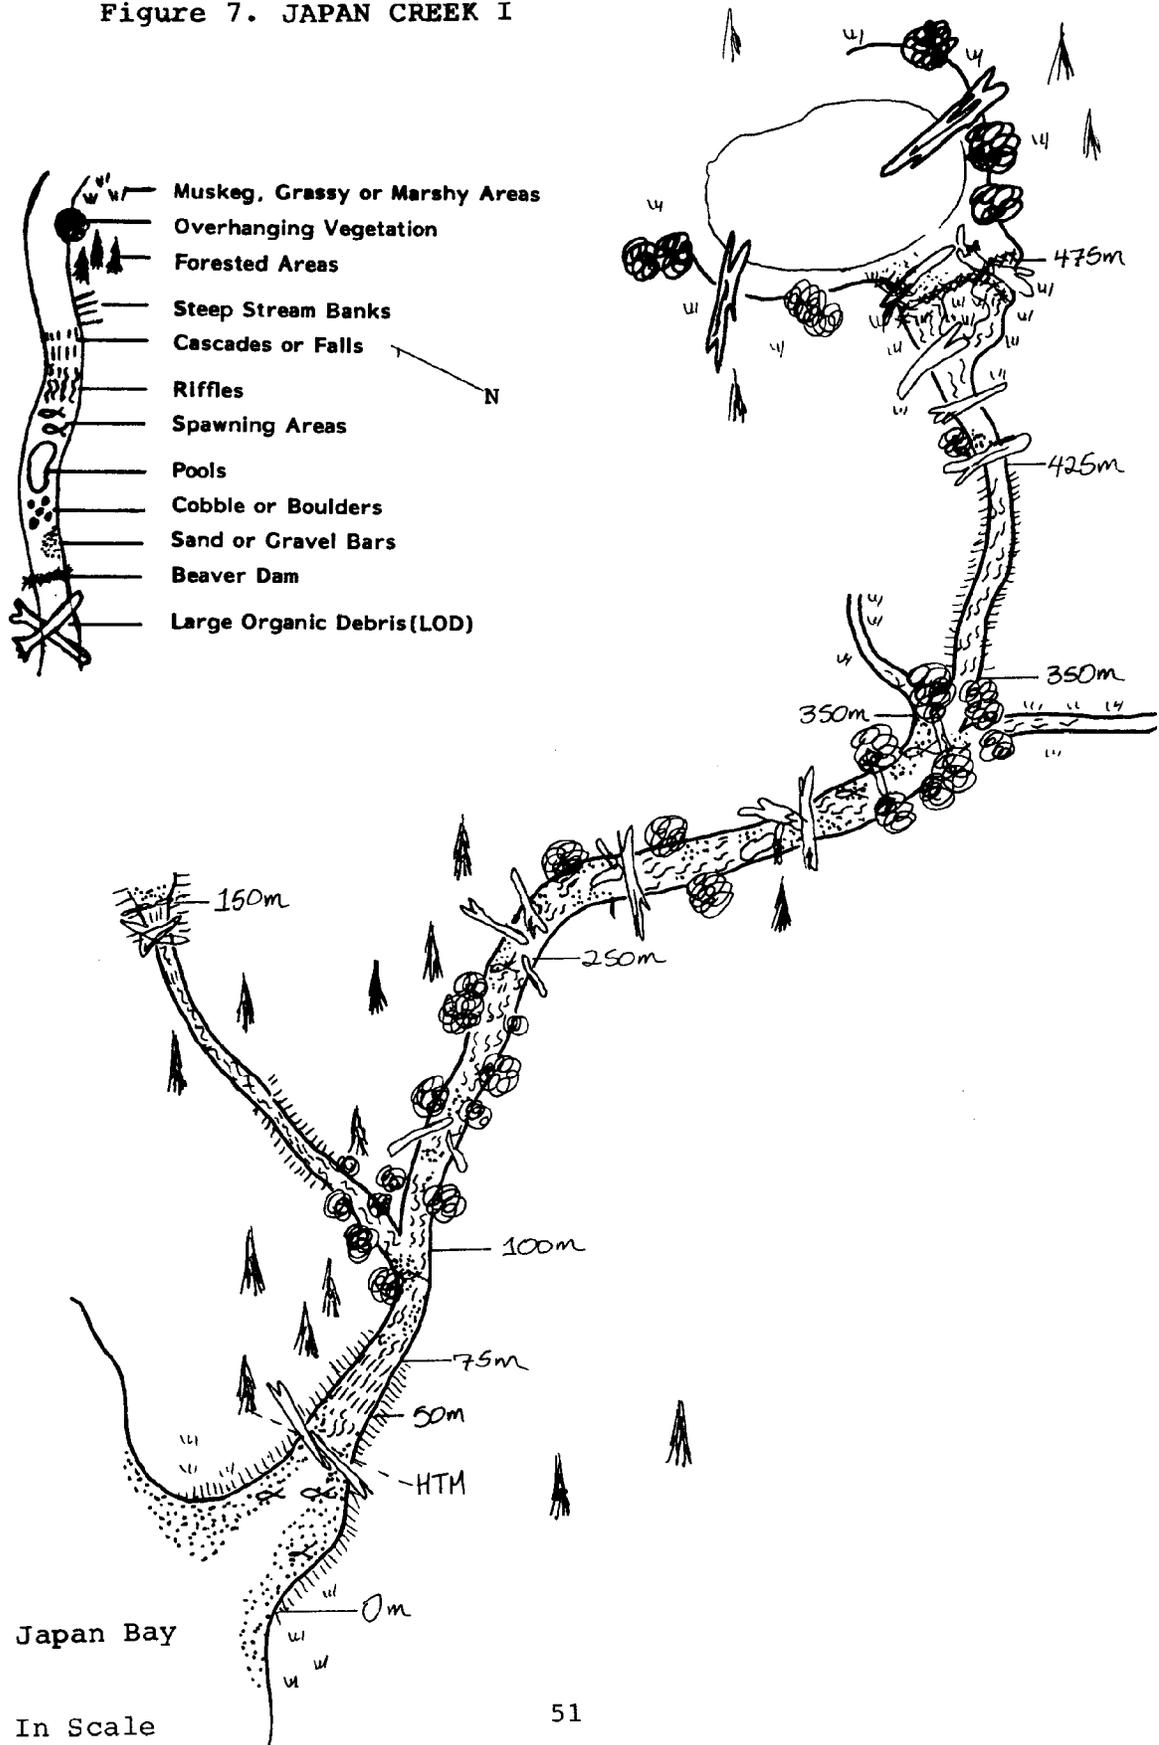
Figure 7. JAPAN CREEK I

Potential production from this creek, assuming a 10% egg-fry survival rate (fair quality gravels), is 3860 pinks and 40 chum returning to Annette Island.

JAPAN CREEK I

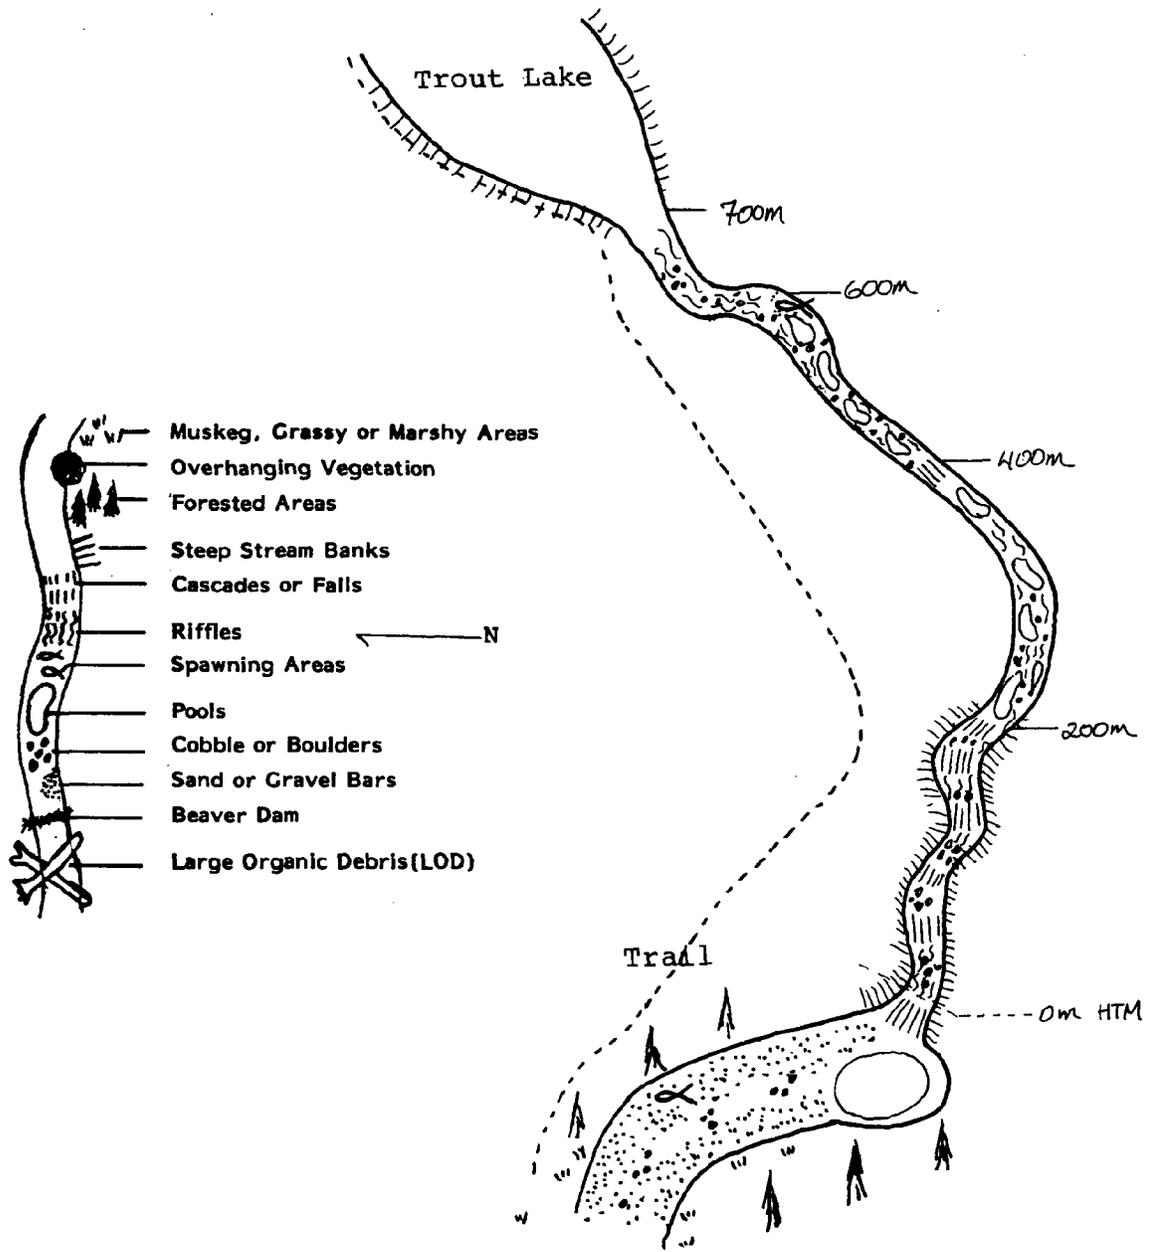
Figure 9. TAIN CREEK

Due to the poor gravel quality intertidally, (1.2% egg-fry survival) probably only approximately 60 pinks return to Annette Island, however, in the upper reaches that chum utilize, 50 chum could return resulting from production in this creek (assuming a 10% egg-fry survival).

TAIN CREEK

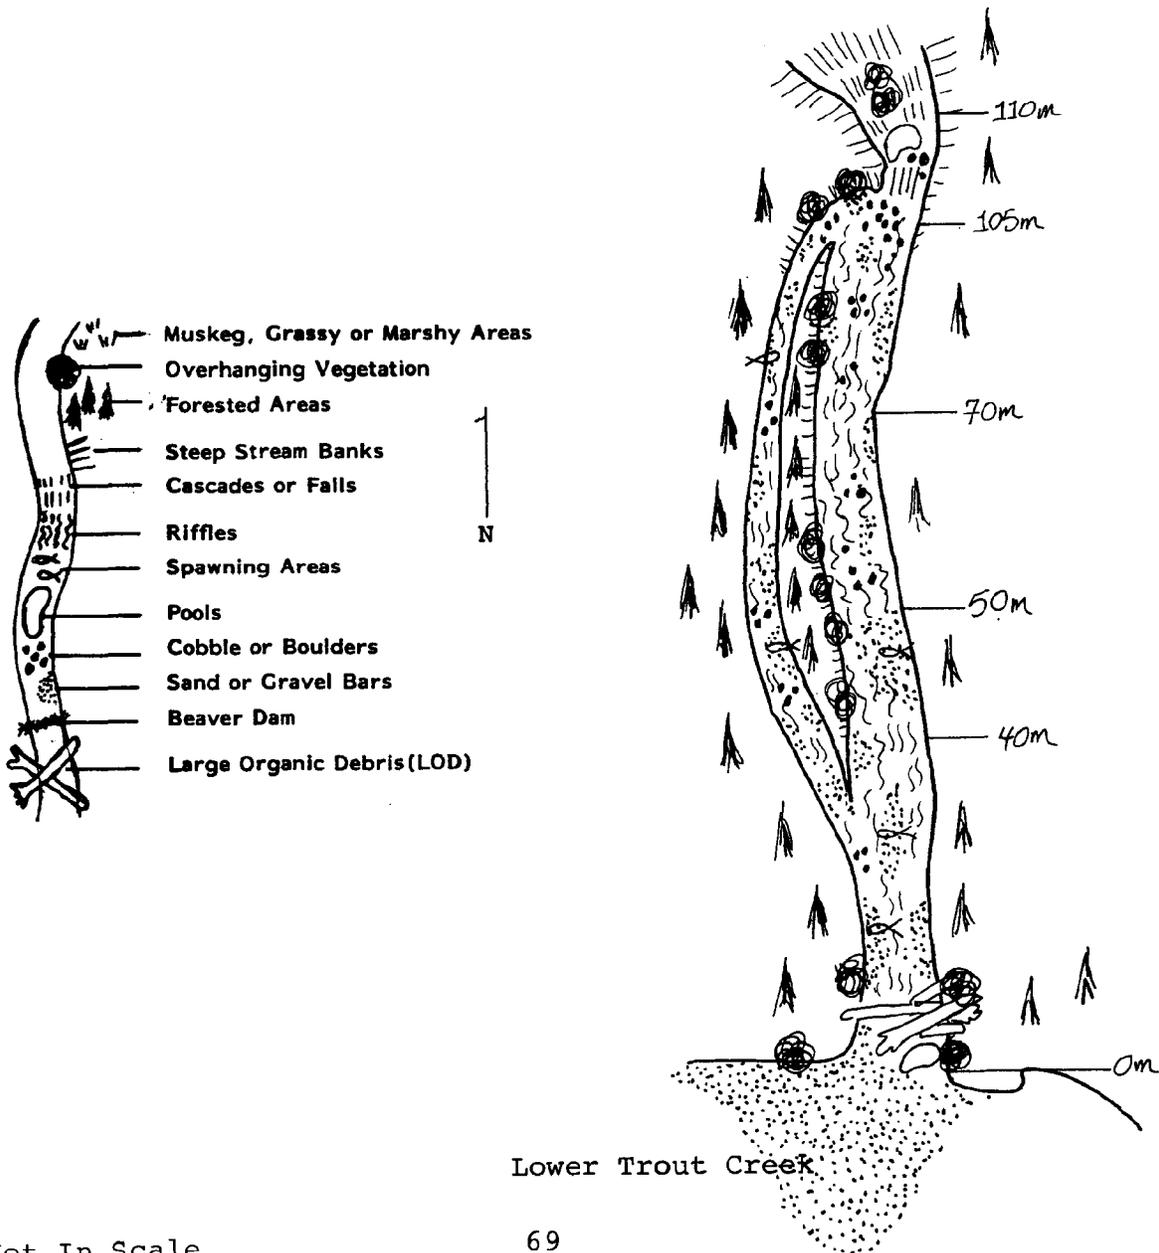
Figure 10. LOWER TROUT LAKE CREEK

Given the above escapements and a 10% egg-fry survival rate (good quality gravels present), it is estimated that 168 sockeye and 152 coho could return to Annette Island resulting from production in this creek.

LOWER TROUT LAKE CREEK

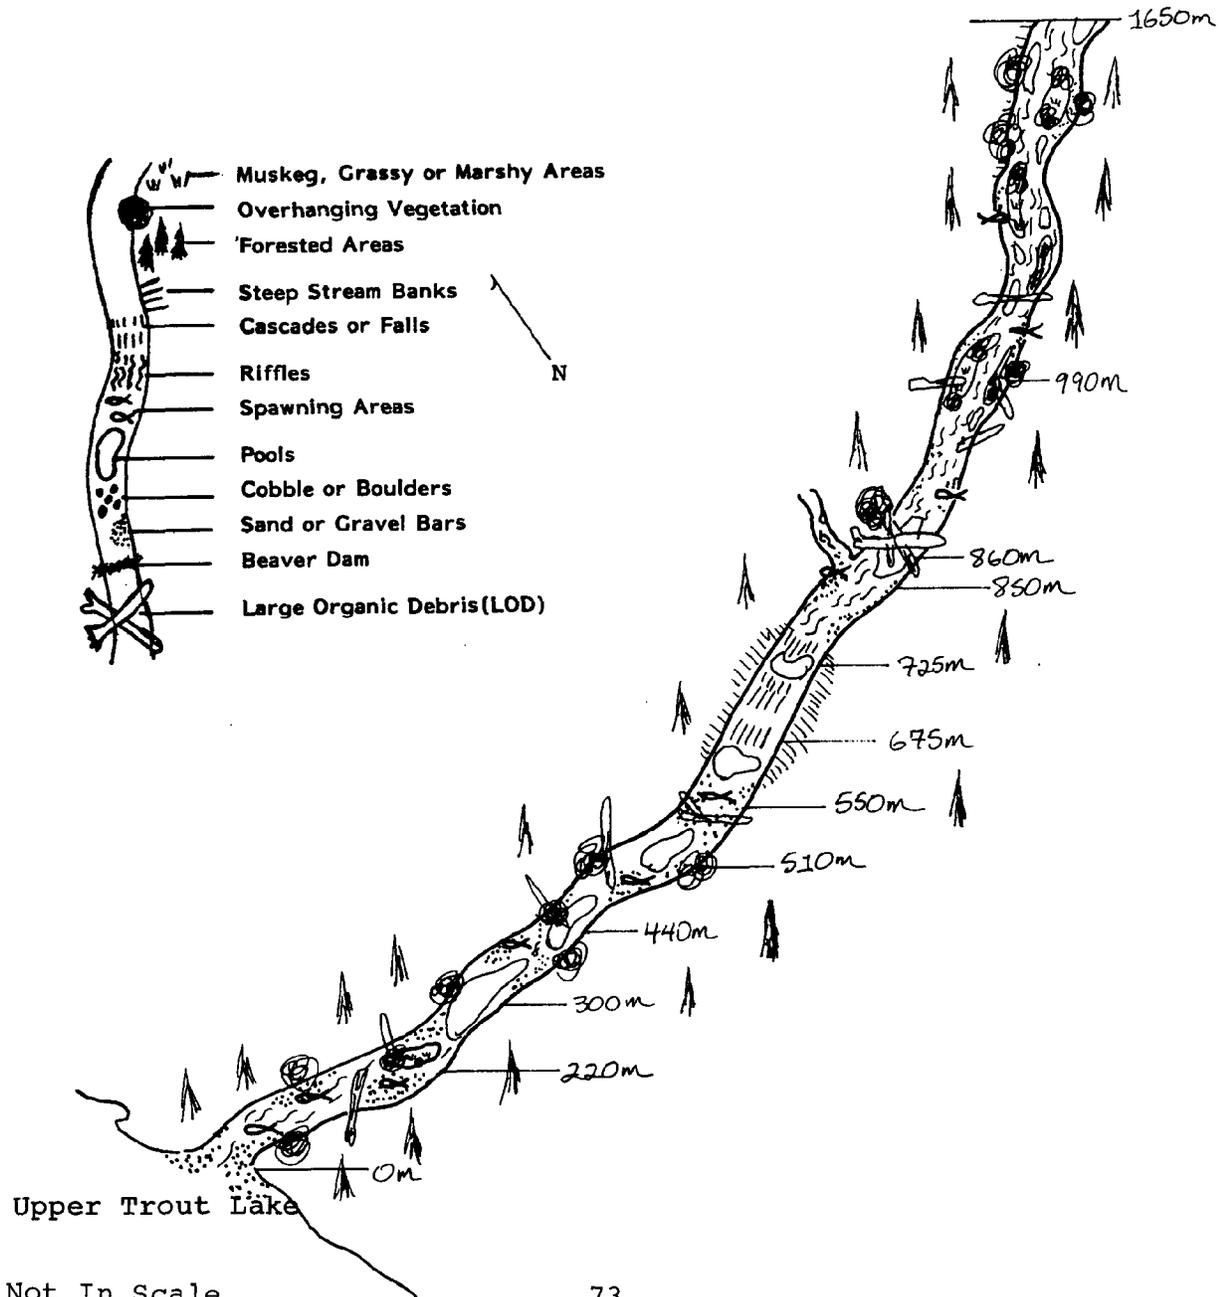
Figure 11. NORTH UPPER TROUT LAKE CREEK - Section 1

With the excellent quality spawning gravels present and good water supply, a 20% egg-fry survival rate is assumed. Potential production given the above escapements would be 2100 sockeye and 1900 coho returning to Annette Island resulting from production in this creek.

NORTH UPPER TROUT LAKE CREEK

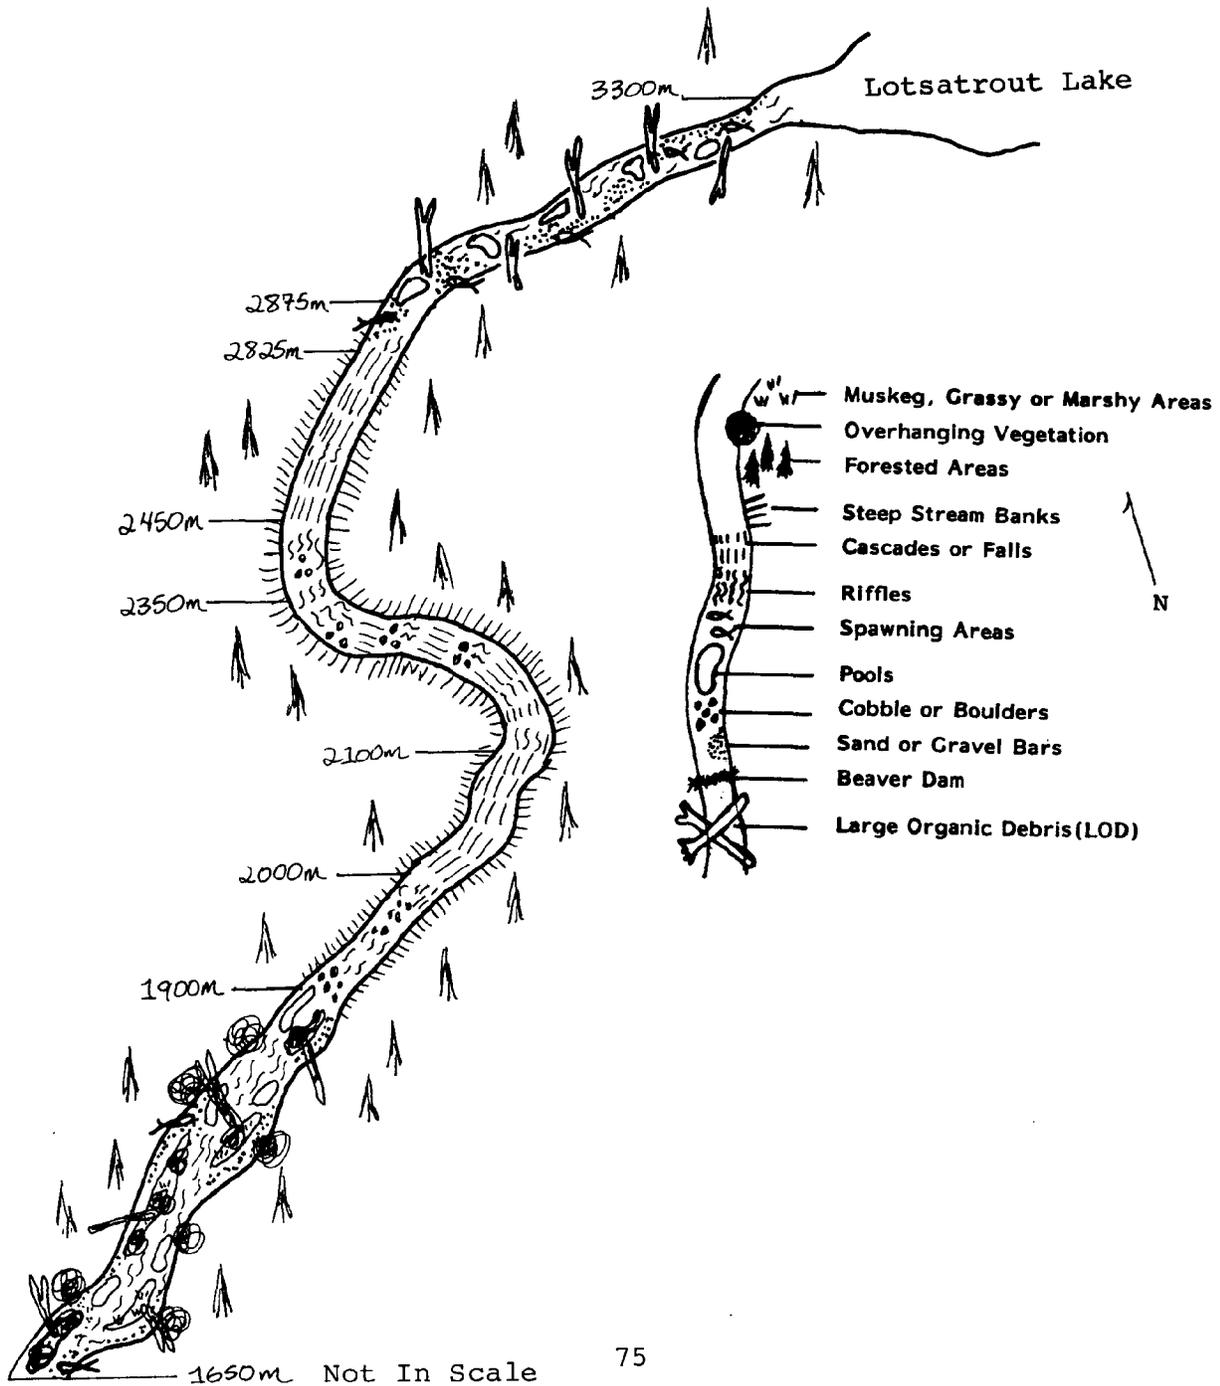
Figure 12. NORTH UPPER TROUT LAKE CREEK - Section 2

NORTH UPPER TROUT LAKE CREEK (CONTINUED)

- 1650-1900m Braided channel and slow flow continues. At 1900m is end of good rearing habitat.
- 1900-2825m Bottom composition: 5% gravel, 20% cobble, 20% rubble, 25% boulder, 30% bedrock. Generally a steep gradient channel with little to no LOD, few large pools and swift velocity - little or no spawning or rearing area. ASW = 8m, ASD = .20m. At 2000m, relatively steep bedrock channel with passable cascades, which ends at 2100m. From 2350-2450m, gently sloping gradient bedrock channel with lots of moss and algae and at 2825m, the bedrock channel ends.

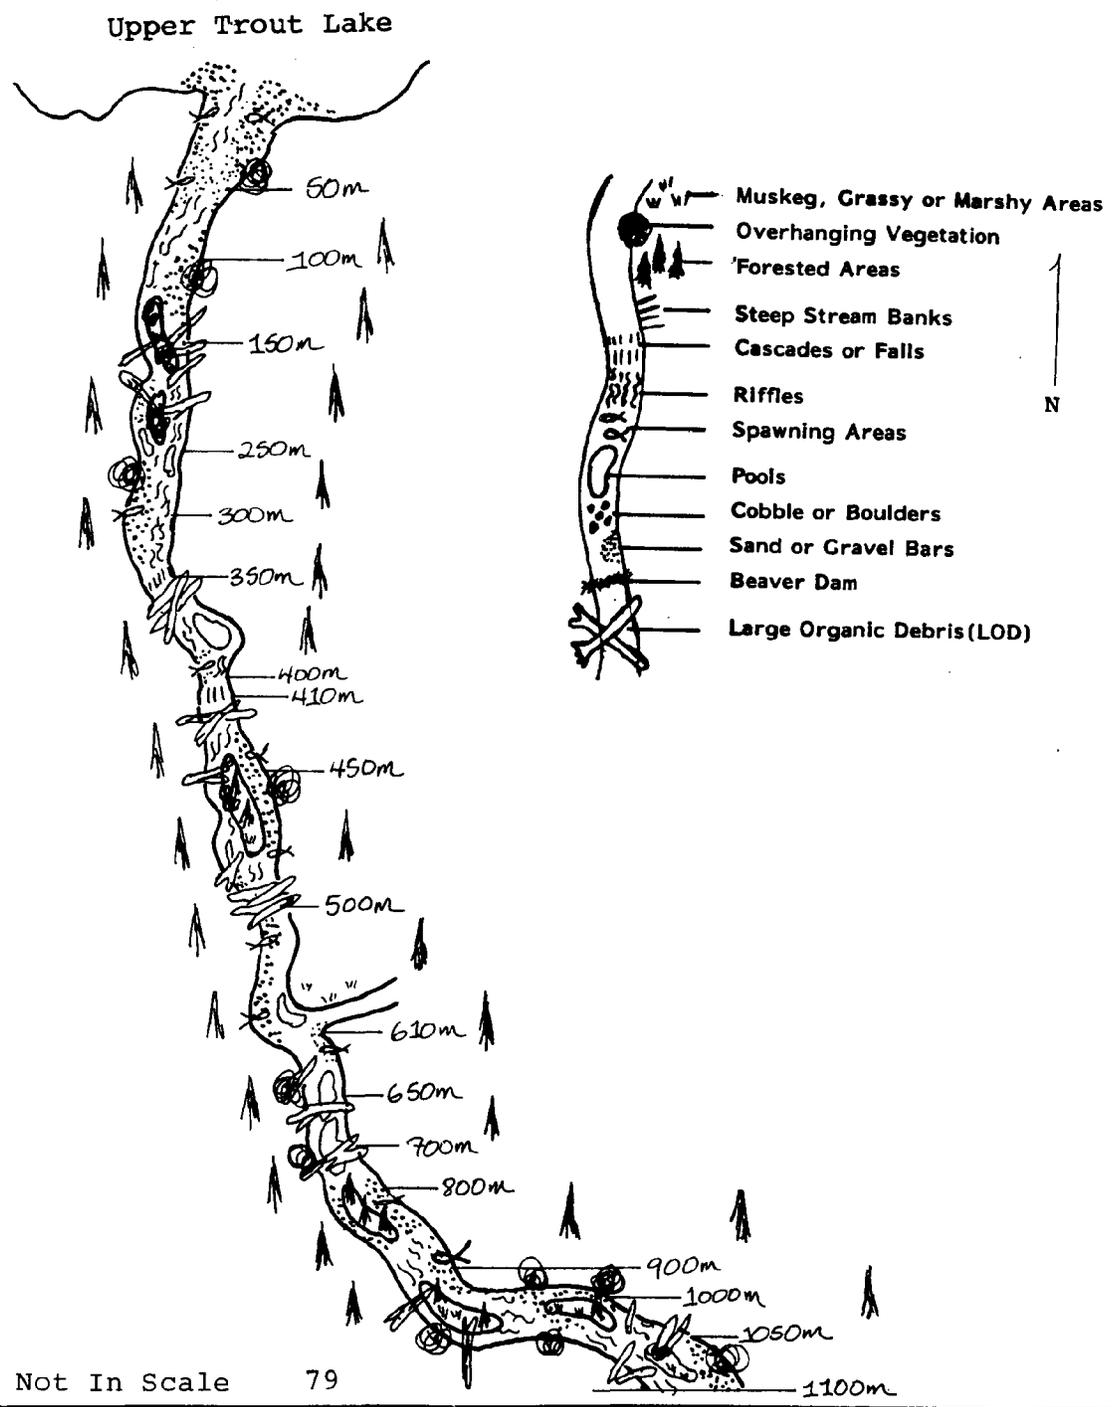
Figure 13. SOUTH UPPER TROUT LAKE CREEK - Section 1

Because of the excellent quality gravels, but expected creek flashiness, a 10% egg-fry survival rate is assumed. Potential production with the above escapements, 2750 sockeye and 2480 coho could return to Annette Island

SOUTH UPPER TROUT LAKE CREEK
