ANNETTE ISLANDS STREAM INVENTORY

Potential Salmon Production Summary

Prepared for the
Metlakatla Indian Community

Evelyn D. Biggs
Fisheries Management Biologist

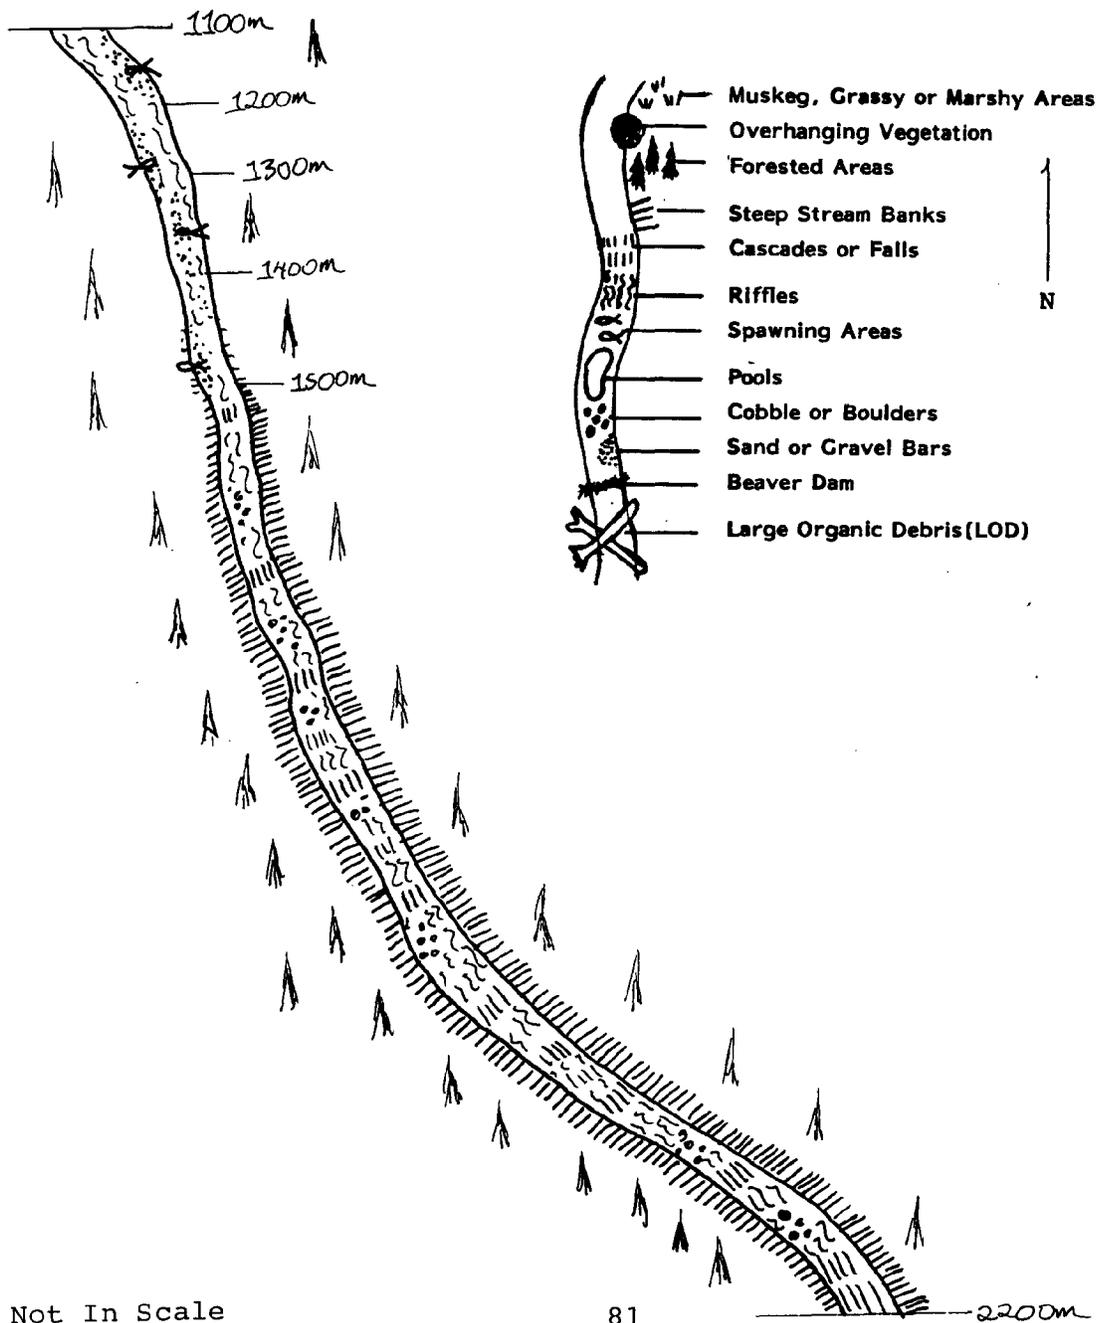
Figure 14. SOUTH UPPER TROUT LAKE CREEK - Section 2

SOUTH UPPER TROUT LAKE CREEK (CONTINUED)

1100-1200m ASW = 5m, 60% gravels, no more channel braiding.
 1200-1300m ASW = 5m, 15% gravels.
 1300-1400m ASW = 4m, 10% gravels - size of gravel has increased.
 1400-1500m ASW = 3m, stream gradient has increased with the bottom having less than 5% gravels, being mostly large cobble, small boulders, and bedrock; very little rearing habitat here or above 1500m.
 1500-2200m Stream increases in gradient; no coho fry up this far; barrier falls at 2200m.

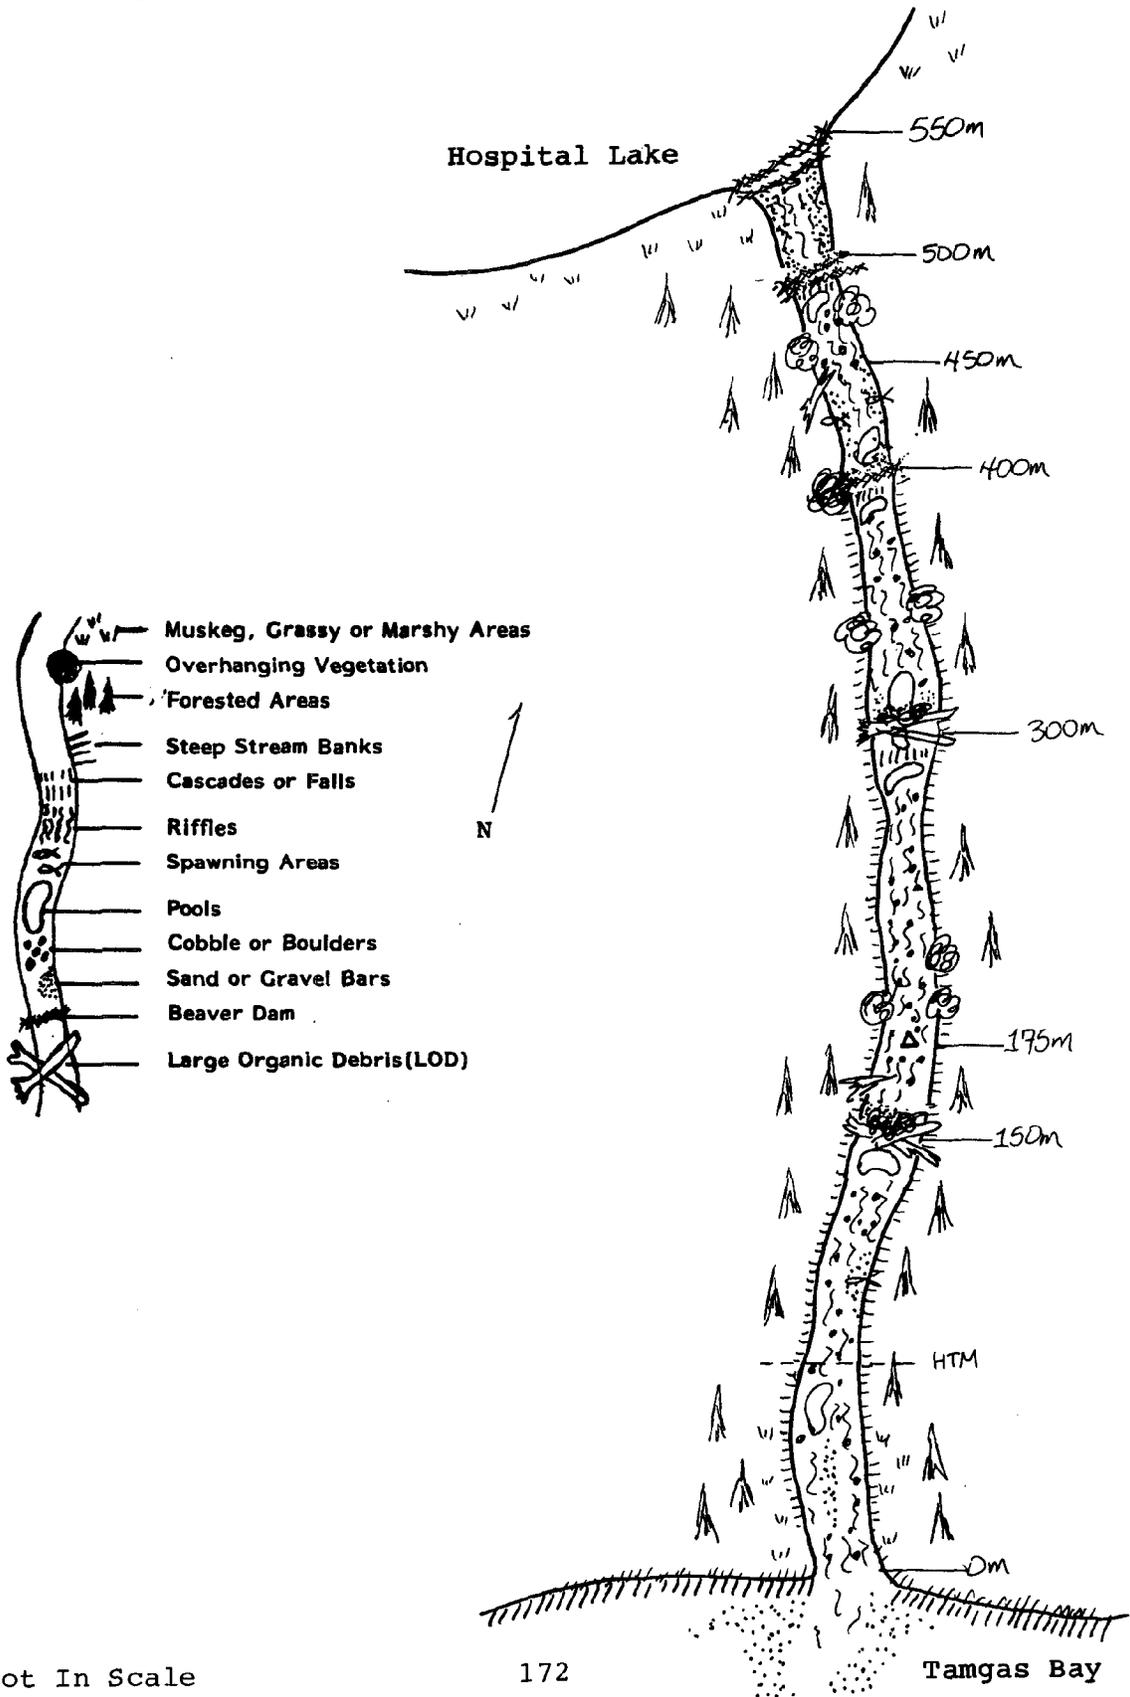
Figure 33. HOSPITAL CREEK

Spawning Area: Limited, only about 50m² above HTM.

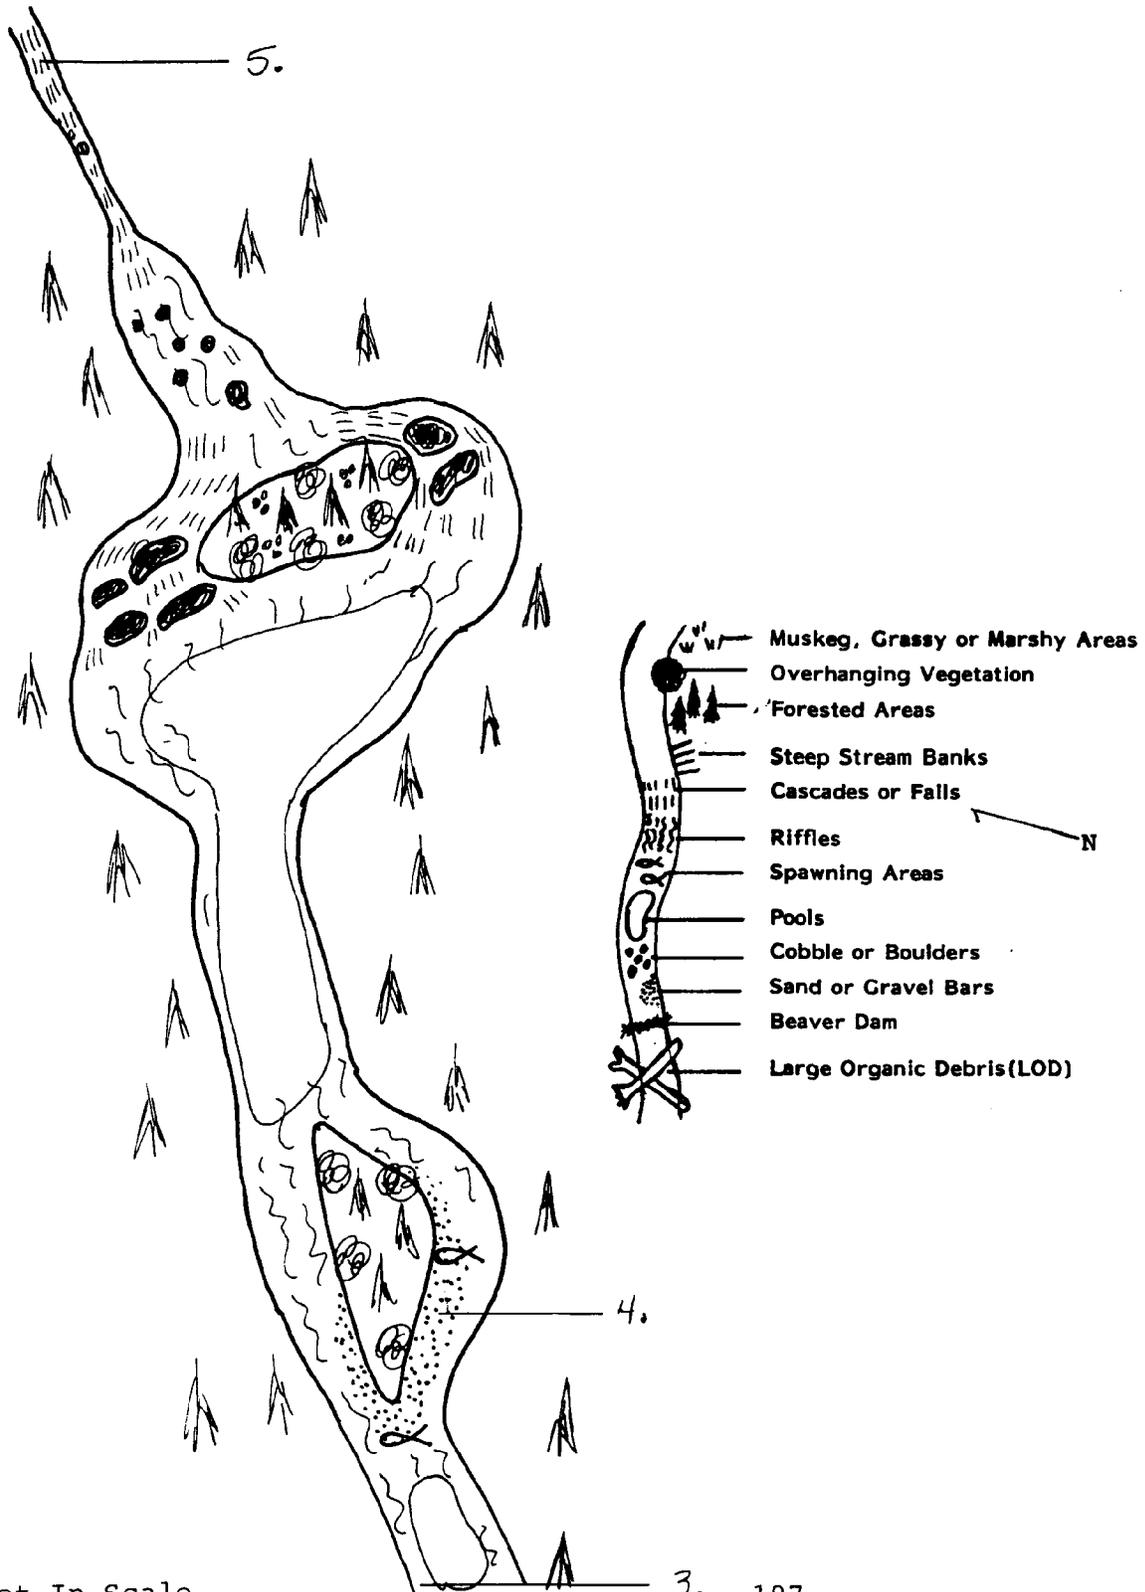
Figure 39. UPPER TAMGAS RIVER - Section 2

UPPER TAMGAS RIVER (CONTINUED)

3. Continued from previous map.
4. Gravel bars, spawning area.
5. Thirty foot barrier falls.

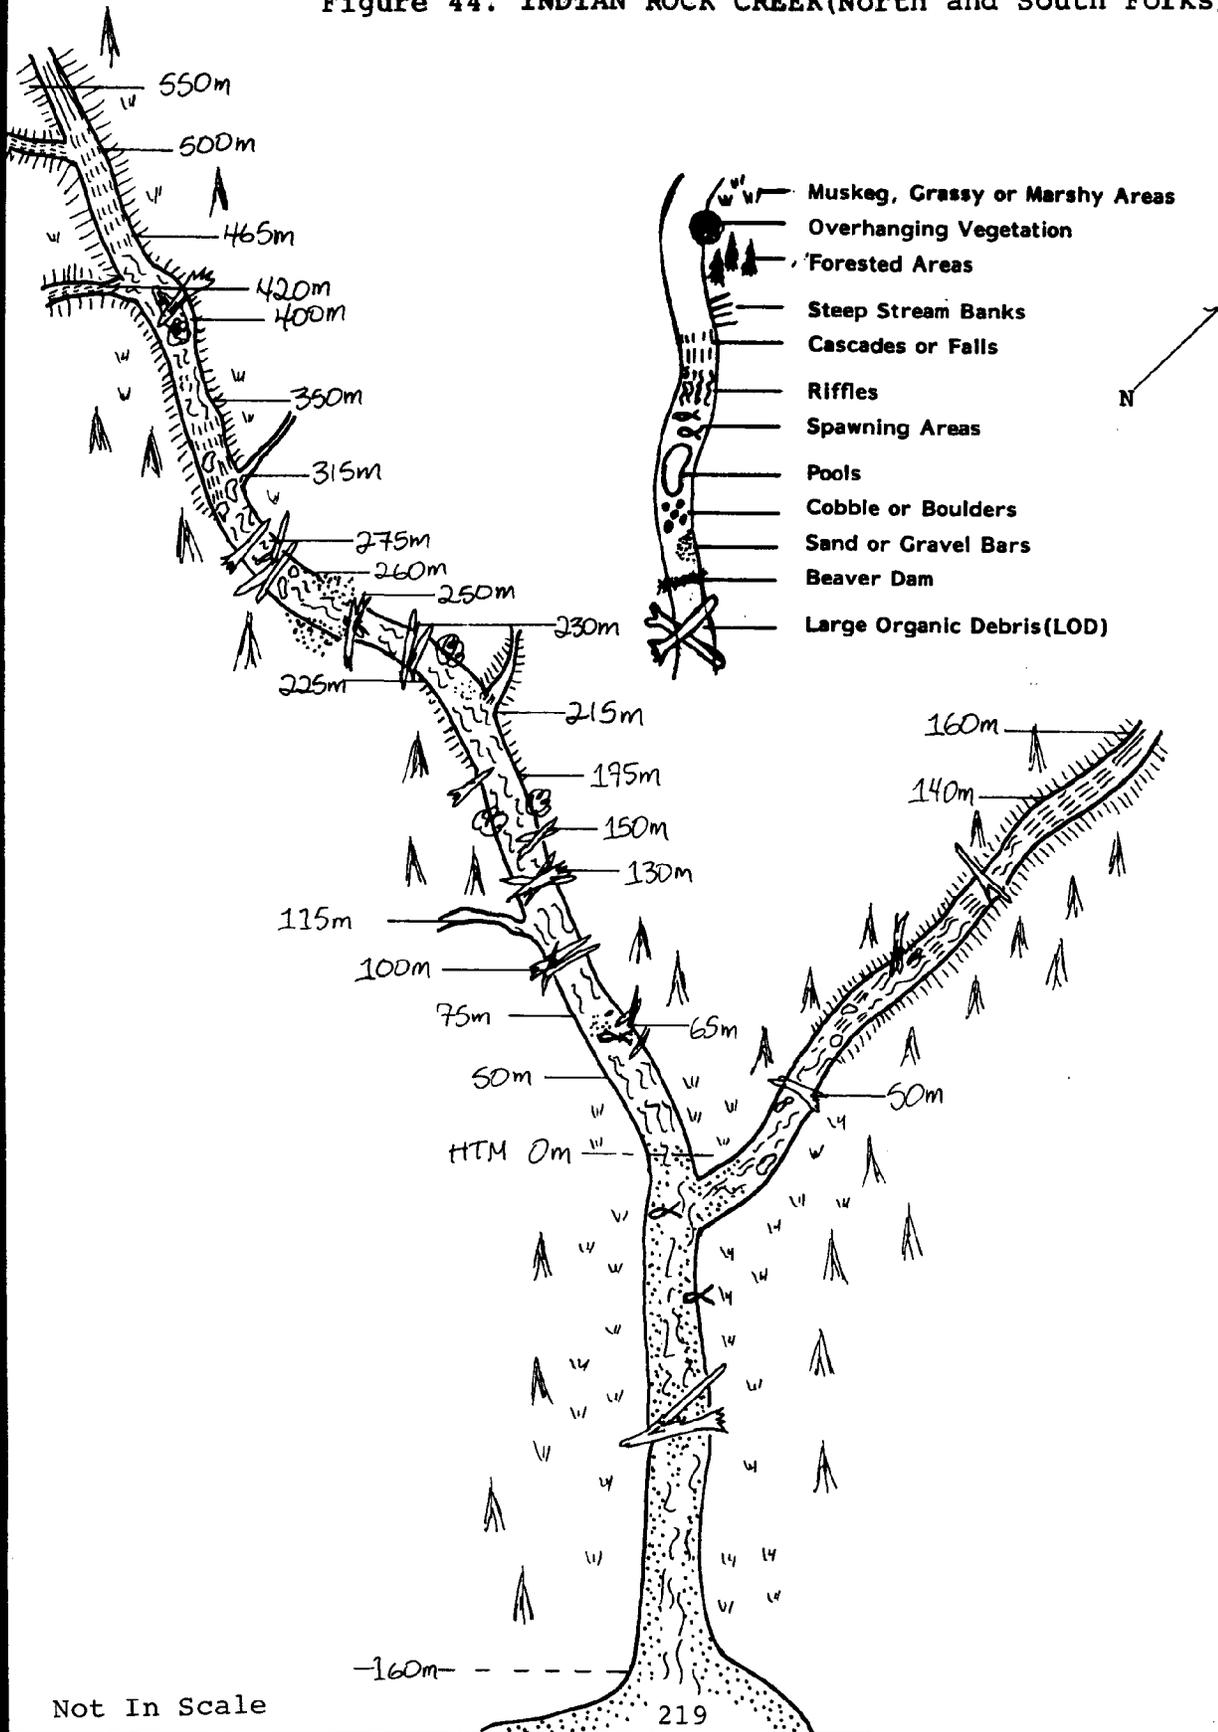
Figure 44. INDIAN ROCK CREEK(North and South Forks)

INDIAN ROCK CREEK (North and South Forks) Watershed No. 308-01
 Stat. No. 101-24-083

- 160-0m 5% spawning area intertidally (80m² area); bottom is mostly gravel and clay at mouth, with gravel and rubble prevailing toward High Tide Mark (HTM) at 0m. Stream forks intertidally at 0m.
