AQUANAUTS COMPOSITE LIFE SUPPORT UMBILICALS—SEALAB III

July 1970

NAVAL CIVIL ENGINEERING LABORATORY

Technical Report R-688

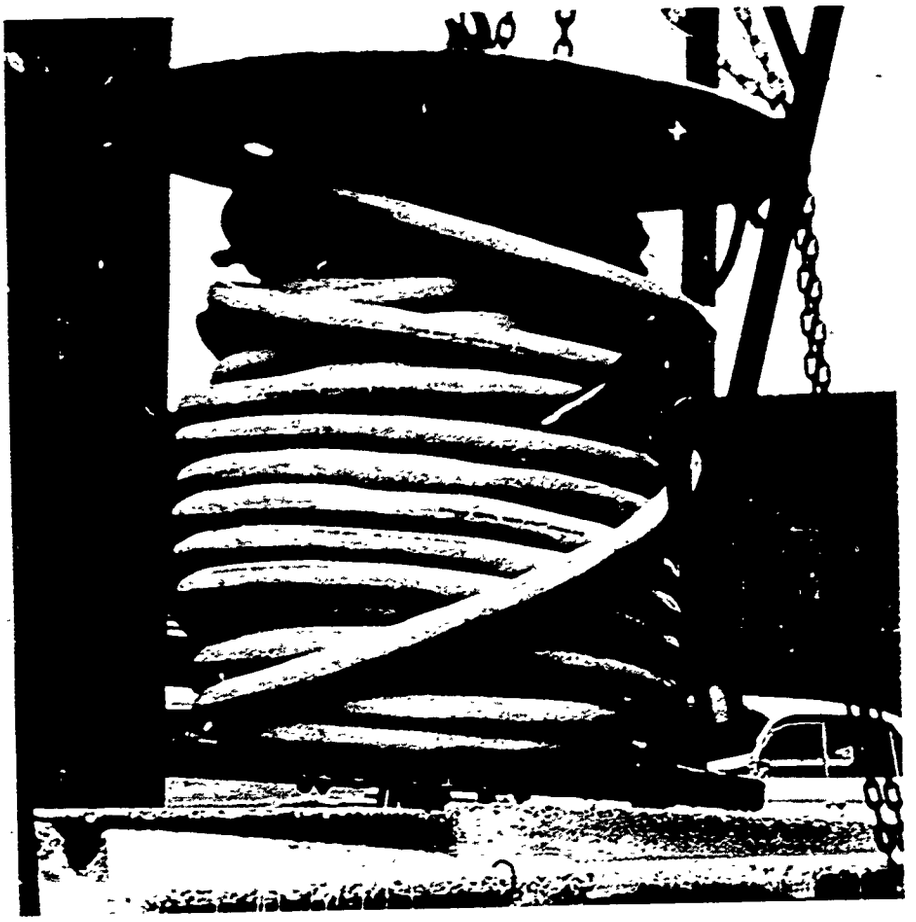
Figure 1. Composite life support umbilical (primary).

1. A 1/4-inch-ID breathing-gas hose of flexible, nonhygroscopic nylon, reinforced with a minimum of two Dacron braids, and a pure extruded polyurethane sheath, with a minimum 12,000-psi burst pressure rating. End fittings were 1/4-inch NPT of 316 stainless steel.

All of the components (Figure 2) were cabled to an 18-inch lay, wrapped with a mylar barrier tape, and jacketed with a 0.090 to 0.100-inch-thick special water resistant polyurethane jacket, bright yellow in color.

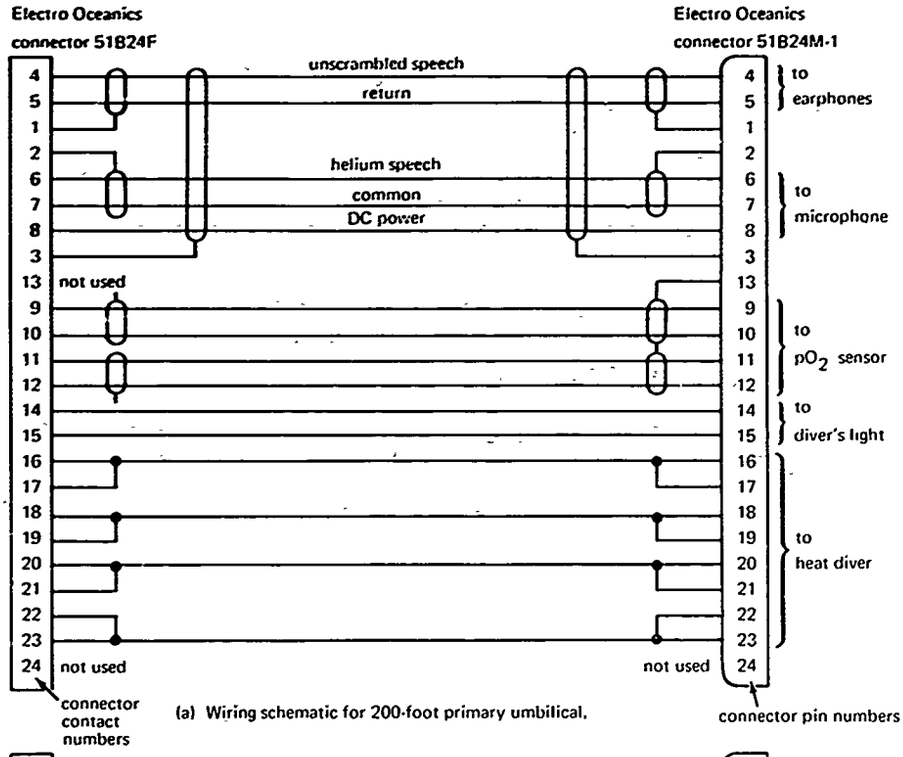
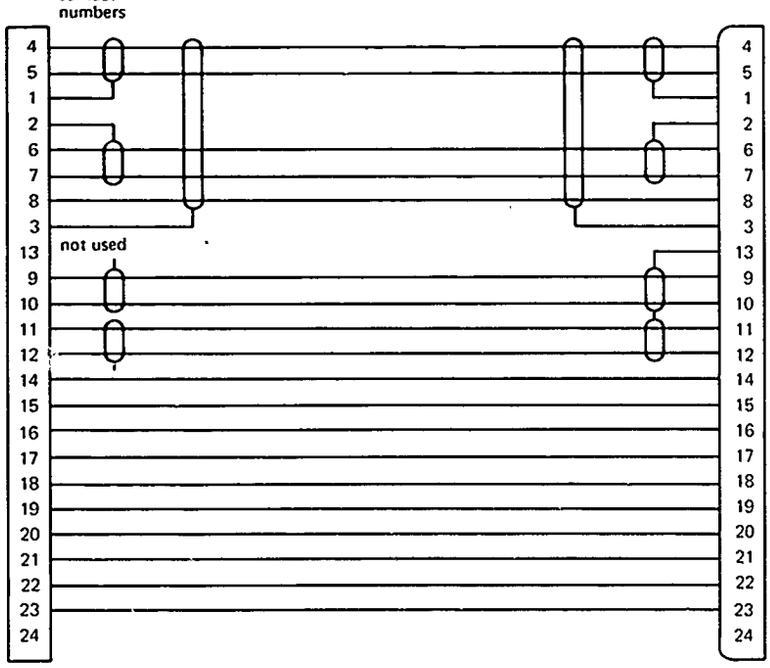
Figure 2. Umbilical schematic (primary).

(a) Wiring schematic for 200-foot primary umbilical.

(b) Wiring schematic variance for 600-foot primary umbilical.

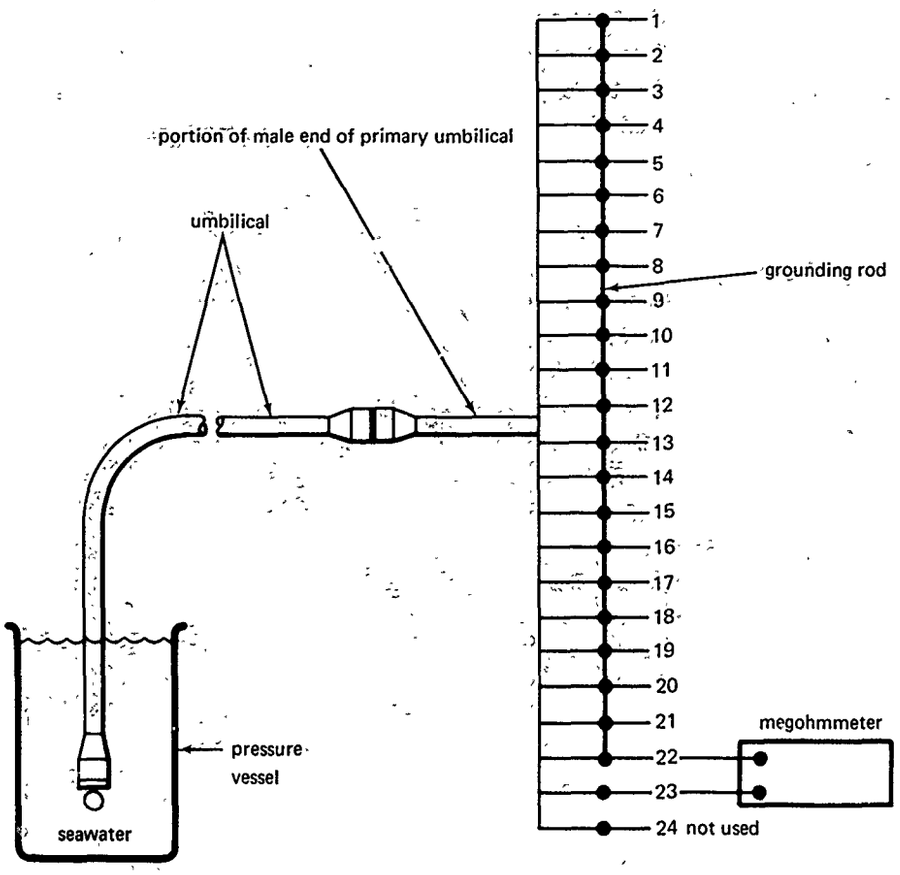
Figure 5. Test arrangement for electrical resistance measurement.

2. Electrical insulation resistance tests were required to be conducted, followed by hydrostatic pressure testing to 300 psig, then an immediate repeat of the insulation resistance testing. Measurements were made at 500 volts; readings were required to be a minimum of 100 megohms. Electrification time for each measurement was 1 minute. Tests between cable or wire shields were prohibited. The test arrangement is shown in Figure 5.

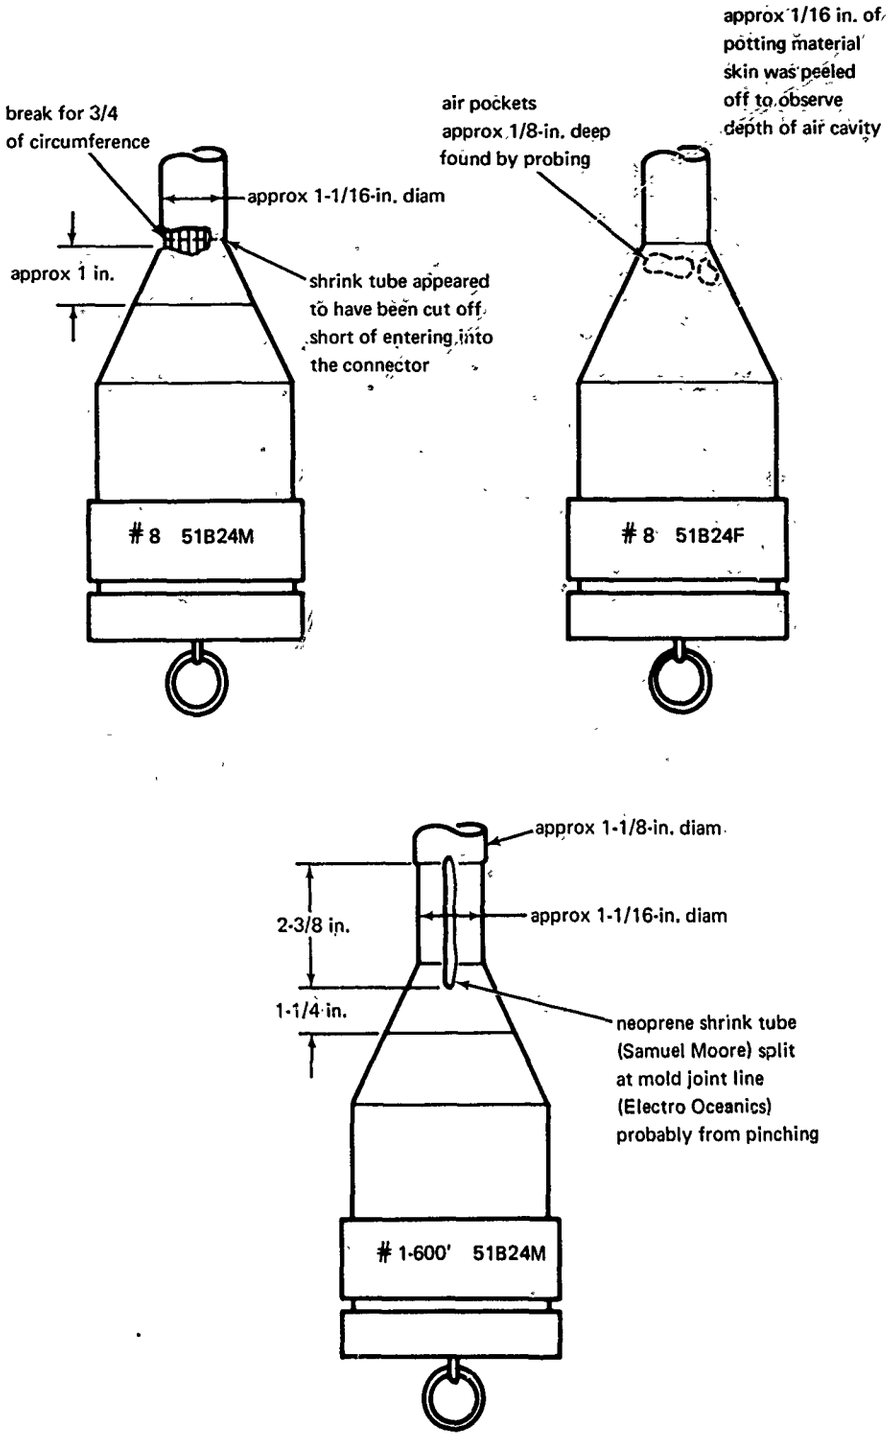
Figure 7. Umbilical failures as observed in May 1968.

In May 1968, during diver training at San Diego, California, two umbilicals failed, apparently at the diver's end. Representatives of NCEL, Electro Oceanics, Inc., Samuel Moore and Company, and the Deep Submergence Systems Project Technical Office (DSSPTO) studied these failures and found that they occurred within the area encompassing the Electro Oceanics connector molding (Figure 7). It was also determined that:

3. In some instances the connector mold fit snugly, in others it was loose. Subsequently, EO found up to 1/16-inch difference in the diameters of breakout bundles.

4. The neoprene sheath on the damaged end of one of the umbilicals appeared to have been cut too short for it to be fully included in the molded connector end. It was felt that this, plus short radius bending of the breakout during use, caused failure of this umbilical in less than 1 hour. Photographs of the diver operations recorded the short radius flexing of the breakouts at the diver end (Figure 8).

Electro Oceanics proposed remolding with a cover the full length of the breakout to forestall future failures. To do this, it was suggested that the neoprene sheathing be cut back to within 6 inches of the breakout encapsulation. The polystyrene stranded materials were also to be cut back, but to random lengths. The breakout was then to be wrapped with mylar tape and the breakout, including a portion of the connector, was to be covered by molding on a 1/4-inch thickness of PVC.

In June 1968, EO attempted field repair of all subsurface air pocket defects in connector moldings by applying polyurethane patches after grinding out suspect materials. These patches did not hold. EO suggested returning the umbilicals to the factory for repair by molding. This could not be done immediately because the umbilicals were urgently needed in San Francisco for diver training. Figure 9 shows umbilicals installed on the habitat at San Francisco.

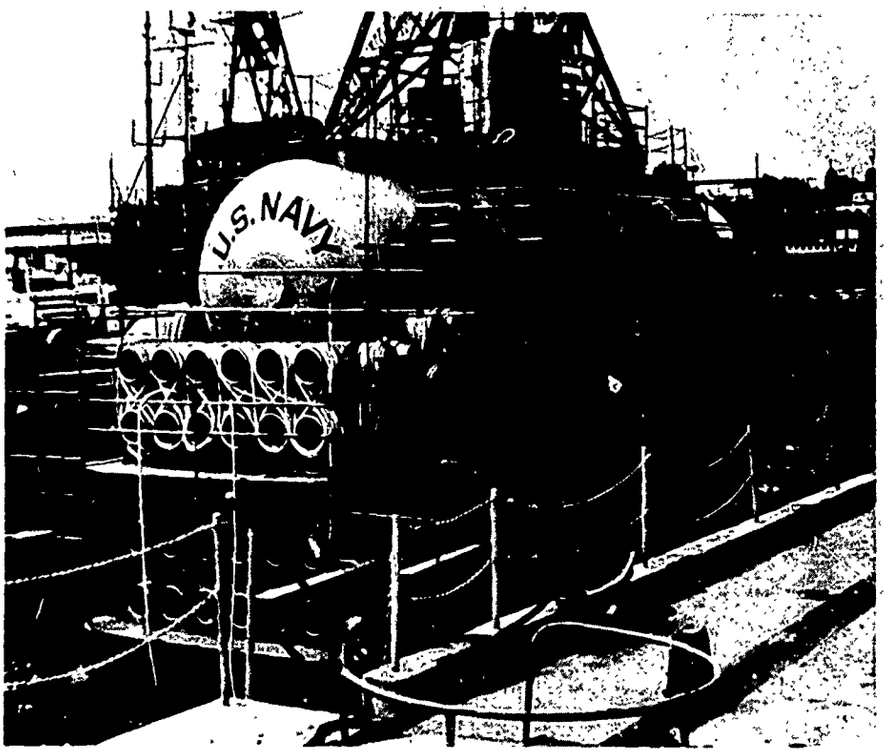
Figure 9. Umbilicals installed on SEALAB III.

In July 1968, NCEL personnel were called to San Francisco because of problems with the umbilicals. One was suspected of having water intrusion because it had low readings during insulation resistance tests. Periodic checks indicated that the umbilical was drying out. Numerous intermittent electrical failures indicated problems with connector contacts. EO personnel were called in to correct these deficiencies. This was accomplished by size checking and slightly flattening oversized female contacts with a special tool.

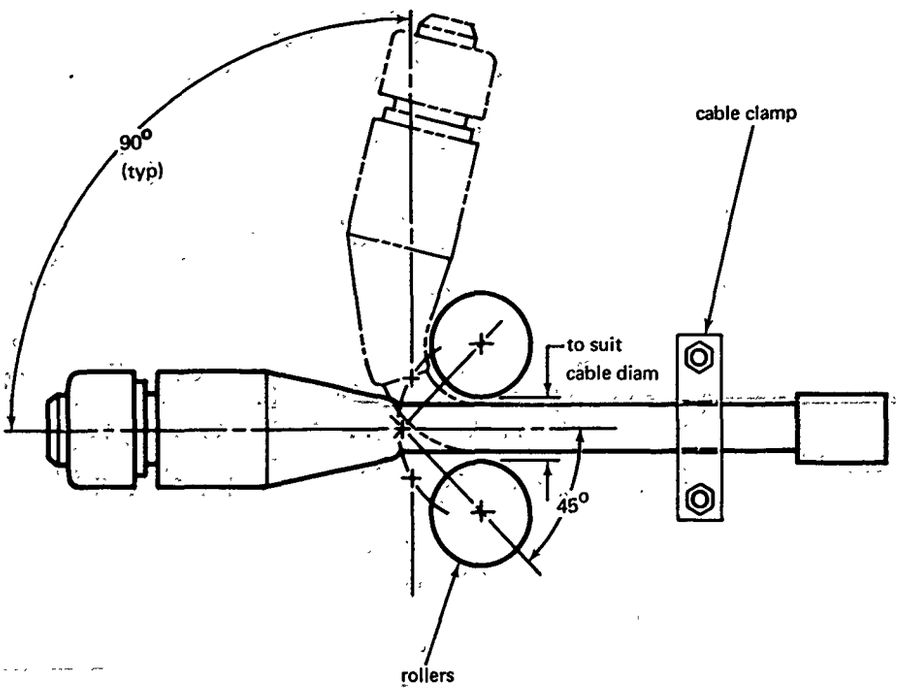
Figure 10. Cable flexing test setup.

A wired and molded plug assembly was loosely inserted between a pair of rollers (see Figure 10). The bonded joint between the boot and cable jacket was located approximately at the intersection of the 45-degree lines through the centers of the two rollers. The lower end of the specimen was firmly clamped by a clamp designed to apply uniform radial pressure to the core of the cable. The diameter of the rollers was 3 inches. The assembly was subjected to 90-degree bending in each direction at a rate of 12 to 14

Flex tests were performed on one umbilical and resulted in loss of continuity in nine circuits in the male connector. Tests of the female connector resulted in loss of continuity in ten of the remaining circuits. As a result, these connectors were dissected to determine the exact causes of failure. Some wires were broken while others had pulled free from the solder pots in the connectors.

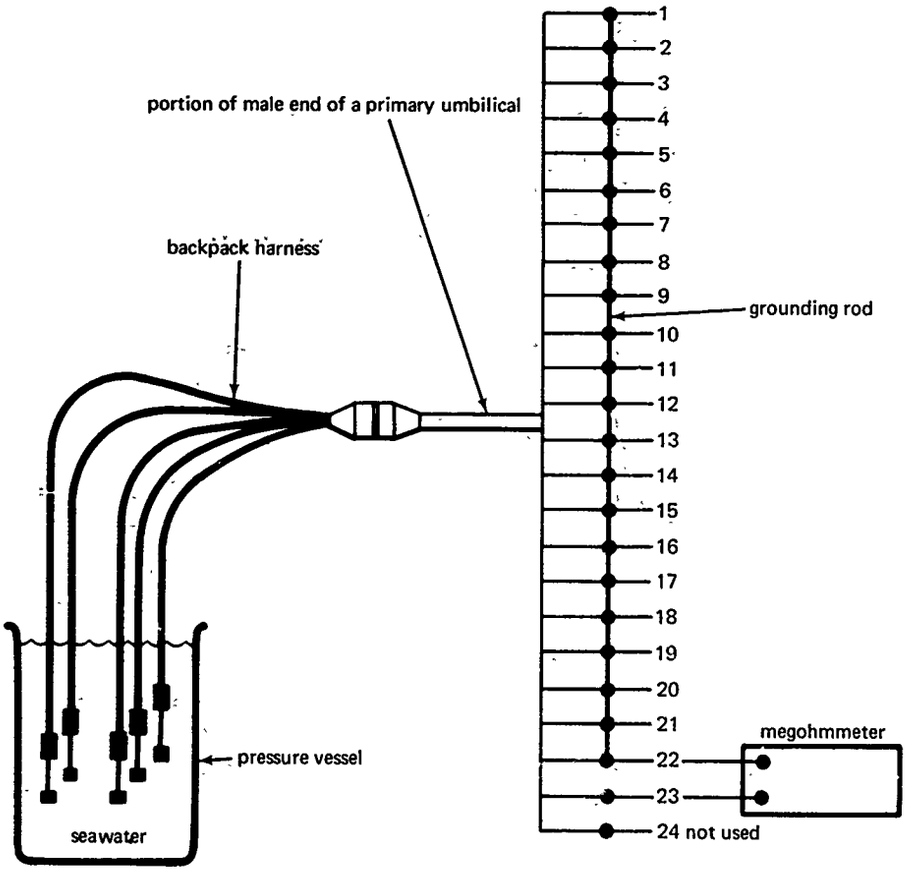
Figure 15. Test arrangement for harness electrical resistance measurement.

performed in pressure vessels. The insulation resistance test procedure, conducted with the setup as indicated in Figure 15, consisted of determining the minimum insulation resistance for each conductor when measured against all other conductors grounded together in the manner described previously for primary umbilicals.

Examination. All connectors, except the special 24-contact 51B24F, were Electro Oceanics standard catalog items molded from neoprene; there was no evidence of loose external contacts. The connector exteriors, although not precision-finished, were acceptable. Inspection of internal contacts of the connectors was not possible.

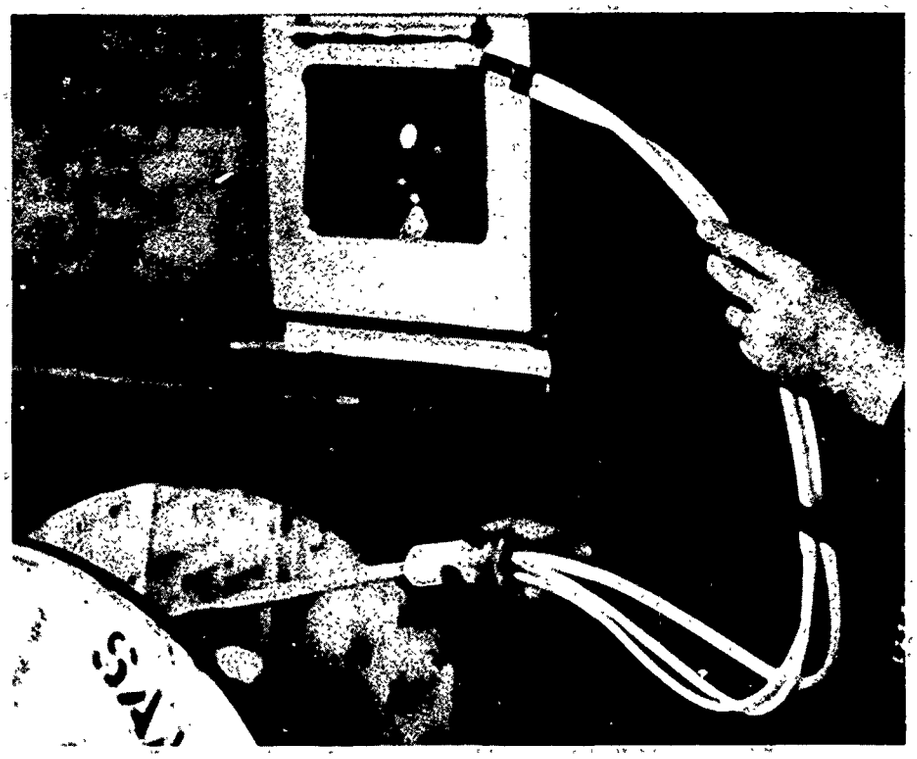
Figure 19. Electrical conductor breakout (secondary umbilical).

Description. Electrical wiring was required to provide services for a pO_2 sensor, intercom earphones, and intercom microphone and amplifier. One end of the umbilical was designed to accept a single 24-pin connector with locking device. The other end terminated in three pigtail breakouts (see Figure 19). The pO_2 sensor breakout was 22 inches long. The two intercom breakouts were 42 inches long.
