Deepwater Horizon Accident Investigation Report

September 8, 2010

This is the report of an internal BP incident investigation team. The report does not represent the views of any individual or entity other than the investigation team. The investigation team has produced the report exclusively for and at the request of BP in accordance with its Terms of Reference, *and any decision to release the report publicly is the responsibility of BP. It has not been prepared in response to any third party investigation, inquiry or litigation.*

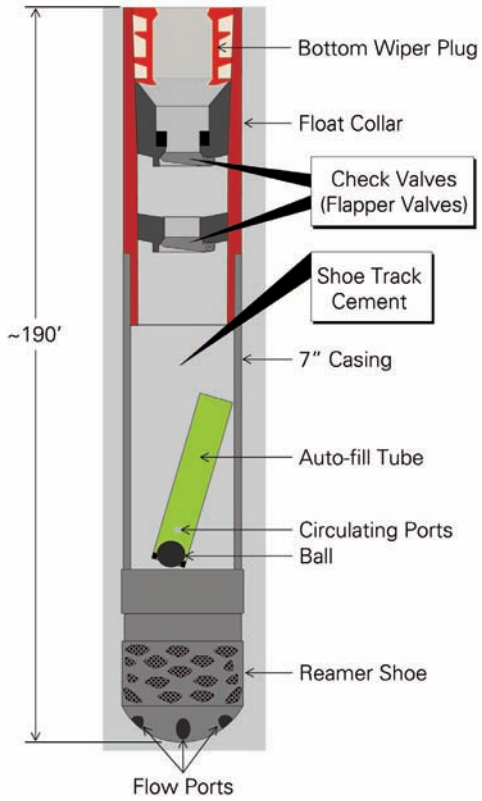
Figure 2. Shoe Track Barriers.

The investigation team identified the following possible failure modes that may have contributed to the shoe track cement's failure to prevent hydrocarbon ingress:

- Contamination of the shoe track cement by nitrogen breakout from the nitrified foam cement. (Refer to Key Finding 1.)
- Contamination of the shoe track cement by the mud in the wellbore.
- Inadequate design of the shoe track cement.
- Swapping of the shoe track cement with the mud in the rat hole (bottom of the hole).
- A combination of these factors.

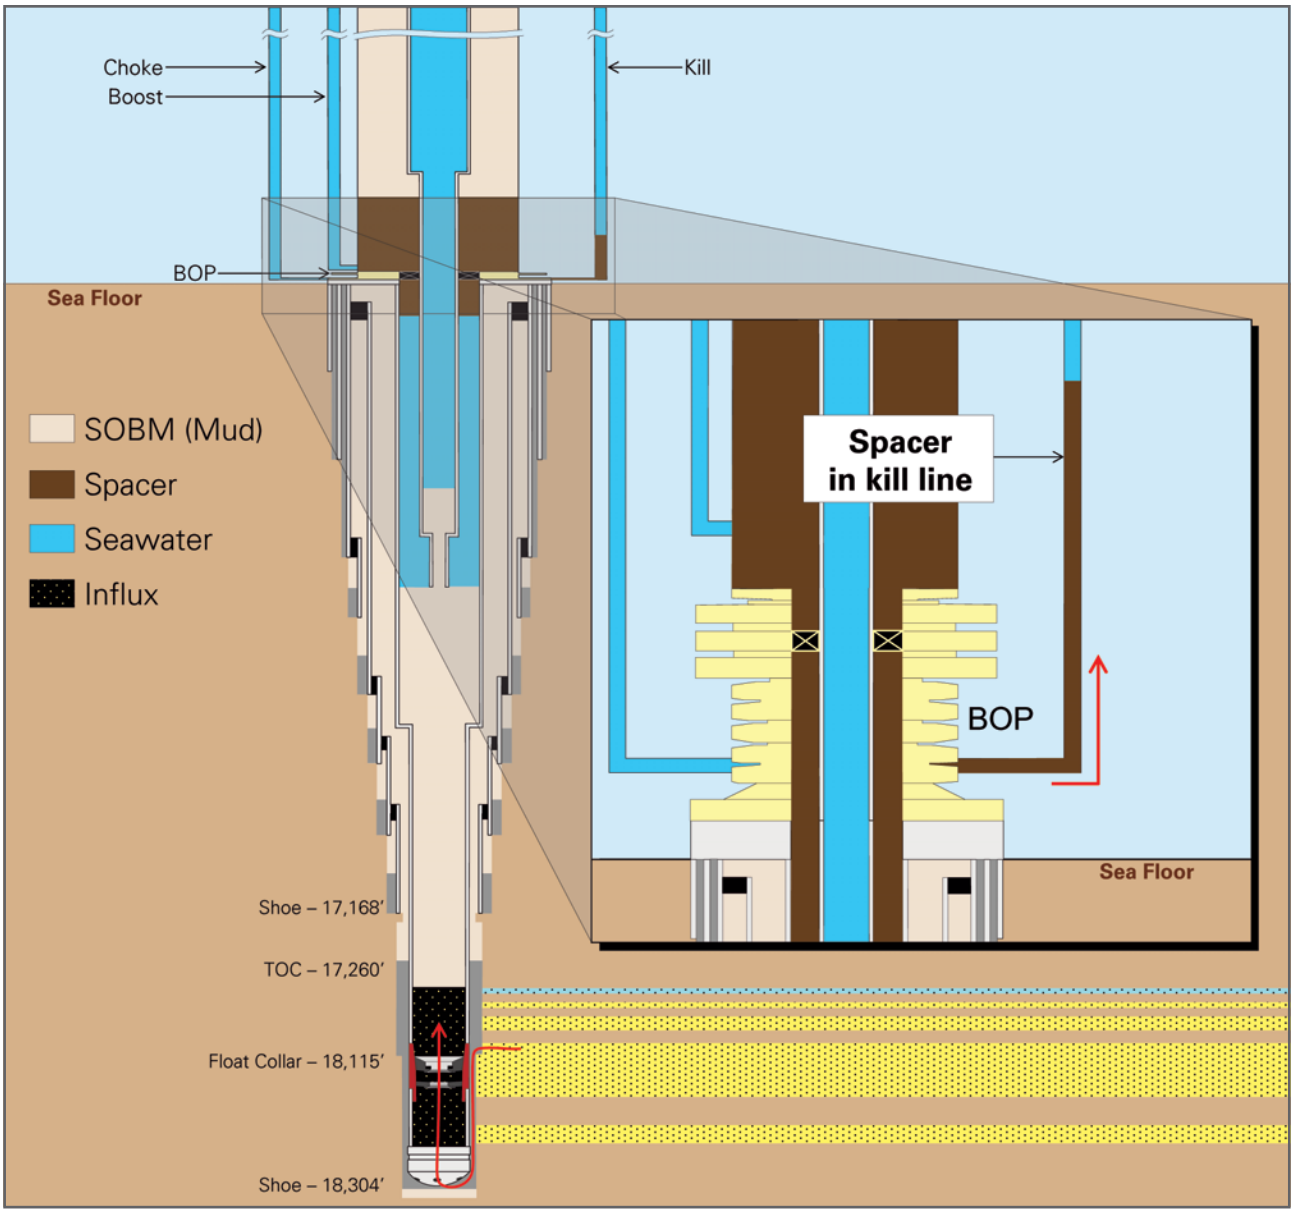
Figure 3. Possible Movement of Spacer into the Kill Line.

From 18:00 hours to 18:35 hours, the drill pipe pressure increased from approximately 50 psi to 1,400 psi. To resume the negative-pressure test, the kill line was filled and then opened, 0.2 bbls flowed, and no further flow was observed from the kill line during a 30-minute period of monitoring. The drill pipe pressure was constant at 1,400 psi.

This pressure of 1,400 psi on the drill pipe was misinterpreted by the rig crew and the well site leaders. According to witness accounts, the toolpusher proposed that the pressure on the drill pipe was caused by a phenomenon referred to as 'annular compression' or 'bladder effect.' The toolpusher and driller stated that they had previously observed this phenomenon. After discussing this concept, the rig crew and the well site leaders accepted the explanation. The investigation team could find no evidence that this pressure effect exists.

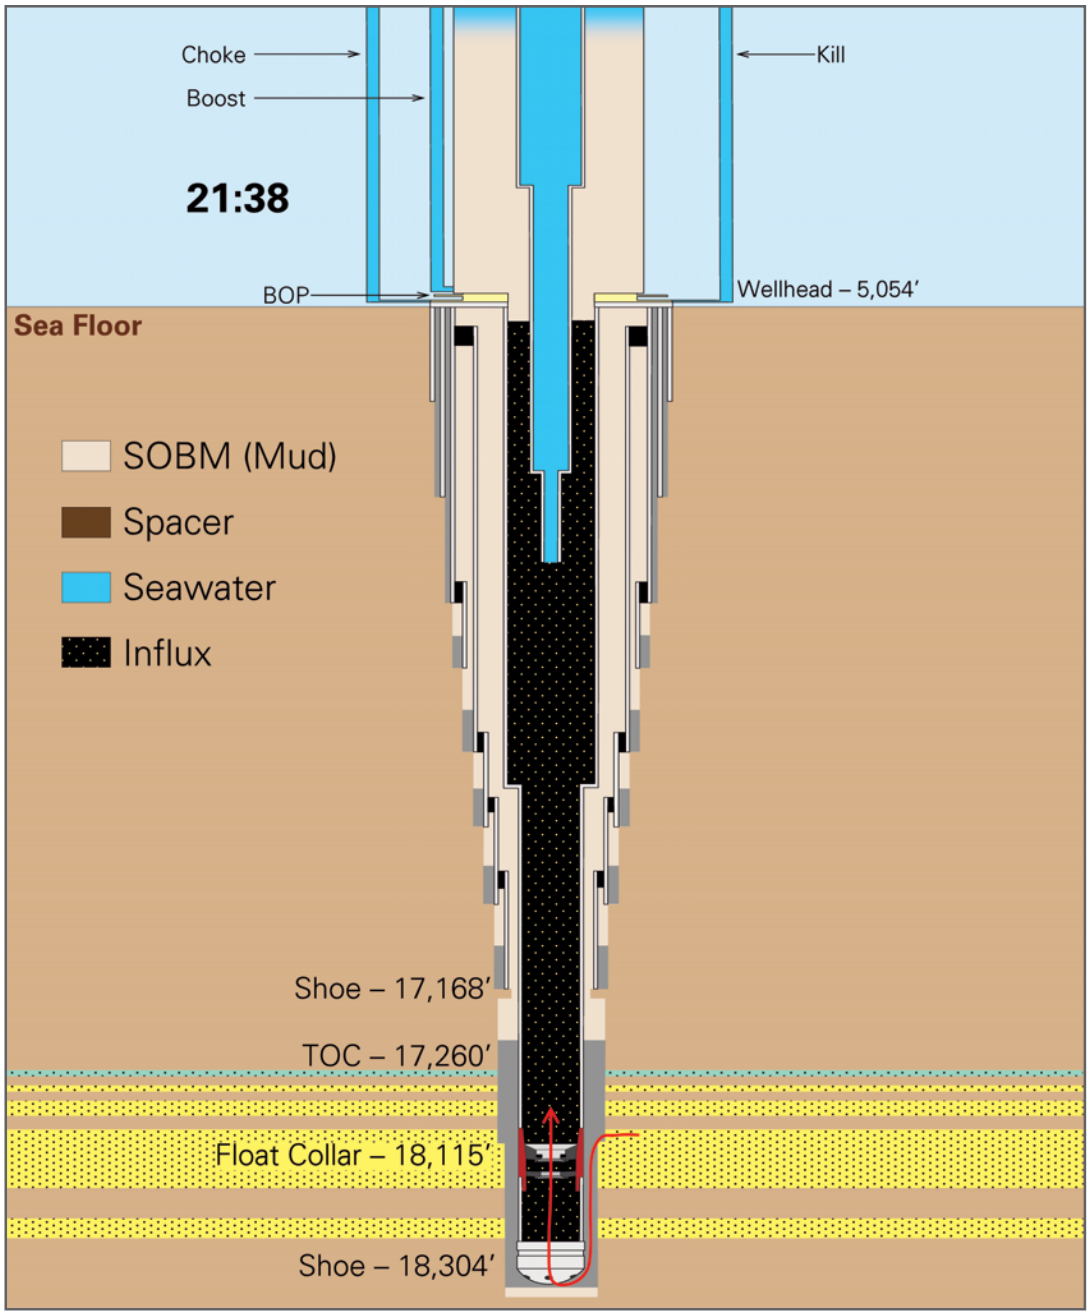
Figure 4. Hydrocarbons Entering the Riser.

Analysis indicates that the first indications of flow from the well could be seen in the real-time data after 20:58 hours. The rig crew and mudloggers either did not observe or did not recognize indications of flow until after hydrocarbons entered the riser at approximately 21:38 hours. The first well control response likely occurred at 21:41 hours.

The *Transocean Well Control Handbook* stated that the well was to be monitored at all times. However, the policy did not specify how to monitor the well during in-flow testing, cleanup or other end-of-well activities.

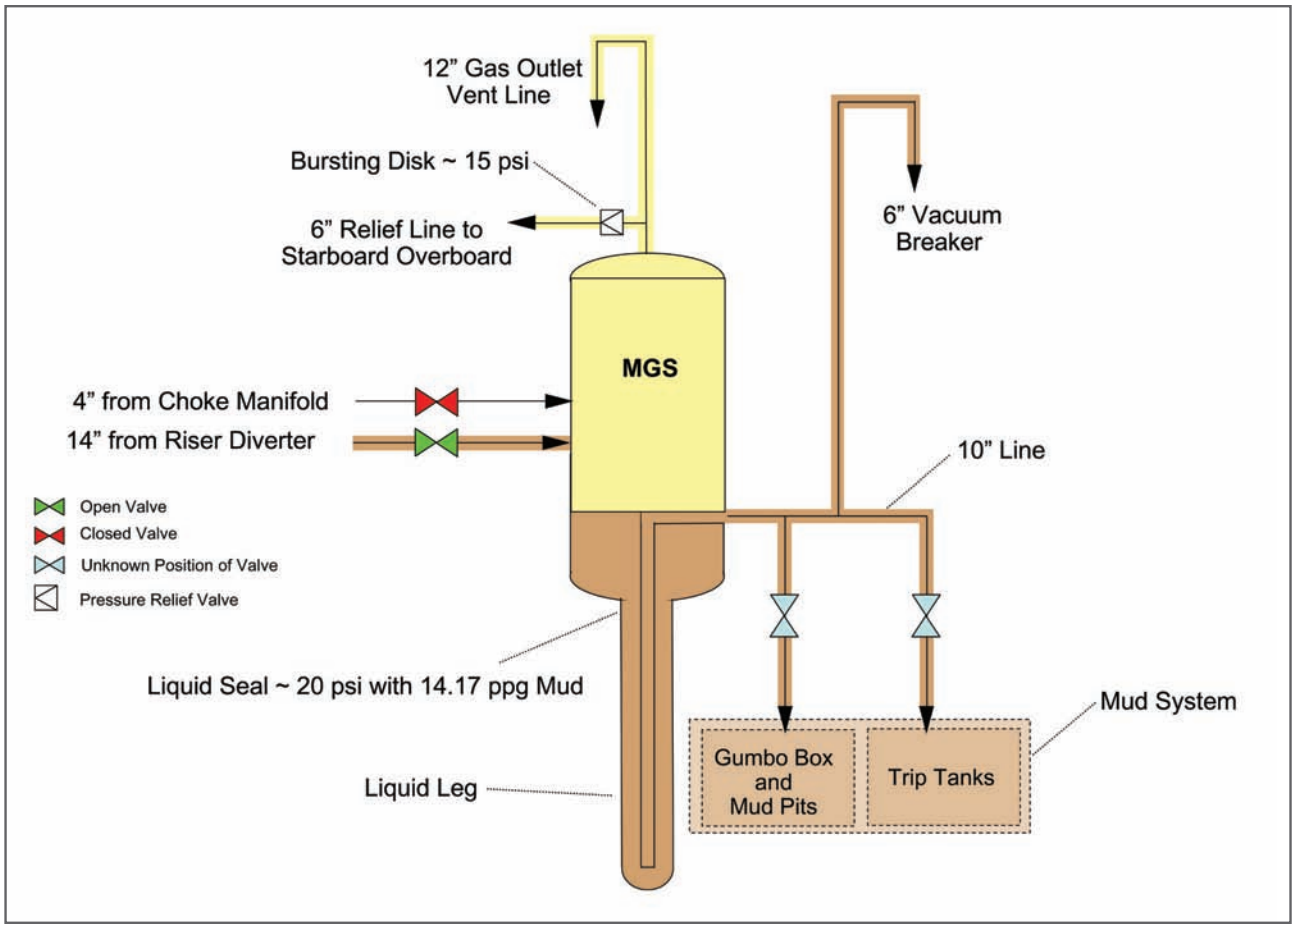
Figure 5. Mud Gas Separator.

The diversion of fluids overboard, rather than to the MGS, may have given the rig crew more time to respond and may have reduced the consequences of the accident.

Transocean's shut-in protocols did not fully address how to respond in high flow emergency situations after well control has been lost. Well control actions taken prior to the explosion suggest the rig crew was not sufficiently prepared to manage an escalating well control situation.

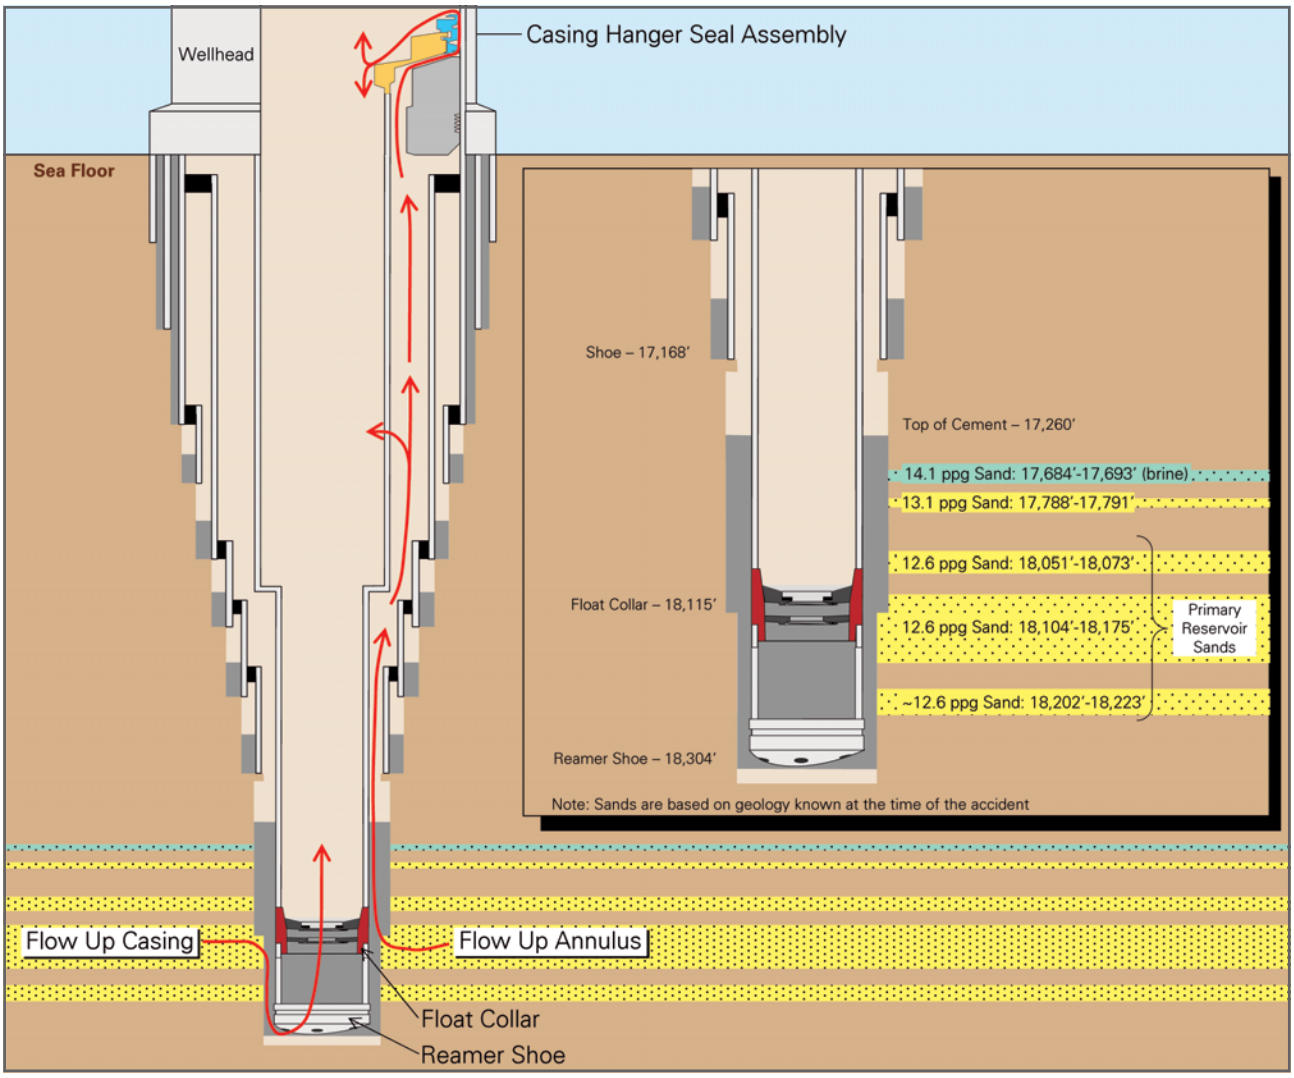
Figure 1. Hydrocarbon Zones and Potential Flow Paths.

The annulus cement barrier failed to prevent hydrocarbons from entering the annulus after cement placement. The investigation team assessed possible failure modes and paths that led to hydrocarbon migration from the formation into the wellbore. (Refer to Figure 1.)

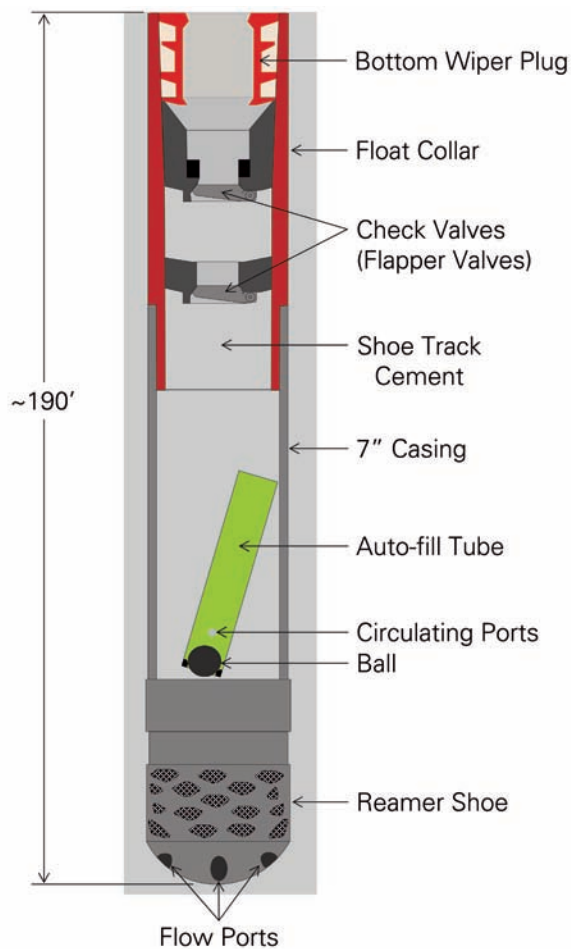
Figure 4. Shoe Track.

The shoe track had three components: the reamer shoe, the cement inside the casing and the double-valve float collar. (Refer to Figure 4.) The shoe track functions as an aid to cementing during the placement operation and then as a barrier to prevent hydrocarbons from entering through the bottom of the casing. If hydrocarbons passed through the shoe track, two failures in the shoe track must have occurred: one involving the cement inside the shoe track and the other involving the double-valve float collar.

Cement in the Shoe Track
The shoe track cement (tail cement) was 16.74 ppg non-foamed slurry using the Halliburton formulation shown in *Table 1*. The purpose of the shoe track cement was to fill an approximately 190 ft. section of the casing (approximately 7 bbls) from the top wiper plug through the reamer shoe, thus preventing hydrocarbons from reaching the float collar.

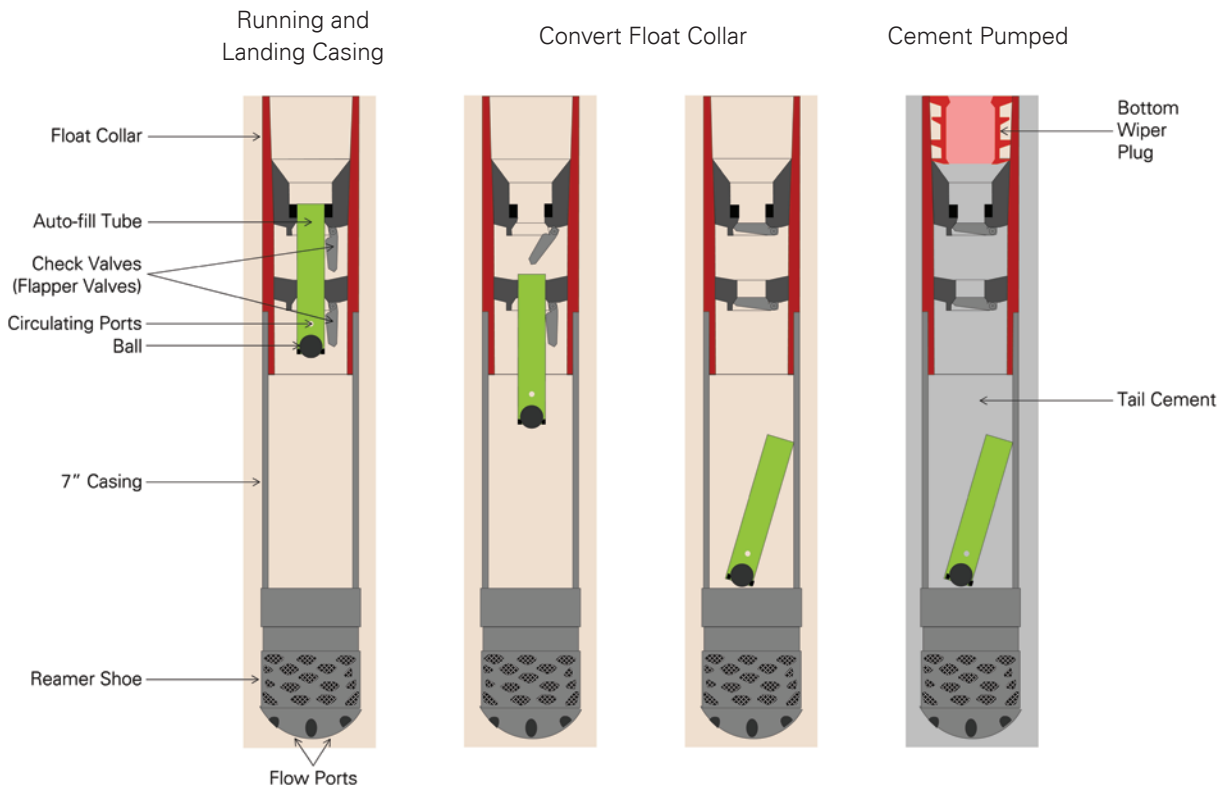
Figure 5. Float Collar Conversion.

At the time this report was written, lab tests were being conducted to determine whether the rush of fluids converted the float collar when the bottom wiper plug's burst disk ruptured or when the plugged shoe was cleared. Preliminary model results indicate that conversion most likely occurred in either case.

The BP Macondo well team interpreted the float collar testing after cement placement as successful. This was further documented in the Halliburton post-job report, which indicated that the float collar was holding backpressure. (Backpressure is the difference between hydrostatic pressure in the annulus and hydrostatic pressure inside the casing, which results from different fluid densities and heights.) However, the investigation team concluded that, with the 38 psi backpressure predicted in the Halliburton April 18, 2010, OptiCem™ program, the backpressure test that was conducted was not a reliable indicator that the float collar sealed.

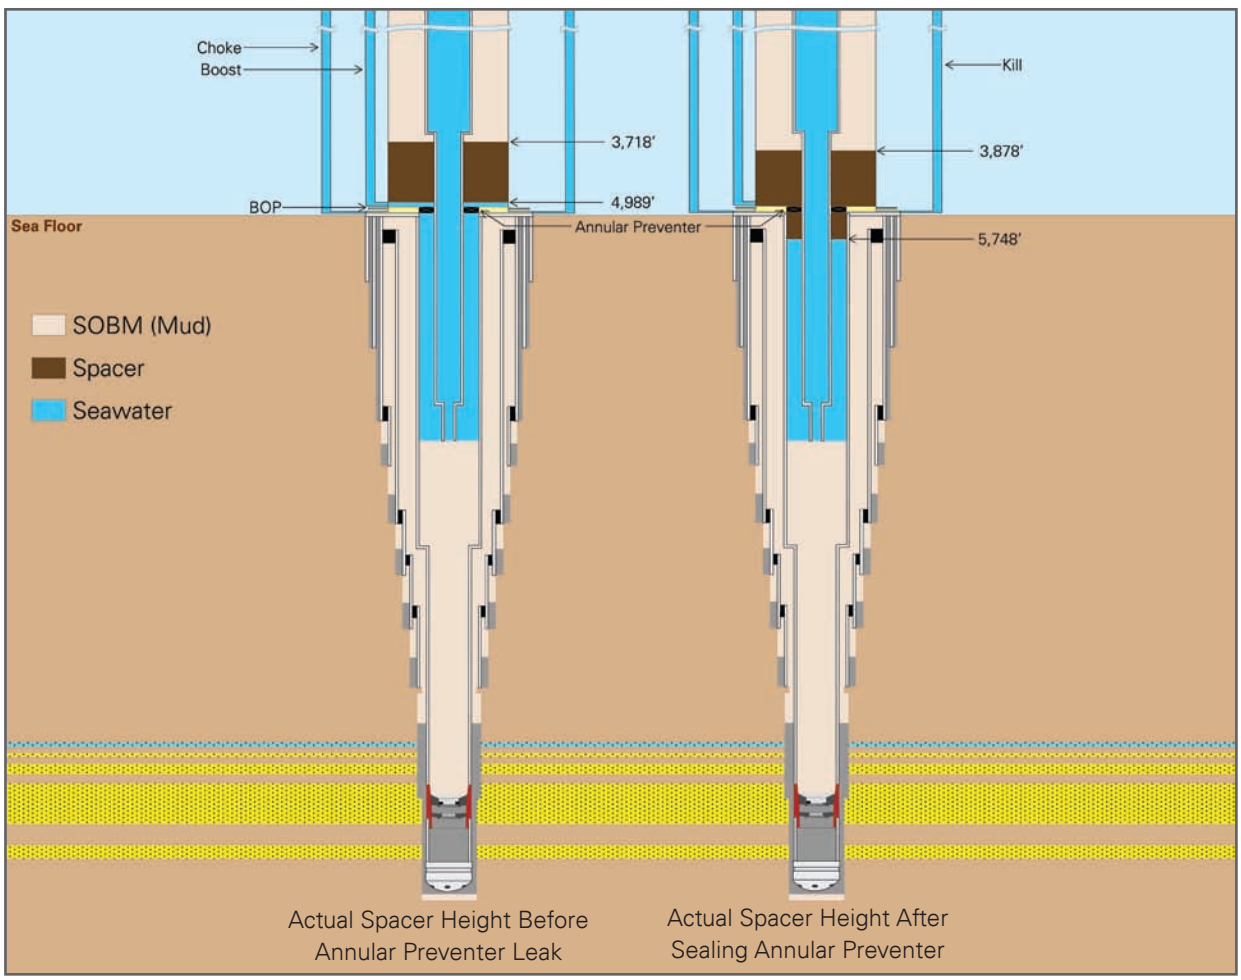
Figure 2. Spacer Placement.

- During the initial attempted negative-pressure test on the drill pipe, the annular preventer was closed, but it failed to seal on the drill pipe, resulting in approximately 50 bbls of spacer leaking past the annular preventer into the BOP during the bleed-off of drill pipe pressure. The investigation team believes that the spacer or spacer/seawater interface was across the BOP during the negative-pressure test procedure. (Refer to *2.3 Opened the Drill Pipe to Bleed Pressure* of this analysis.) The bottom of the spacer, therefore, was not above the upper annular preventer as intended. *Figure 2* shows the actual spacer placement before and after sealing the annular preventer.

- The presence of the spacer across the kill line inlet could have complicated the interpretation of the negative-pressure test. (Refer to *2.5 Continued the Negative-pressure Test on the Kill Line* of this analysis for a discussion of the anomalous pressure readings during the negative-pressure test.)

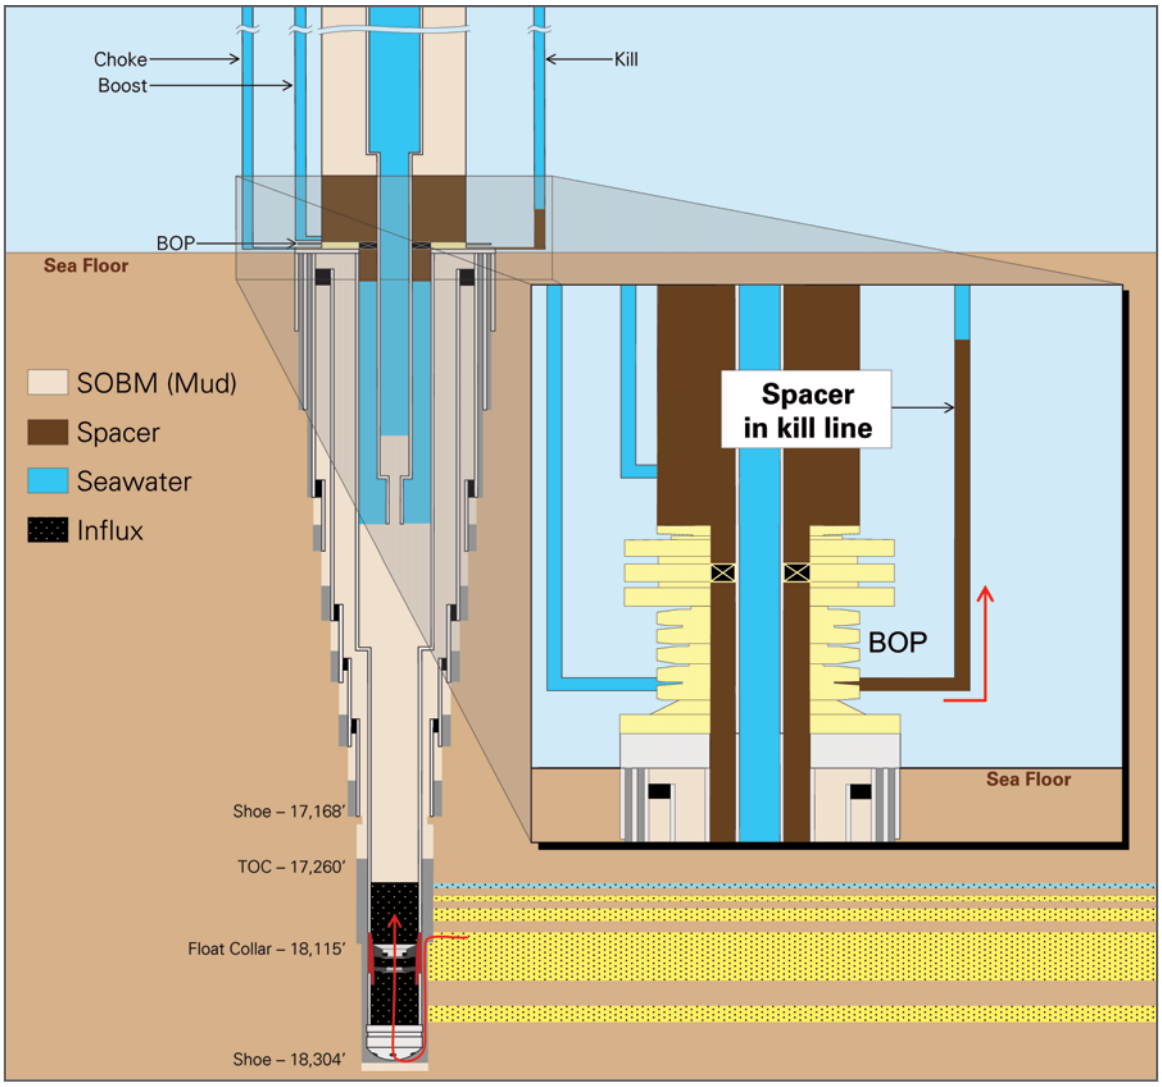
Figure 3. Possible Movement of Spacer into Kill Line.

As previously discussed in *2.2 Displaced Mud to Seawater* of this analysis, spacer material was unintentionally placed across the kill line at the BOP. At least 3 bbls of highly viscous fluid (occupying approximately 150 ft. in the kill line) could have been drawn into the kill line during this part of the test. (Refer to Figure 3.)

In this situation, where the drill pipe should have been in direct pressure communication with the kill line and there was 1,400 psi on the drill pipe, flow should have exited the kill line when the kill line was opened to the mini trip tank. However, the rig crew observed no flow into the mini trip tank. The investigation team considered the following possible reasons for the lack of flow:

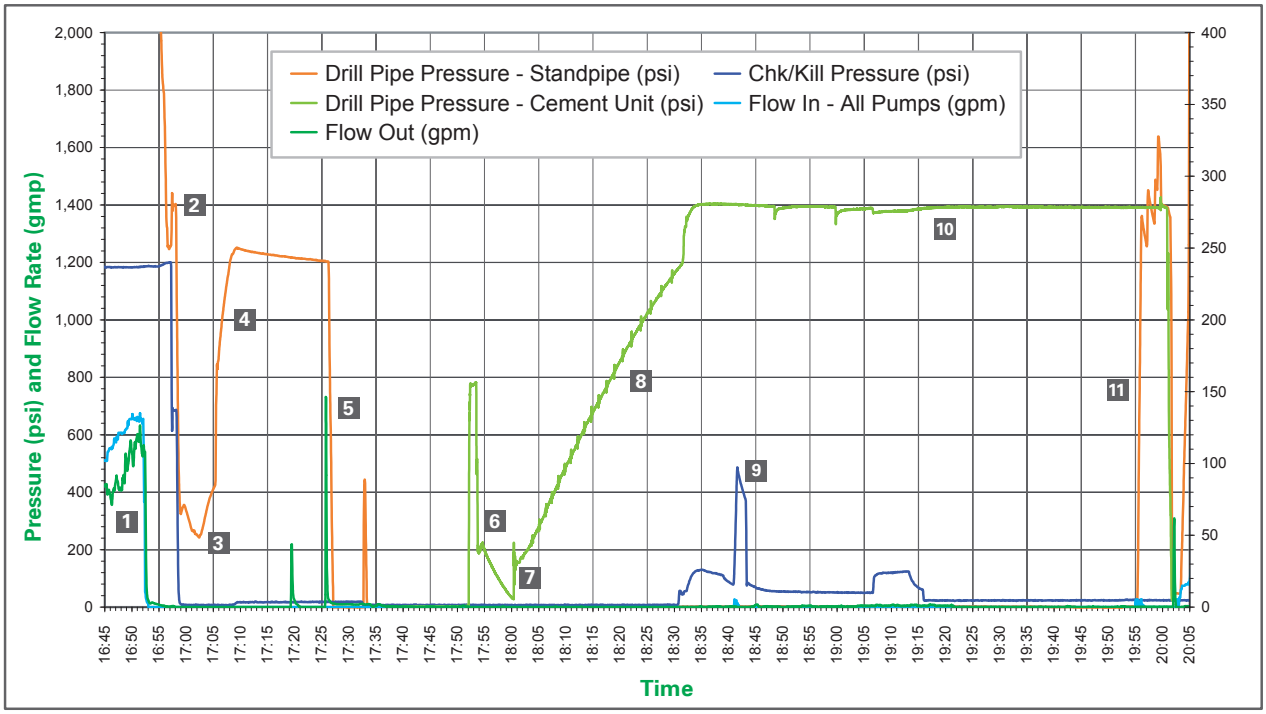
1. Spacer displacement complete; mud pumps stopped.
2. Annular preventer closed; attempt to bleed drill pipe pressure to zero.
3. Drill pipe pressure decreases to only 273 psi; annular preventer leaking.

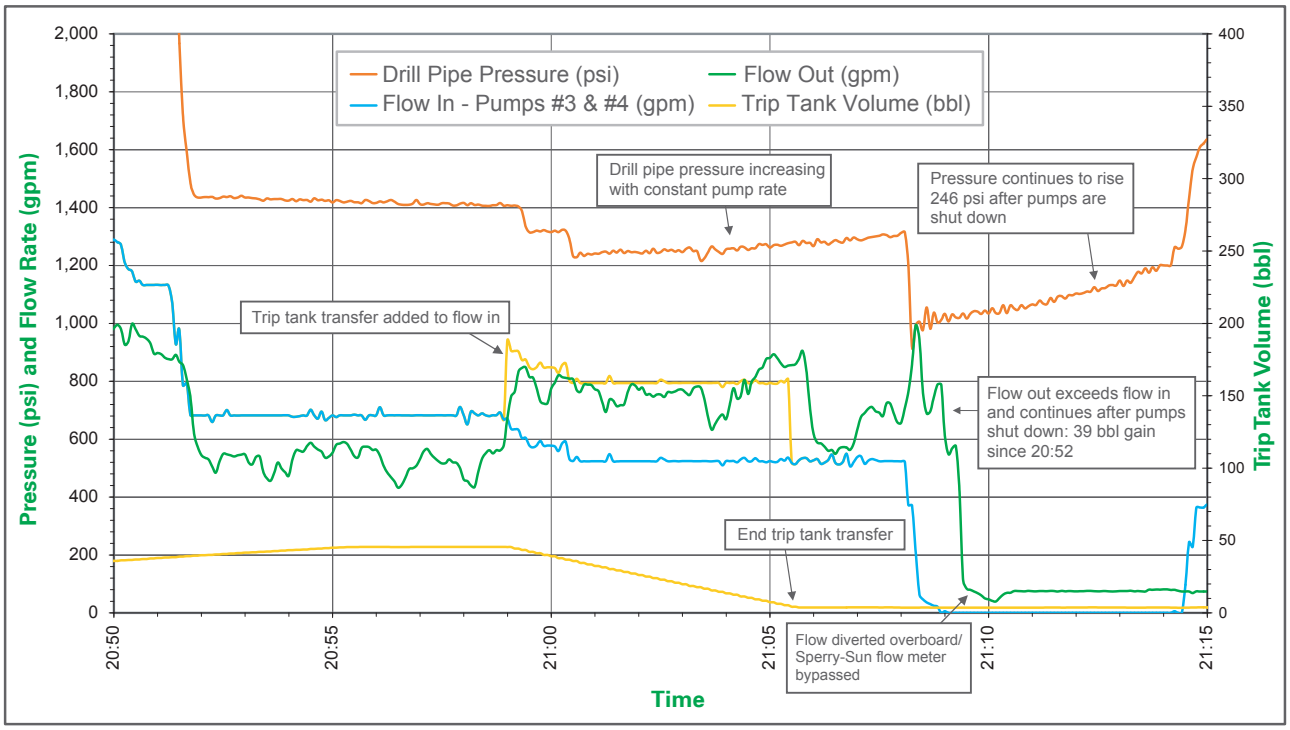
Figure 8. Flow Indication Graph Showing Anomalies (Real-time Data).

The first indication of flow likely would have been at 20:58 hours, but emptying of the trip tank could have masked this flow indication in the real-time data. The pressure abnormality starting at 21:01 hours would have been the first clear indication of flow visible to the rig crew and mudloggers.

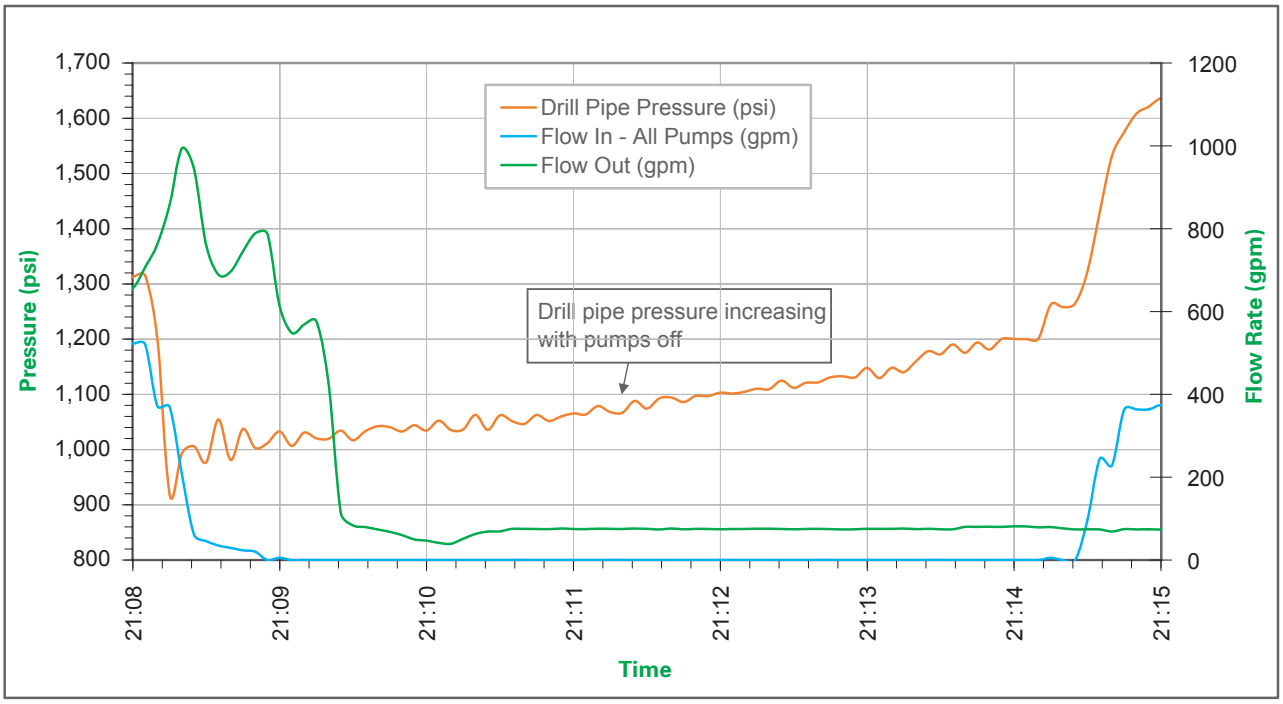
Figure 9. Pressure Increase During the Sheen Test (Real-time Data).

- The drill pipe pressure continued to increase from 1,017 psi at 21:08 hours to 1,263 psi at 21:14 hours. (Refer to Figure 9.) Modeling indicated this pressure increase was caused by 14.17 ppg mud rising above the stinger in the annulus. In addition, modeling suggested that this pressure increase was indicative of flow through the shoe track at a rate of approximately 9 bpm. (Refer to *Appendix G. Analysis Determining the Likely Source of In-flow* for the detailed analysis.)

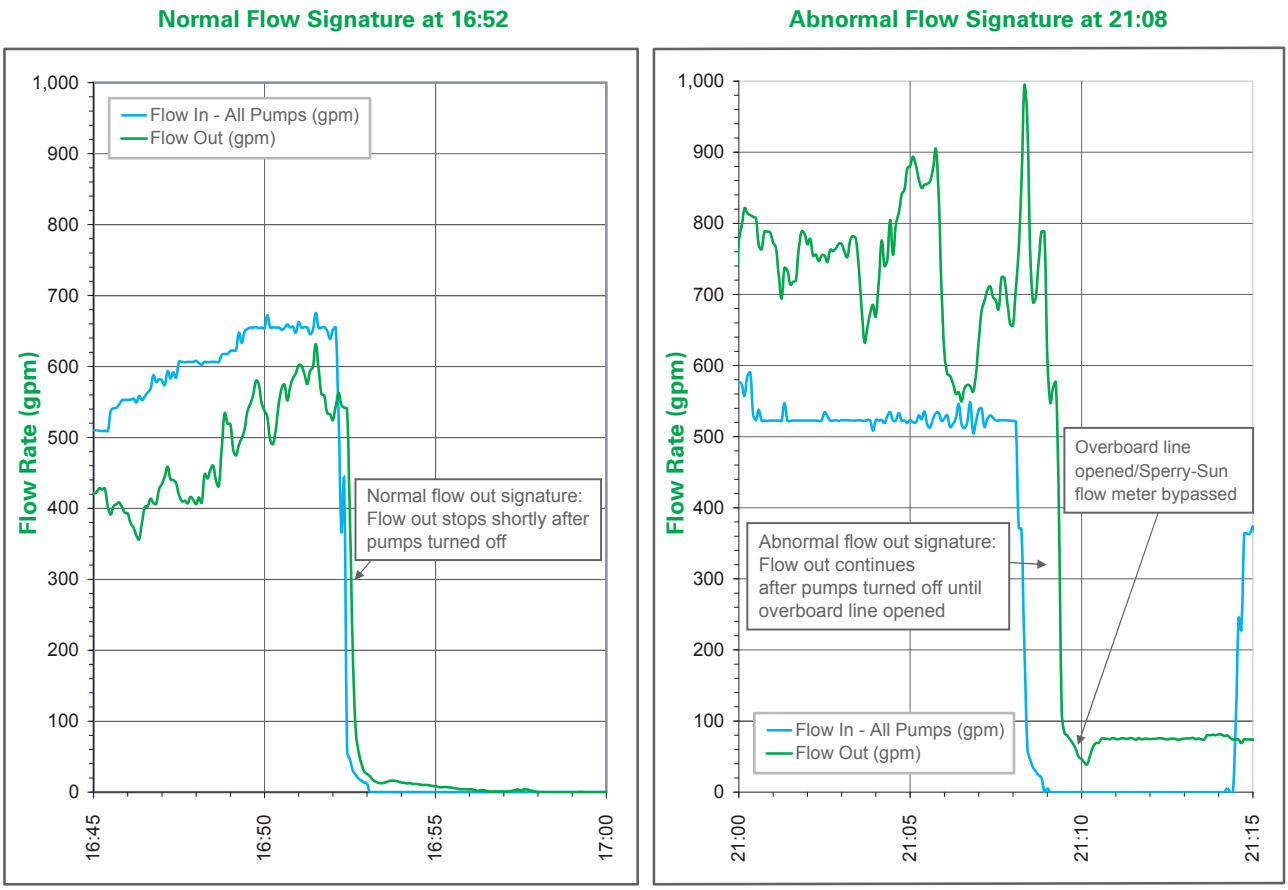
Figure 10. Normal Versus Abnormal Flow Out Signature as Pumps Shut Off (Real-time Data).

- The investigation team compared the flow out signature (i.e., the length of time it took the flow meter sensor to indicate zero flow after shutting the pumps off) to a time when the well was known to be stable. (Refer to Figure 10.) A distinctly different signature was observed at that time, indicating that the well was flowing.

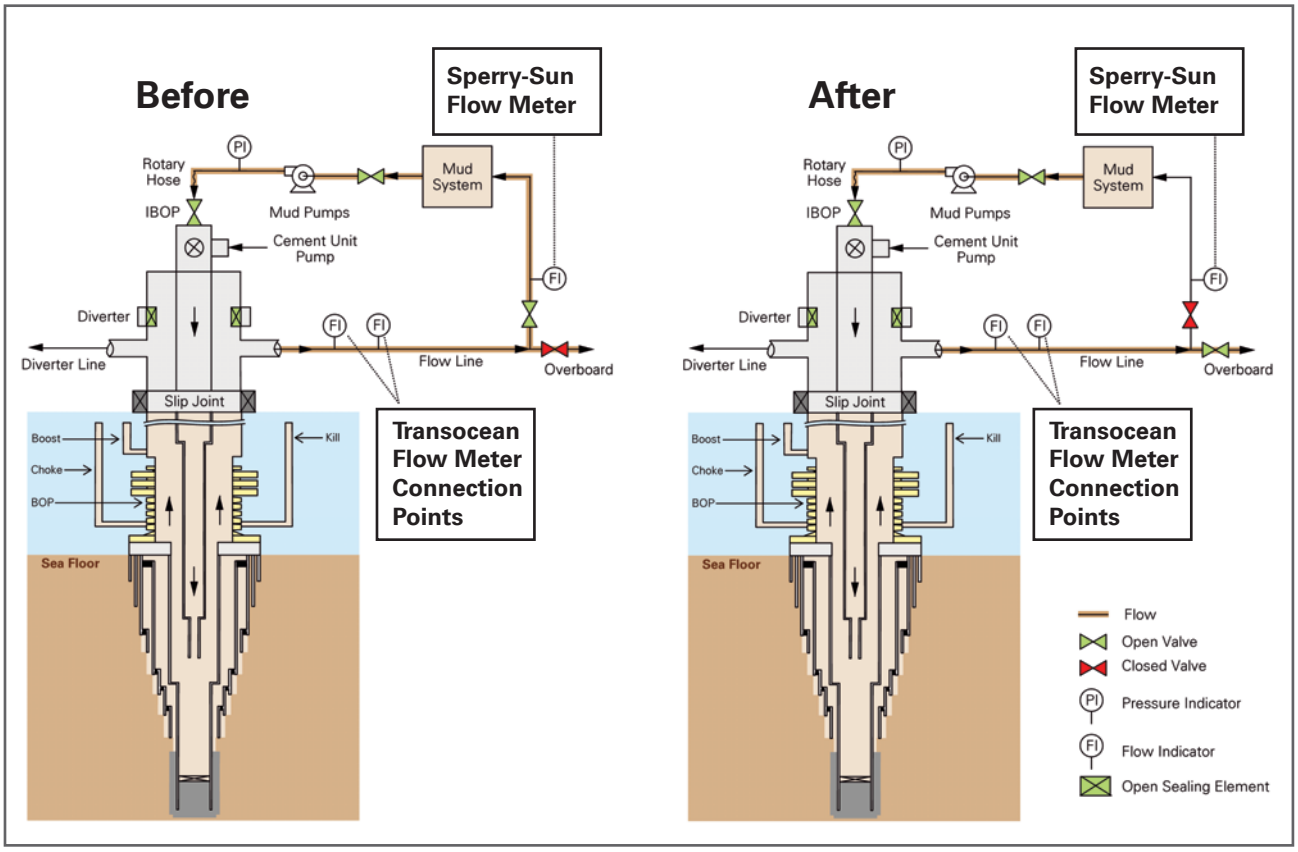
Figure 11. Flow Path Before and After Routing the Spacer Overboard.

The driller should have been able to monitor flow from the well, even after routing the flow overboard. Even though the Sperry-Sun flow meter was not sensing flow after 21:10 hours, information available to the investigation team showed that separate Transocean flow sensors would have been available to the driller. (Refer to Table 1 and Figure 11.)

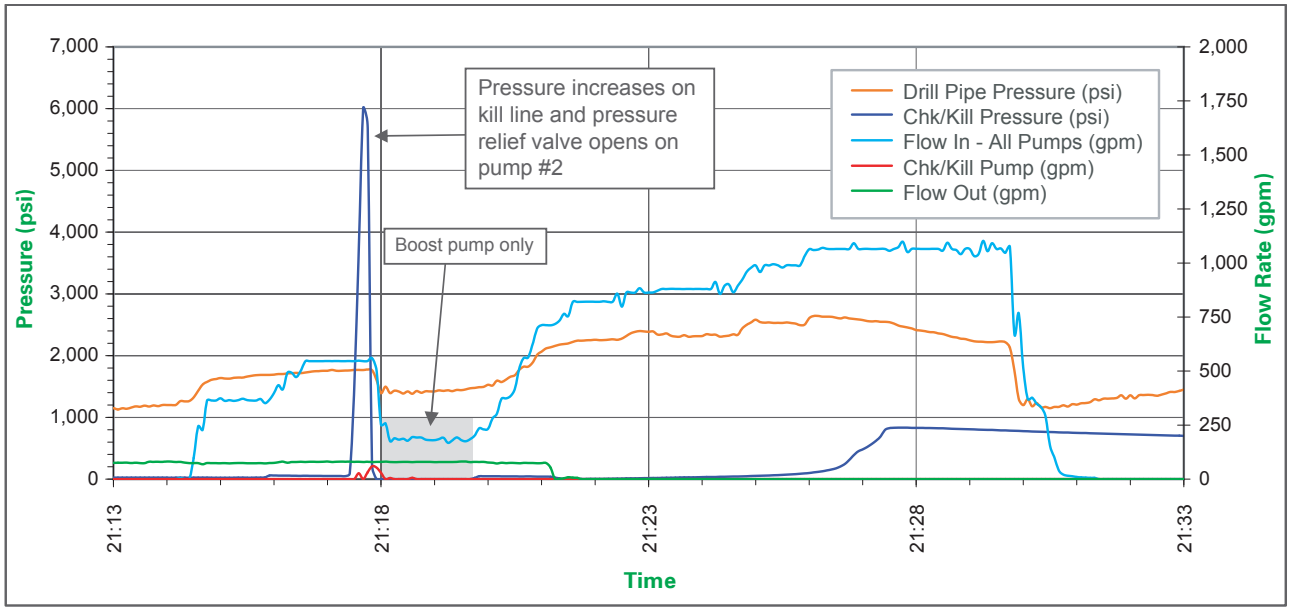
Figure 13. Mud Pump #2 Pressure Increase at 21:17 Hours (Real-time Data).

- An analysis of real-time data combined with MBI testimony suggested that the rig crew was trying to bring mud pump #2 online at 21:17 hours (32 minutes before the explosion). The pump was likely started against a closed valve, lifting the pressure relief valve (PRV). (Refer to Figure 13.)
- Mud pumps #2, #3 and #4 were all shut down, and pump #1 continued to pump into the boost line. Three minutes later, pumps #3 and #4 were put back online, and several personnel were investigating the problem with pump #2. This was another operation that potentially distracted the rig crew from monitoring the well.

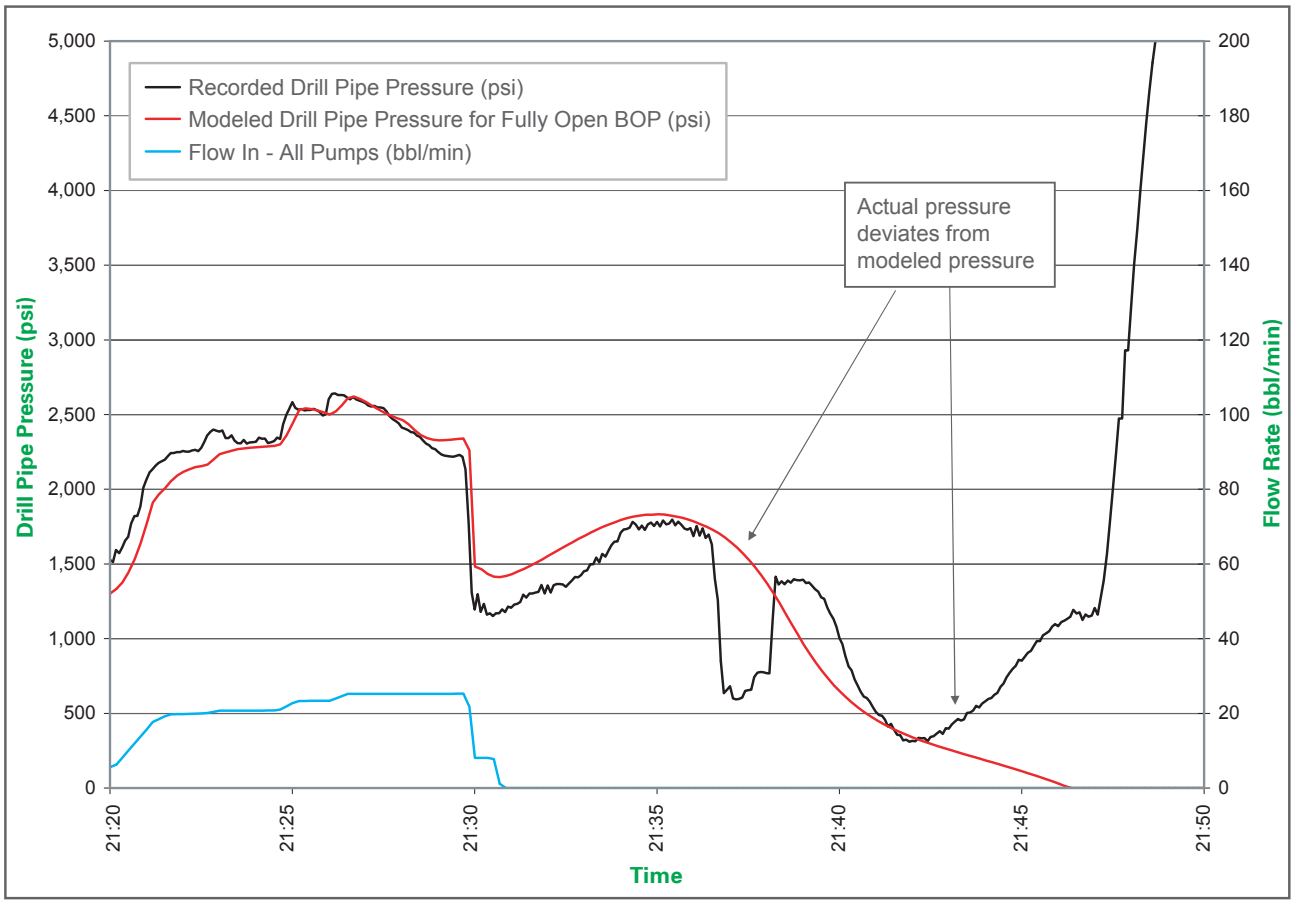
Figure 14. OLGA® Well Flow Modeling for Flow Condition with an Open Annular Preventer.

- As mentioned previously, at approximately 21:33 hours (approximately 21:30 hours per MBI testimony), the chief mate observed the toolpusher and the driller discussing 'differential pressure' on the well. This coincided with the real-time data showing the drill pipe pressure increasing at this time.
- The OLGA® well flow modeling predicted the pressure responses from 21:31 hours to 21:42 hours fairly accurately, with the exception of the sudden pressure changes shown in the real-time data from 21:36 hours to 21:38 hours. (Refer to Figure 14 for specific readings.)

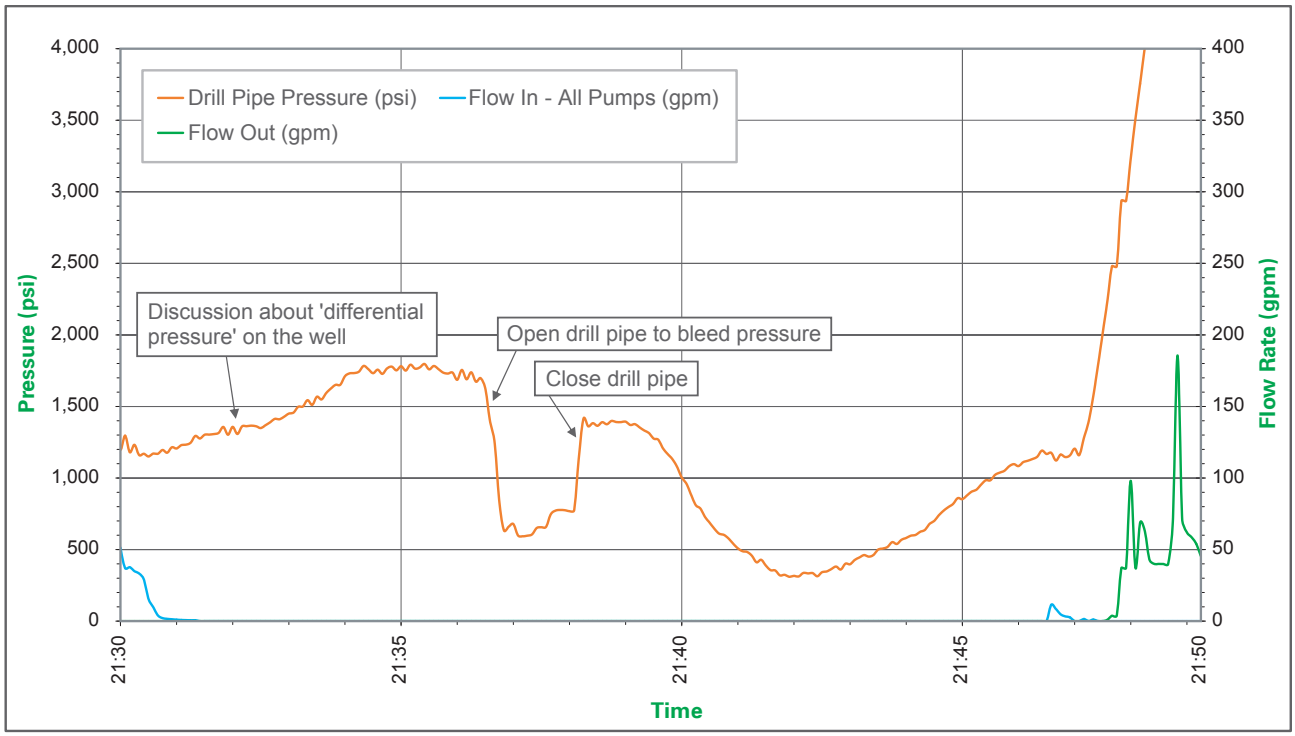
Figure 15. Investigation of Pressure Responses After Shutting Down Pumps (Real-time Data).

- The sudden pressure changes between 21:36 hours and 21:38 hours were indicative of a bleed-off at the surface. Modeling supported the bleeding of the drill pipe at the surface through a 4 in. surface line as the likely action taken at this time because the pressure response is immediate. (Refer to Figure 15.) A pressure transient caused by a pressure drop deep within the well would have been indicated by a slower pressure change on the real-time data.

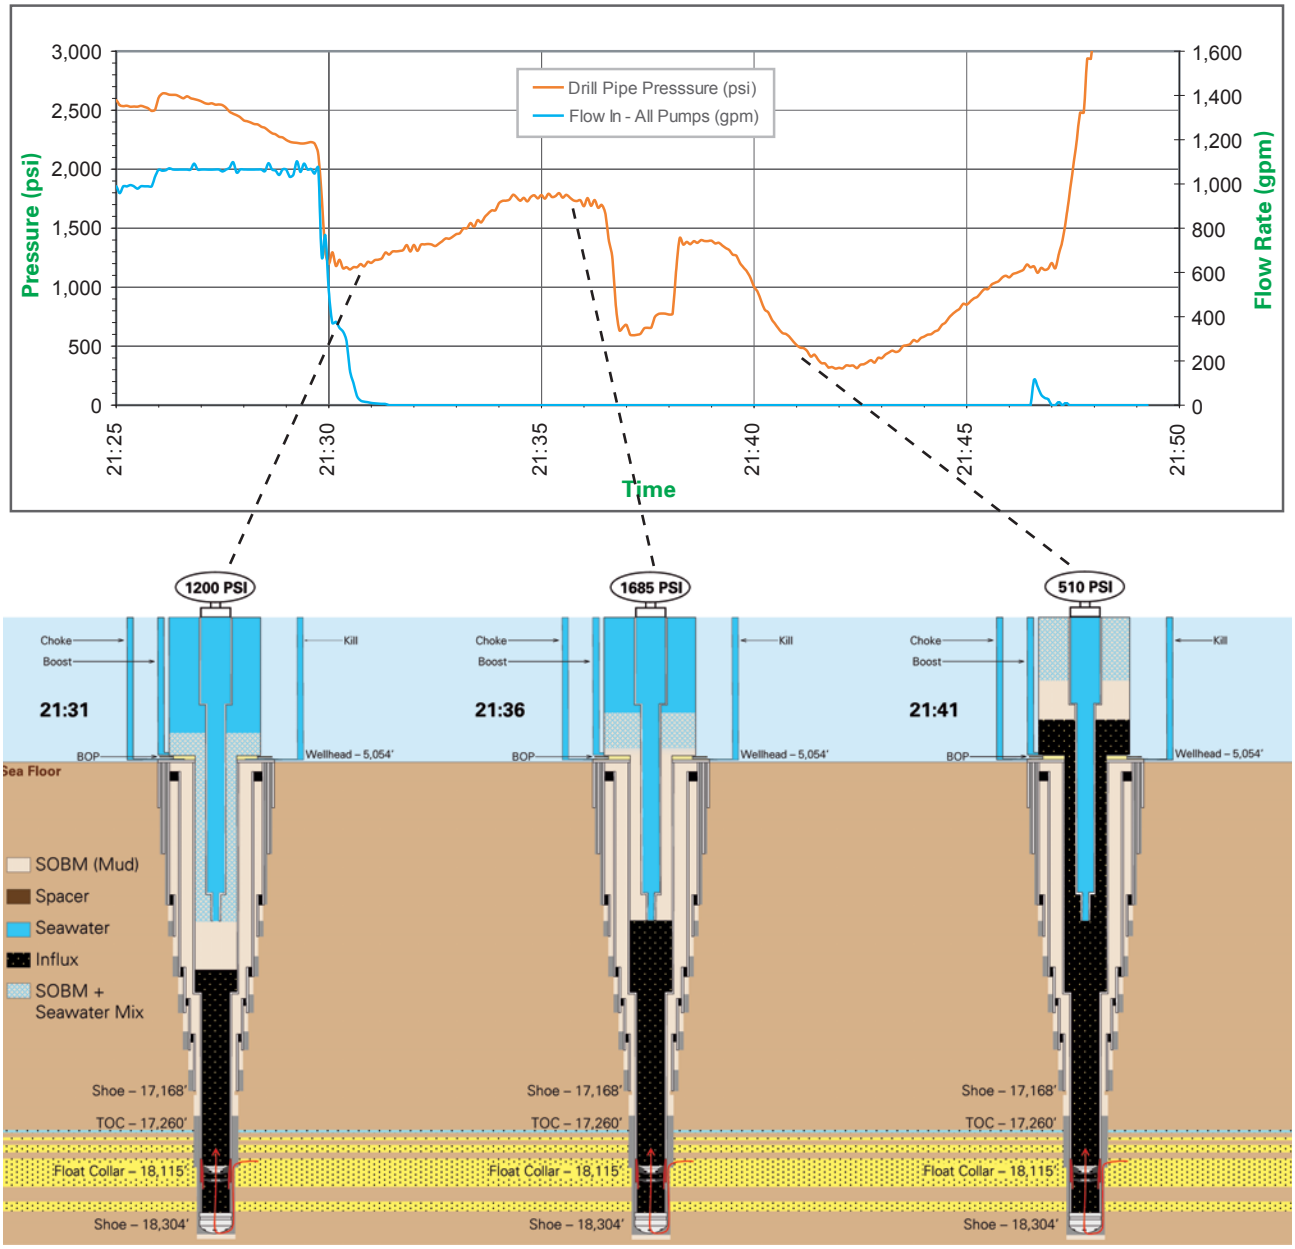
Figure 16. Modeled Pressure Responses Resulting from Hydrostatic Changes in the Wellbore.

- The rig crew may have conducted this bleed-off when they were investigating the 'differential pressure.' This action would not be consistent with a rig crew responding to a recognized well control condition.
- Other than the sudden pressure changes between 21:36 hours and 21:38 hours (interpreted to be the bleed-off of the drill pipe pressure), the drill pipe pressure increased until 21:35 hours as 14.17 ppg mud rose above the stinger and then declined after that as hydrocarbons rose above the stinger.
- Modeling indicated that this fluctuation was consistent with the change in fluid densities (spacer, seawater, mud and hydrocarbons) moving through the various cross-sectional areas in the well. *Figure 16* illustrates the hydrostatic changes occurring in the well and the corresponding pressure responses.
