Deepwater Horizon Accident Investigation Report

September 8, 2010

This is the report of an internal BP incident investigation team. The report does not represent the views of any individual or entity other than the investigation team. The investigation team has produced the report exclusively for and at the request of BP in accordance with its Terms of Reference, *and any decision to release the report publicly is the responsibility of BP. It has not been prepared in response to any third party investigation, inquiry or litigation.*

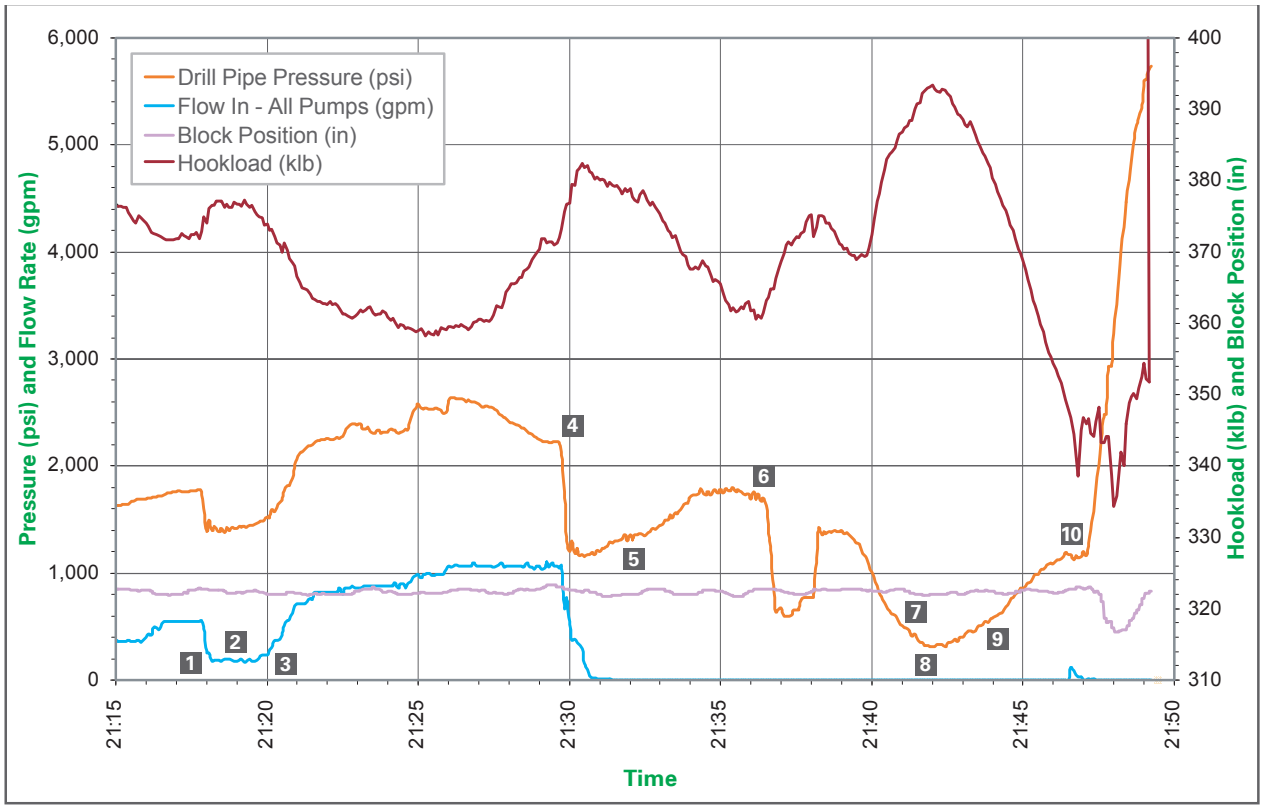
Figure 17. Interpretation of Well Control Response (Real-time Data).

- One of two possible actions would have caused the rapid pressure increase to 5,730 psi from 21:47 hours to 21:49 hours:
  - The rig crew possibly first closed an annular preventer and then closed a VBR in accordance with Transocean's protocol for handling well control events.

- The rig crew possibly first closed an annular preventer and then increased its closing pressure to create a seal.

1. Pressure relief valve on pump #2 opens; toolpusher called to rig floor.
2. All pumps shut down except boost pump.
3. Assistant driller called to pump room.
4. Pumps shut off.
5. Toolpusher and driller discuss 'differential pressure.'
6. Opening of 4" surface line to bleed pressure.
7. Mud/water flows onto rig floor and then unloads through the derrick.
8. Diverter and annular preventer activated; diverted to mud gas separator.
9. Well site leader and senior toolpusher receive calls from rig floor; annular preventer attempting to close.
10. BOP sealing.

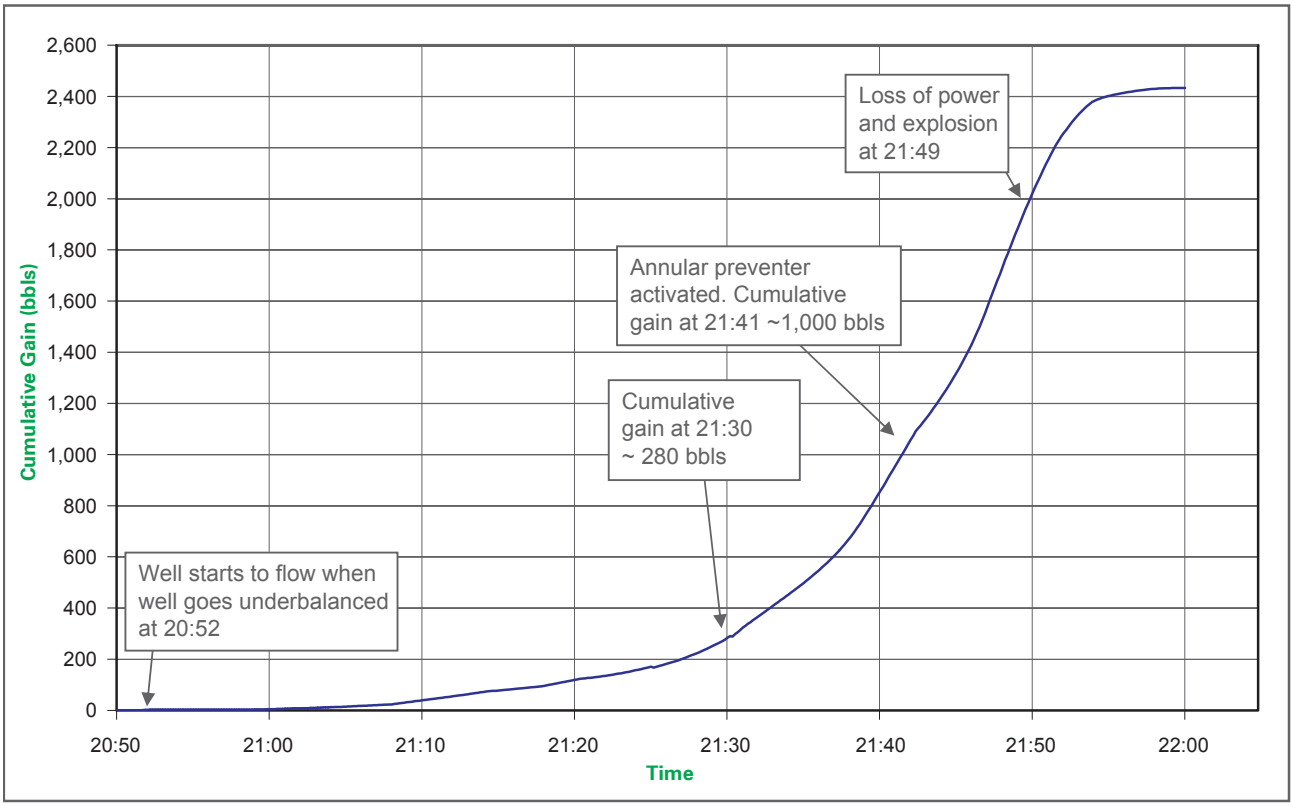
Figure 18. OLGA® Well Flow Modeling Prediction of Cumulative Gain Excluding Pumped Volumes 20:52 Hours–21:49 Hours.

When the annular preventer was activated at approximately 21:41 hours, the model estimated the influx volume to be approximately 1,000 bbls. By the time the explosion occurred at approximately 21:49 hours, the model estimated the gain to be approximately 2,000 bbls. (Refer to Figure 18 for the cumulative gain over time.)

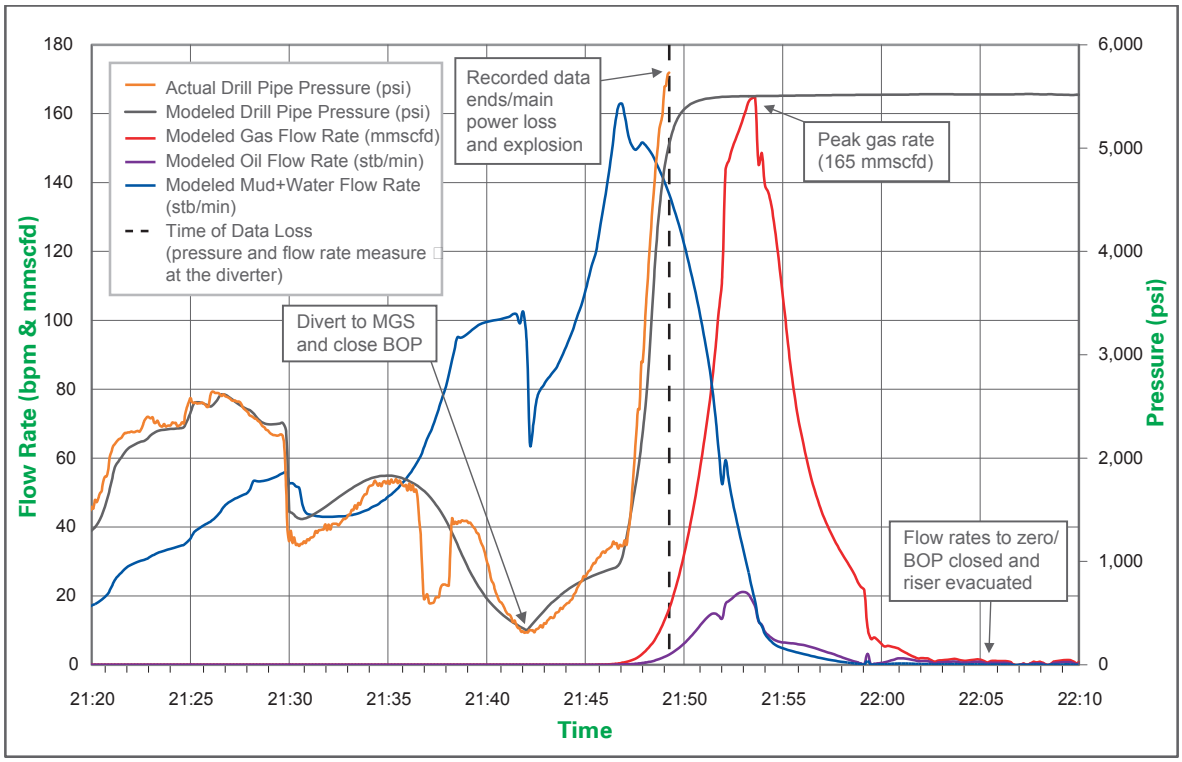
Figure 1. OLGA® Well Flow Modeling Prediction of Fluid Outflow from the Riser.

Figure 1 shows the predicted flow rates of mud/water, gas and oil. At approximately 21:46 hours, the gas reached the surface, and over a 5-minute period the flow of gas increased to more than 140 mmscfd. Simultaneously, the flow of mud and water to the surface reduced from 140 bpm to 20 bpm. The modeled timeline of flow to the surface aligns with eyewitness accounts described in *Table 1*.

Based on the assumption that the BOP remained closed and sealed around the drill pipe, *Figure 1* shows that predicted flow tails off approaching 22:00 hours, though it is evident from the actual event that this did not occur. (Refer to *Appendix W. Report–Dynamic Simulations Deepwater Horizon Incident BP*.) The failure modes that may have allowed the flow to continue are described in *3.5 Sustaining the Flow Following the Closure of the BOP* of this analysis.

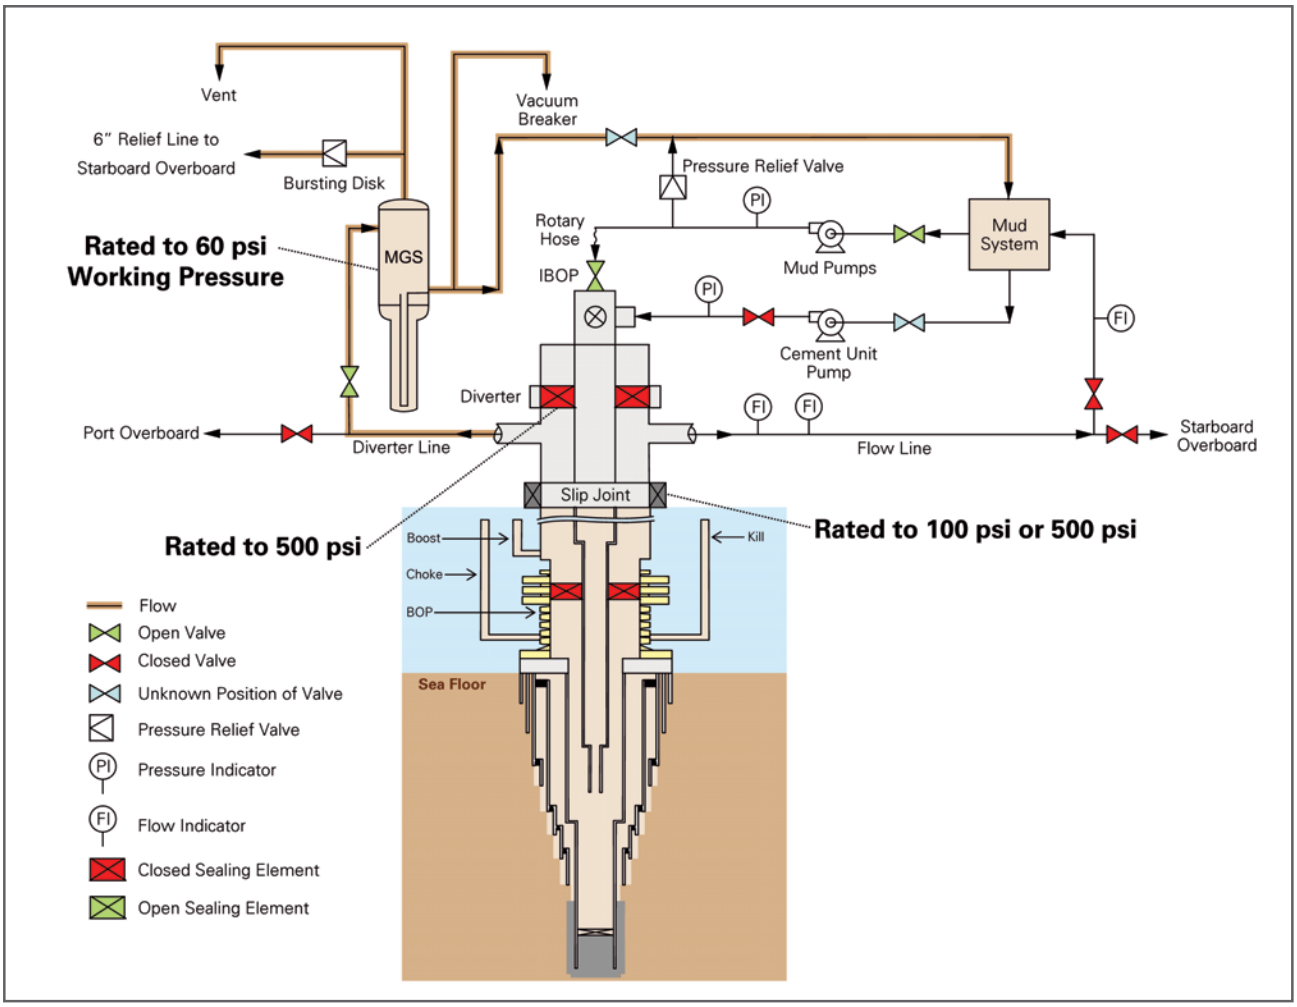
Figure 2. Simplified Process Flow Diagram of Selected *Deepwater Horizon* Surface Equipment.

Based on these modeled pressures, it appears that some of the surface equipment could have begun to fail and release hydrocarbons. (Refer to Figure 2.) The two most vulnerable pieces of equipment were the MGS vessel, which was rated for 60 psi; and, if selected in low-pressure mode, the riser slip joint seal, which was rated for 100 psi.

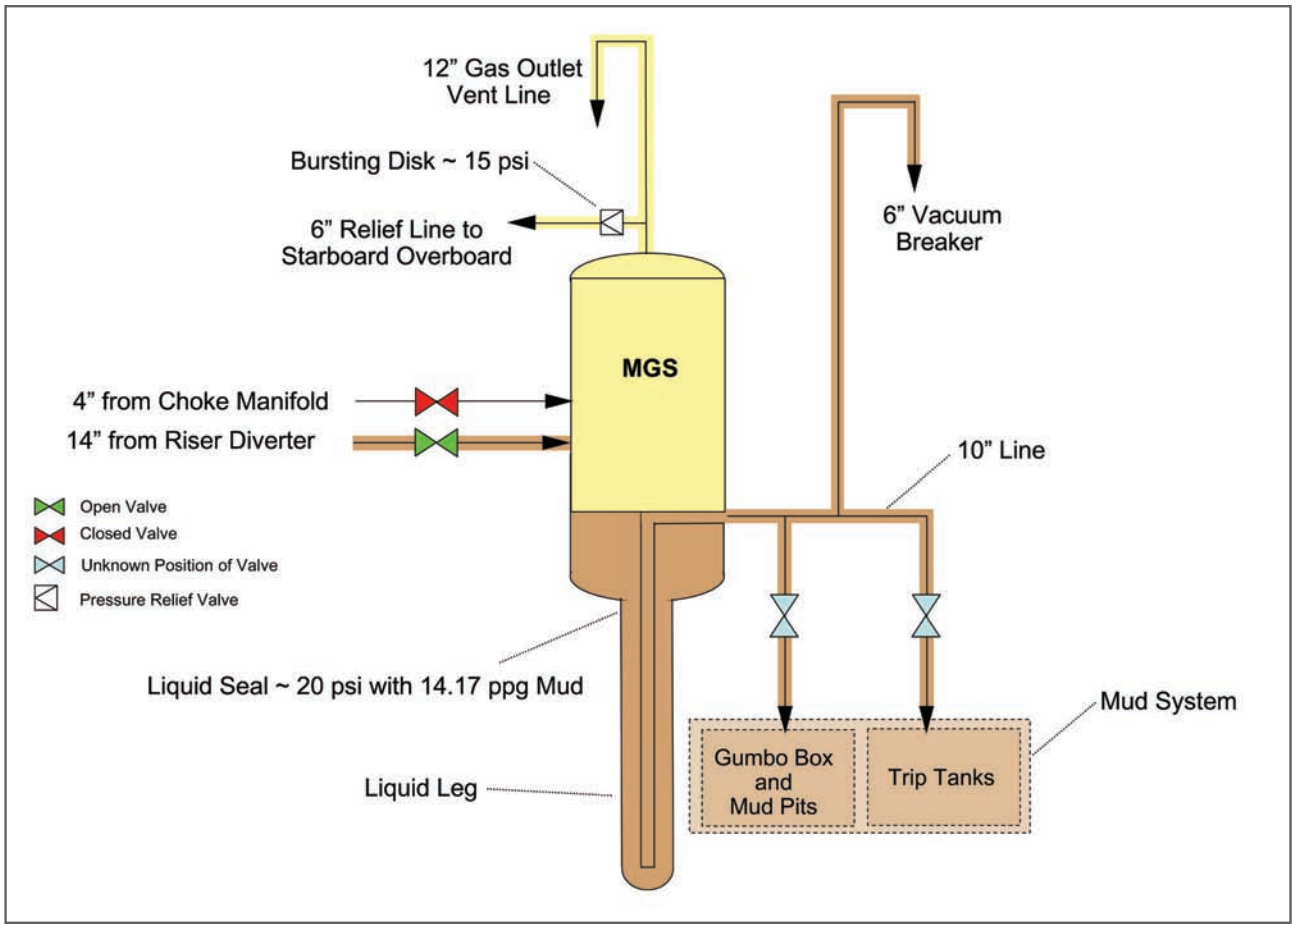
Figure 3. Simplified Drawing of the MGS.

Because the 12 in. MGS outlet vent and the 6 in. vacuum breaker vent were goosenecked, they would have diverted flow back down toward the rig.

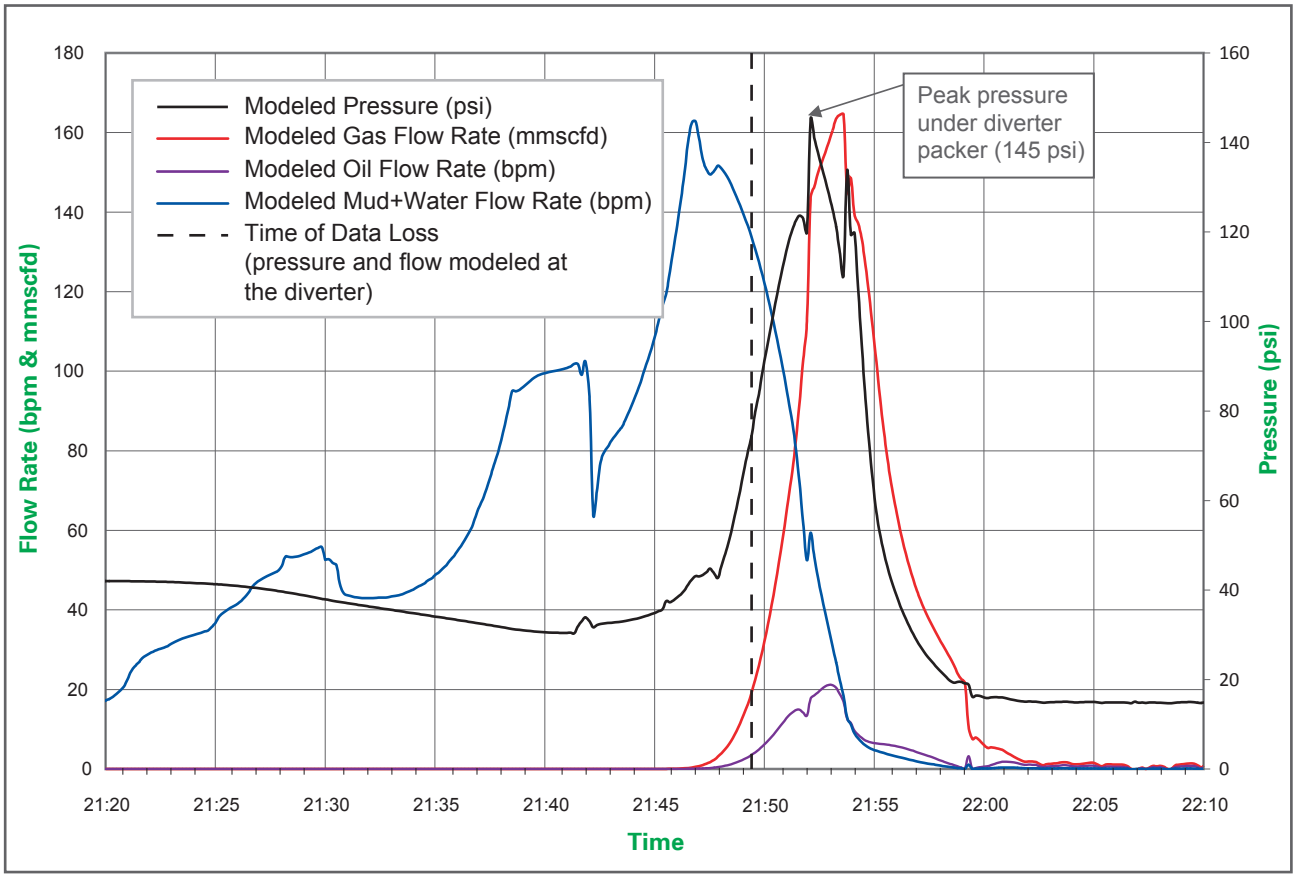
Figure 4. OLGA® Well Flow Modeling Prediction of Backpressure and Flow at the Diverter Packer.

A simplified model of surface equipment was used to determine the backpressure at the diverter packer. As shown in *Figure 4*, this pressure could have reached 145 psi.

At these pressures it was possible that some components of the MGS vessel such as flange connections began to fail, but it was unlikely that the vessel itself ruptured.

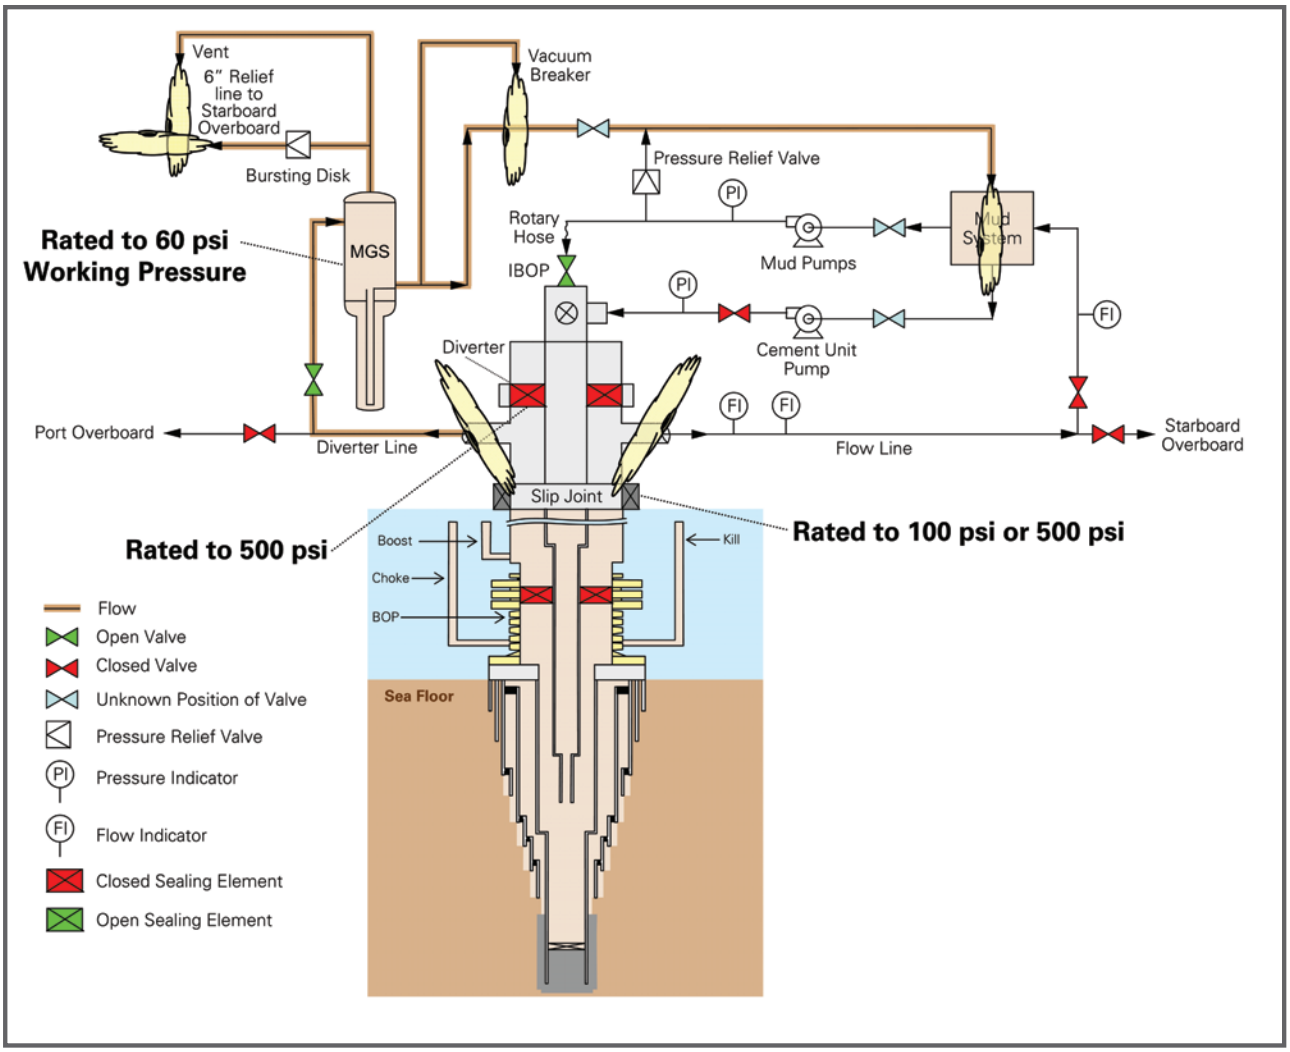
Figure 8. Schematic of Postulated Hydrocarbon Release Locations.

The case presented in this analysis assumes that the 12 in. MGS vent and the 10 in. MGS liquid outlet to the gumbo box, the riser slip joint seal, the MGS 6 in. bursting disk and the 6 in. MGS vacuum breaker vent were all open flow paths. *Figure 8* is a simplified illustration of these open flow paths.

The design of the MGS system allowed the rig crew to divert riser fluids to the MGS vessel when the well was in a blowout condition. The decision to divert the well through the MGS rather than the starboard diverter increased the potential for the gas to reach an ignition source. (Refer to Figure 8.)

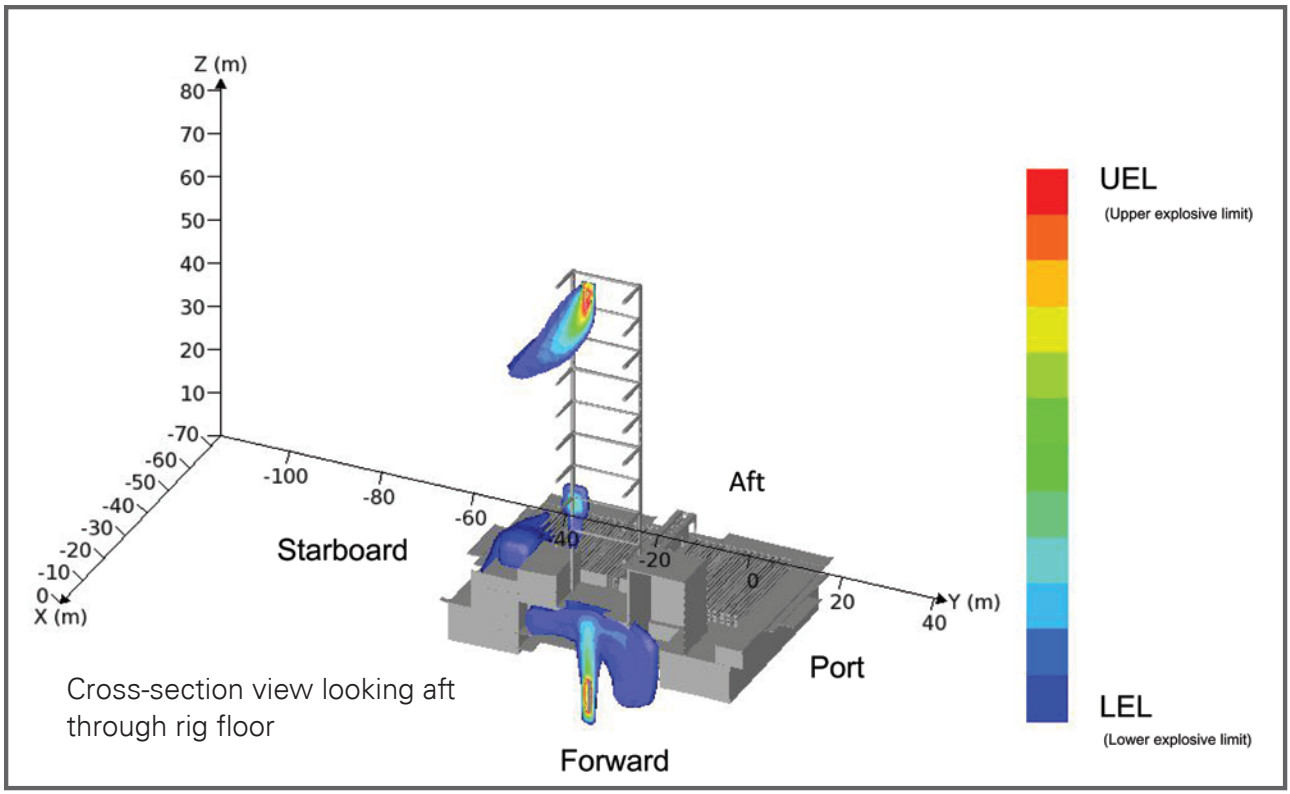
Figure 9. Vapor Dispersion at 100 Seconds.

The graphics in *Figure 9* and *Figure 10* show the modeled outcomes of gas rapidly dispersing across the drilling rig. Gas could have also migrated into enclosed spaces under the deck through the mud system or through the HVAC supply fans for the engine rooms.

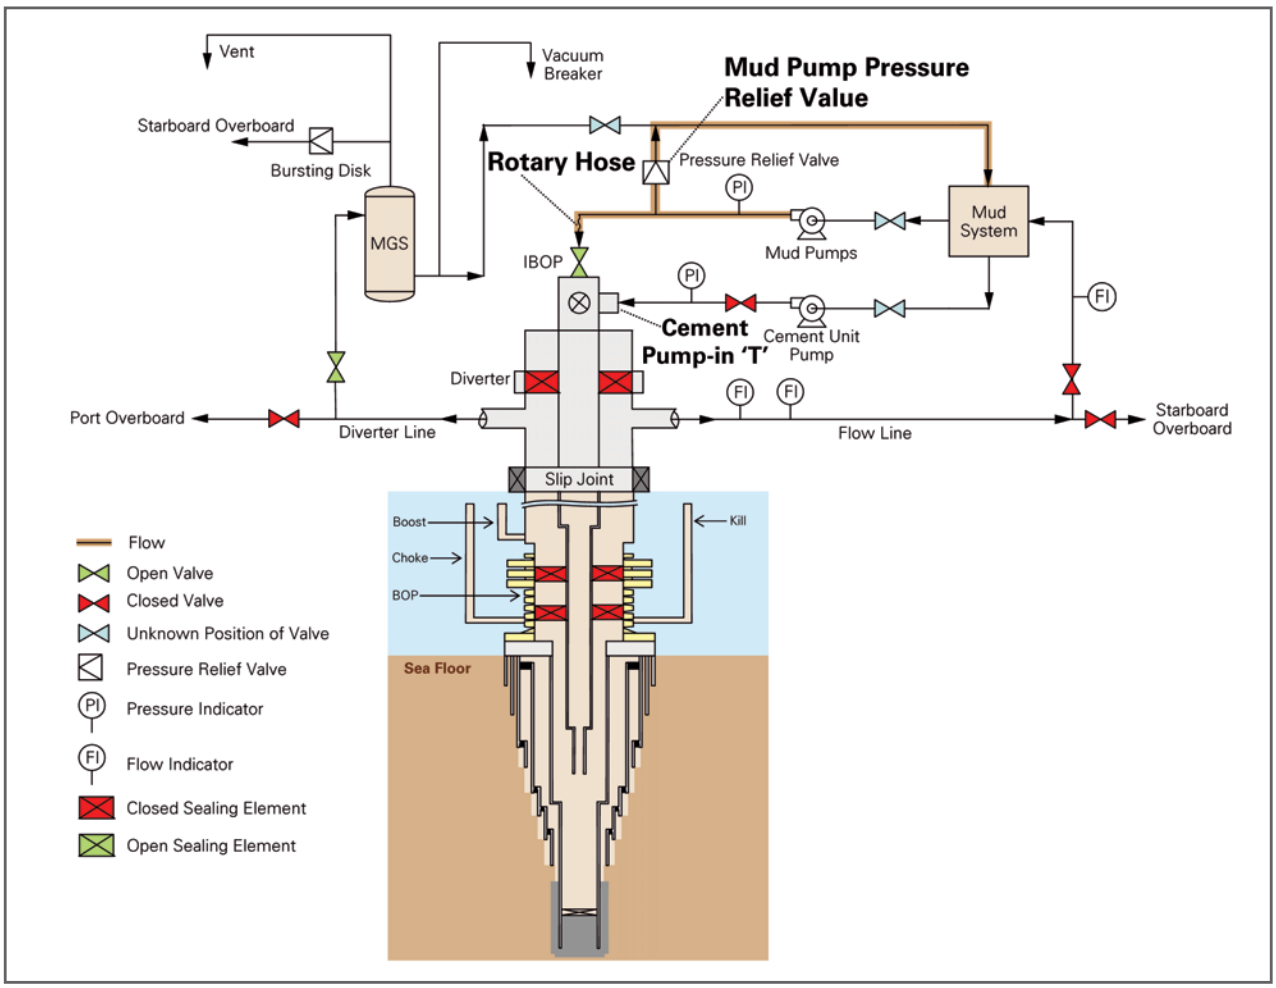
Figure 11. Relevant Surface Equipment Downstream of the IBOP at ~21:47.

It was important to clarify the position of the internal blowout preventer (IBOP) valve, as this determines the number of potential flow paths to the surface if the BOP had closed and sealed. The simplified process flow diagram in *Figure 11* shows that there were two pressure indicators (PIs), each of which was recorded via the real-time data system. One PI measured drill pipe pressure from upstream of the IBOP, and one measured drill pipe pressure from downstream of the IBOP.

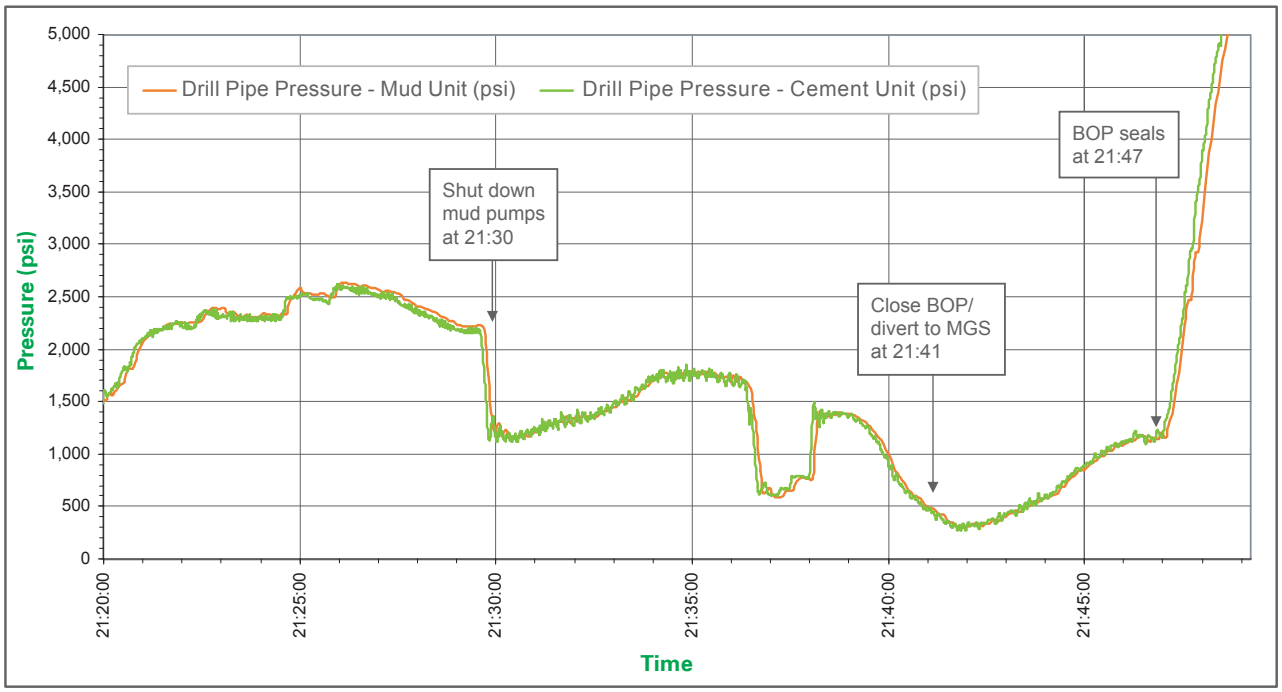
Figure 12. Drill Pipe Pressure Measured at Cement Pump PI and Mud Pump PI.

Figure 12 shows the pressure trend data from each of the PIs during the 30 minutes prior to the loss of power and the explosions. The fact that the trends tracked almost identically over a significant range of changing pressures indicates that the IBOP must have been open.

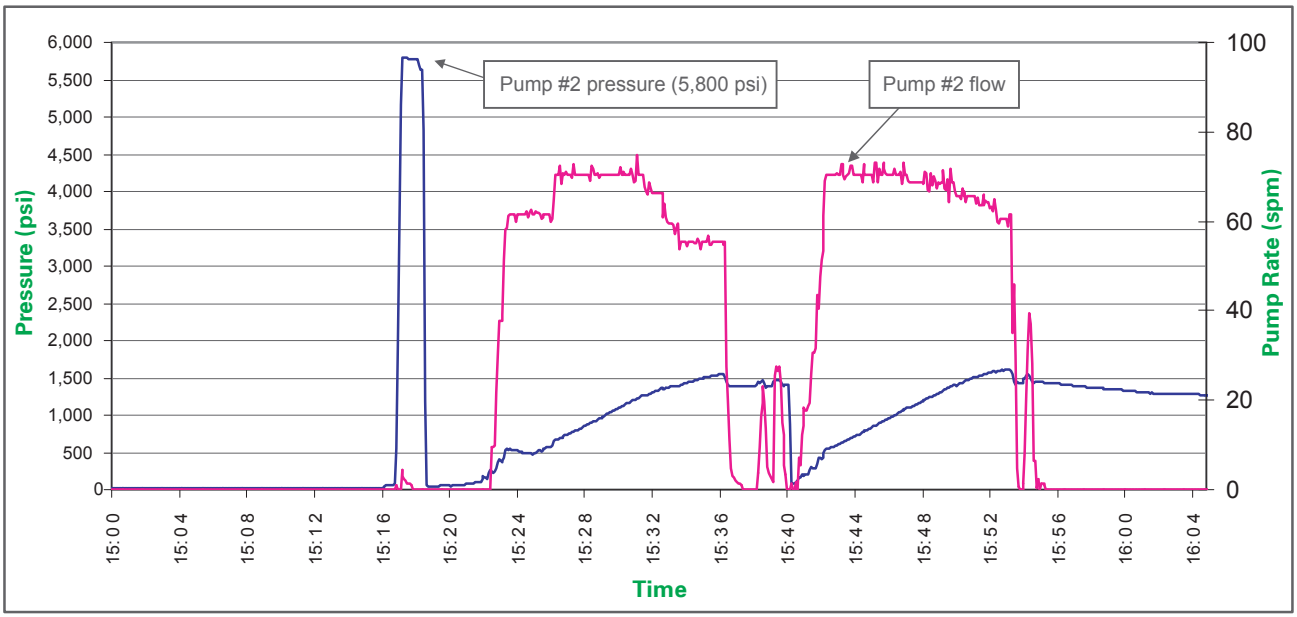
Figure 13. Mud Pump #2 Pressure Plot Showing Line Test During Negative-pressure Test.

- Mud pump #2 was tested to 5,800 psi during the negative-pressure test procedure at 15:17 hours.
- While trying to start mud pump #2 at 21:17 hours, the pressure increased to 6,000 psi.

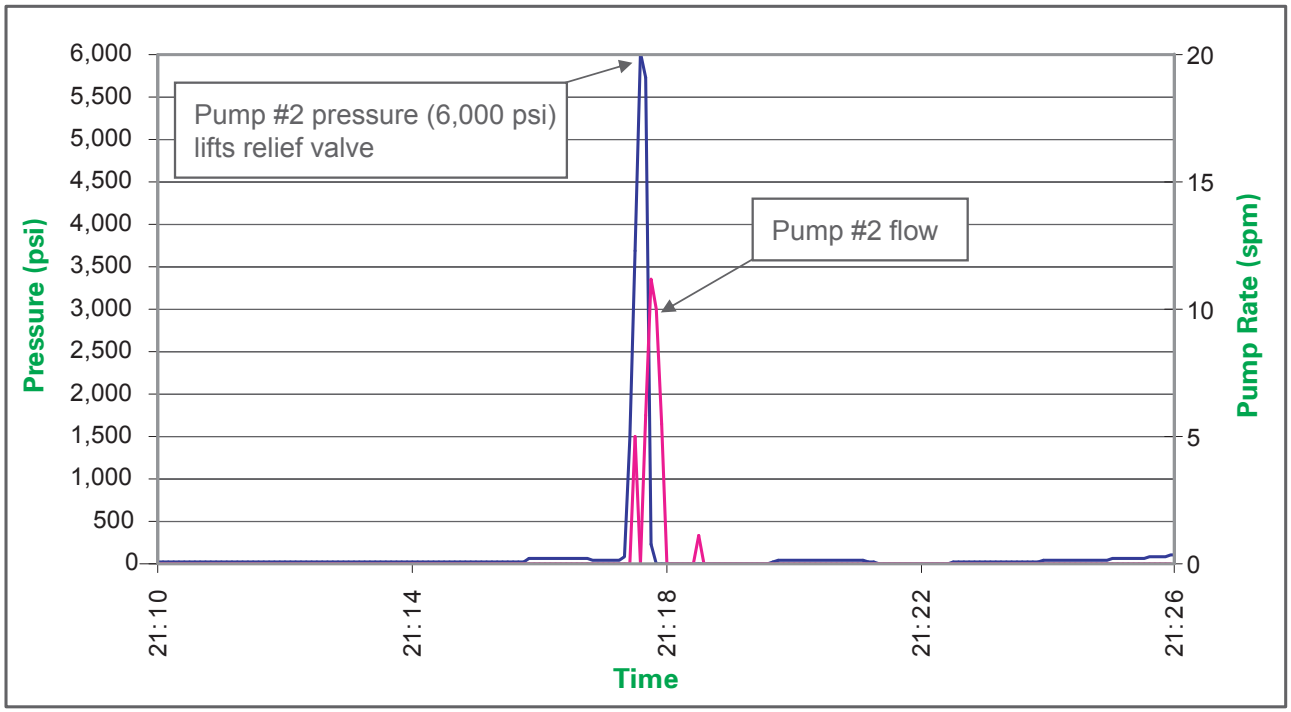
Figure 14. Mud Pump #2 Pressure Plot Showing Lift Pressure of PRV.

The investigation team believes that mud pump #2 was started against a closed discharge valve at 21:17 hours and the PRV lifted.

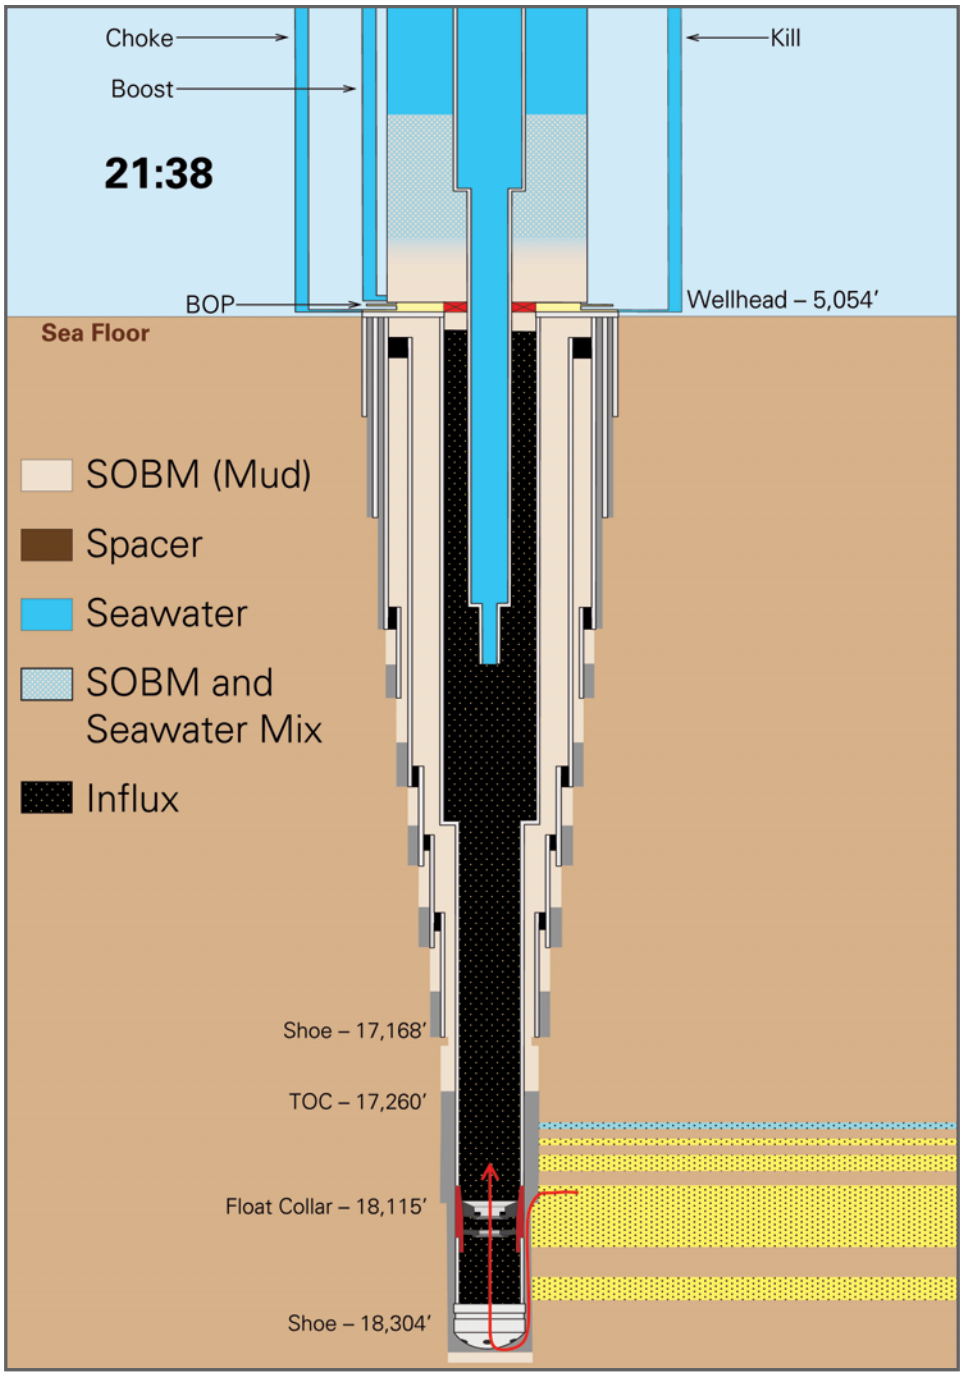
Figure 15 shows a view of the different fluids across the wellbore at 21:38 hours, if the BOP was closed, and illustrates that hydrocarbons would probably have been located below the BOP at that time. In the figure, a sharp interface among different fluids is shown for simplicity of illustration. In reality, there would have been varying degrees of fluid mixing.

The simulations have been proven to be quite sensitive to the net pay assumption. Therefore, the time of 21:38 hours, when hydrocarbons were assumed to be just below the BOP, could be off by 1 or 2 minutes.

Figure 15. Illustration of Wellbore and Position of Hydrocarbons at 21:38 Hours if BOP Was Closed.

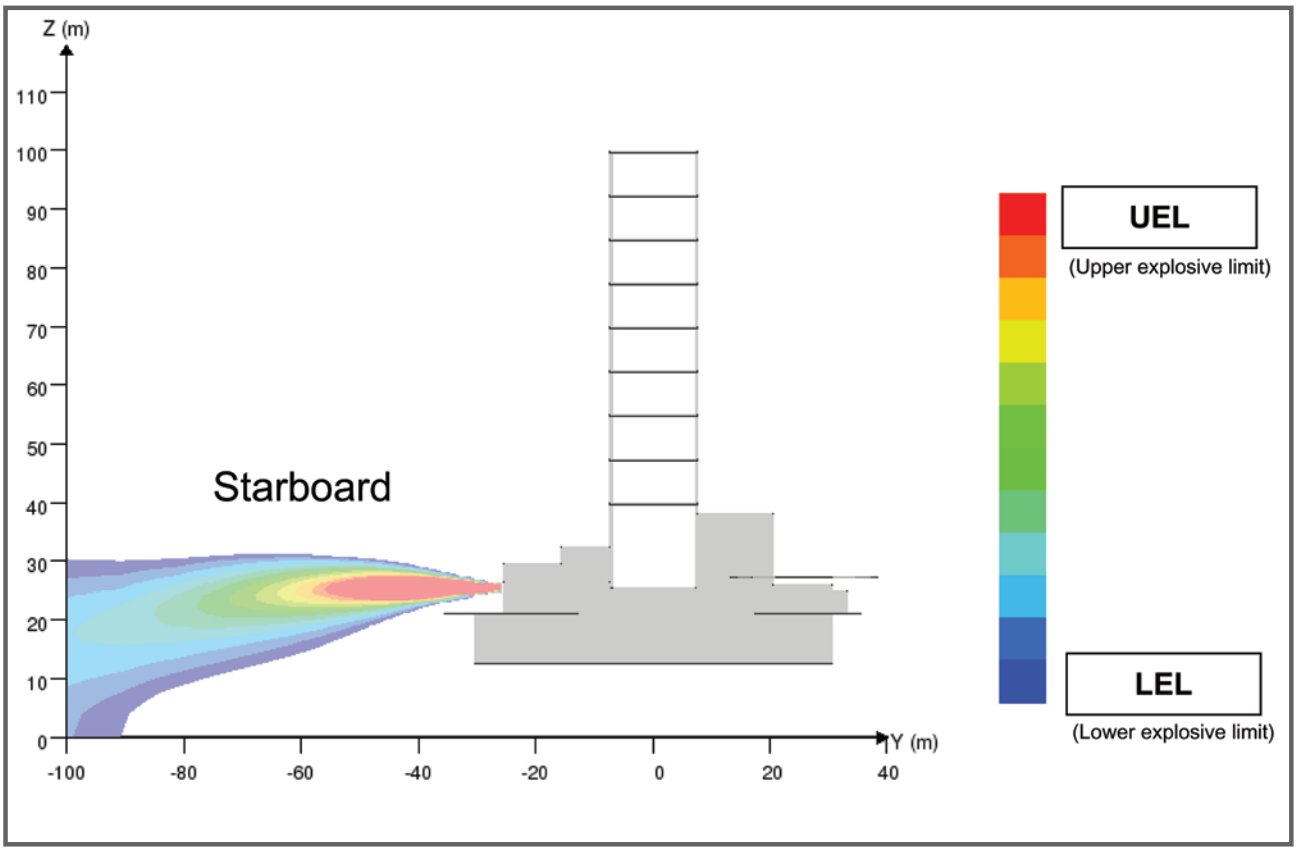
The investigation team has also concluded that if the well had been lined up to the starboard diverter rather than the MGS, the majority of the gas would have been diverted safely overboard. The pressure increase during the blowout may still have caused a failure of the riser slip joint seals, which would have allowed gas onto the rig floor through the moon pool. However, the majority of the gas would probably have vented through the starboard diverter, reducing the likelihood of hydrocarbons reaching an ignition source and may have reduced the consequences of the event.

Figure 16 shows the likely vapor dispersion pattern based on the orientation of the rig and the prevailing wind conditions on the evening of the accident.

Figure 16. Vapor Dispersion Case for Diverting to the Starboard Diverter.

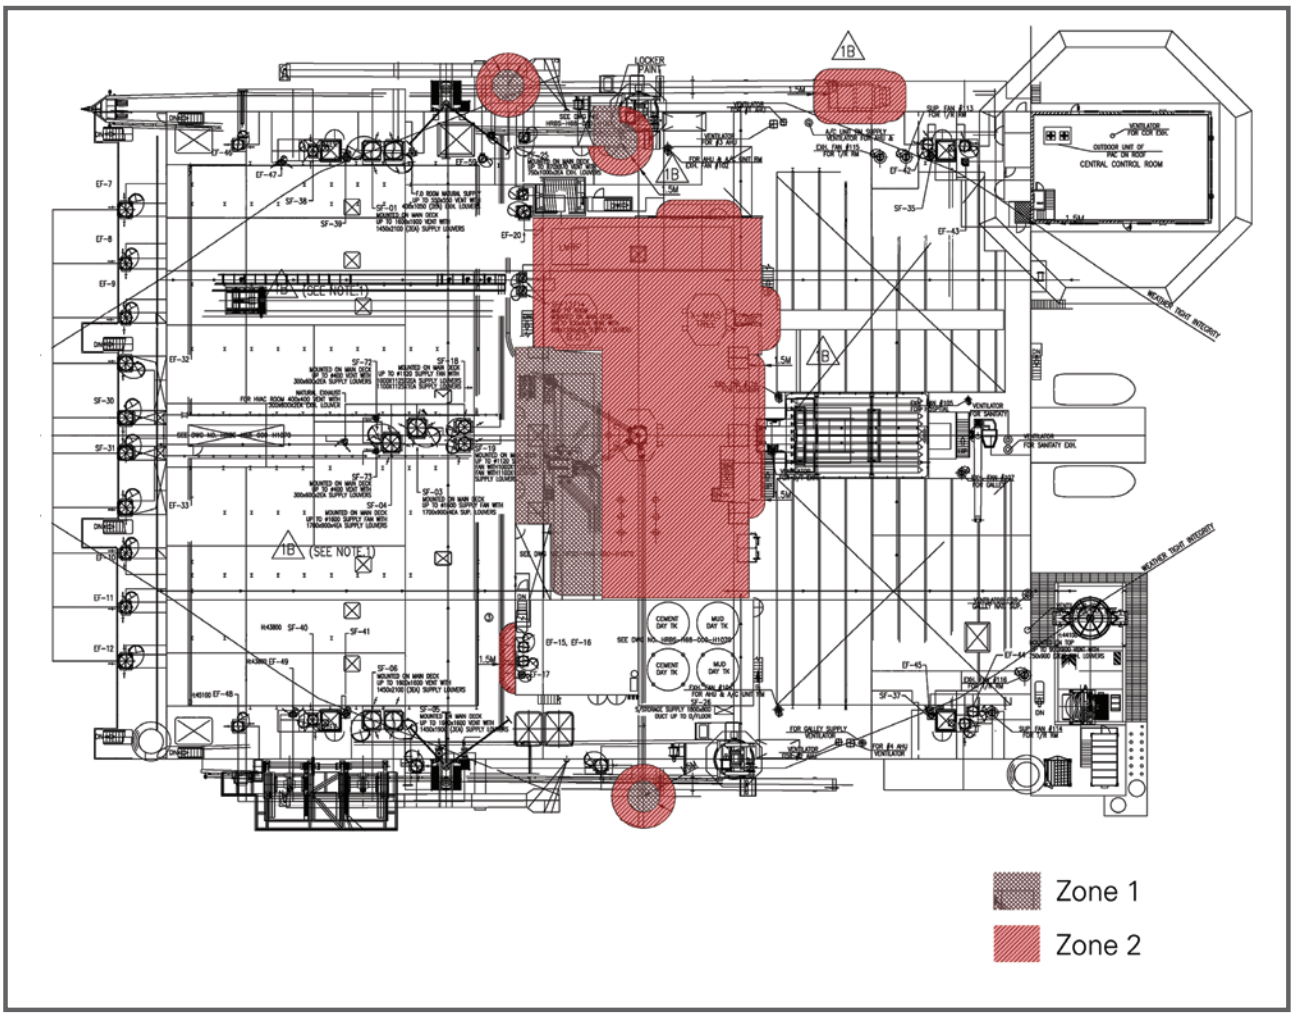
The extent of electrically classified areas on *Deepwater Horizon* appeared to be consistent with normal industry practices; however, for gas release events beyond the drill floor, multiple ignition sources could have existed. (Refer to Figure 17.)

Figure 17. Hazardous Area Classification—Main Deck.

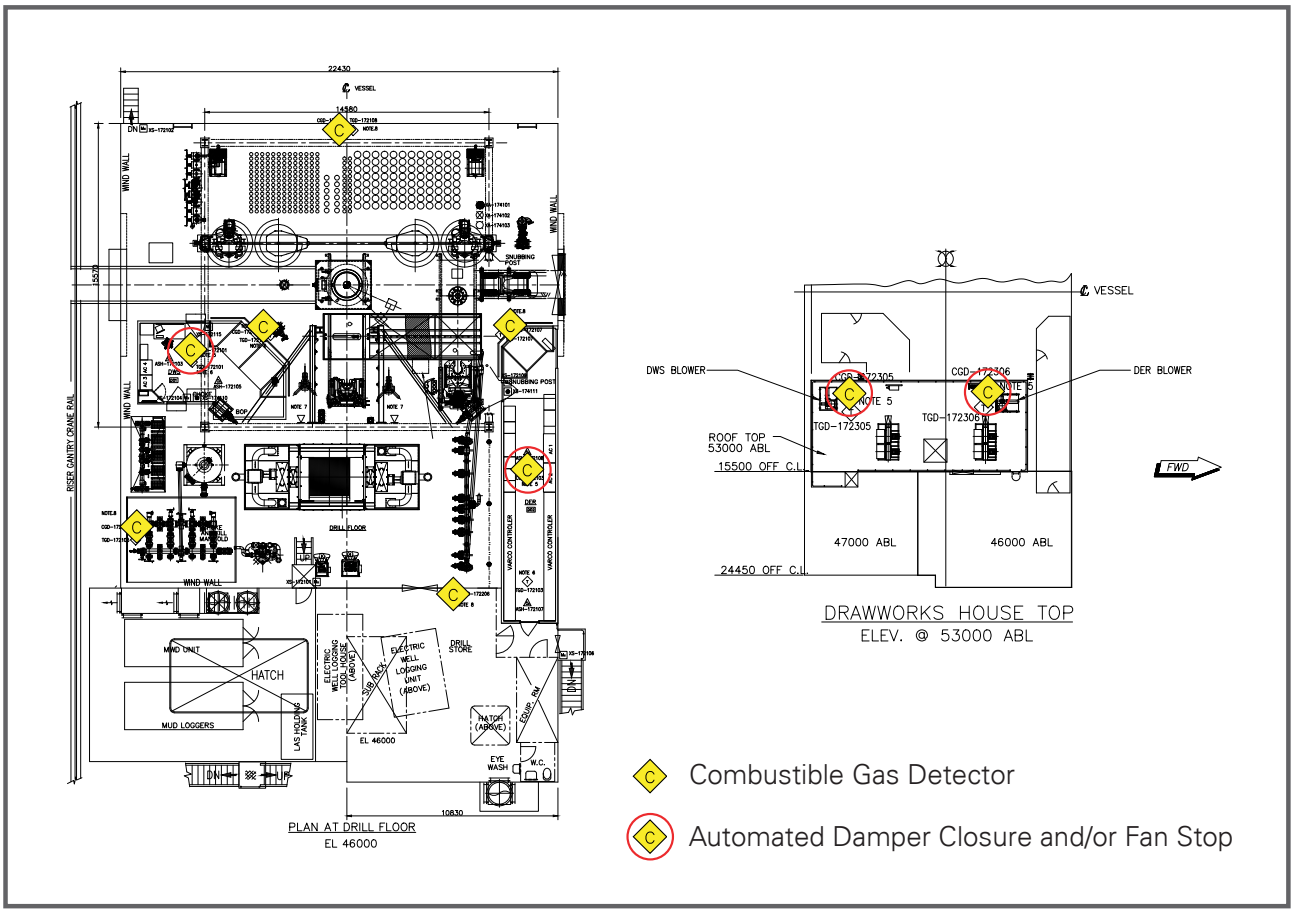
The design of the gas detection system was apparently based on a single CGD at each location. Such a system lacks the redundancy levels associated with a high-reliability design. If a single CGD did not work, was inhibited or was out of commission, the protective functions provided by that device would have been lost. Preliminary analysis of available maintenance records and a recent third party condition assessment indicated that gas detectors were adequately tested and maintained.

The physical locations of the CGDs are shown in *Figure 18* (drill floor and above), *Figure 19* (second deck) and *Figure 20* (main deck). These figures show the 13 CGDs that had automated actions and the 14 CGDs that did not.

Figure 18. CGD Locations—Drill Floor and Above.

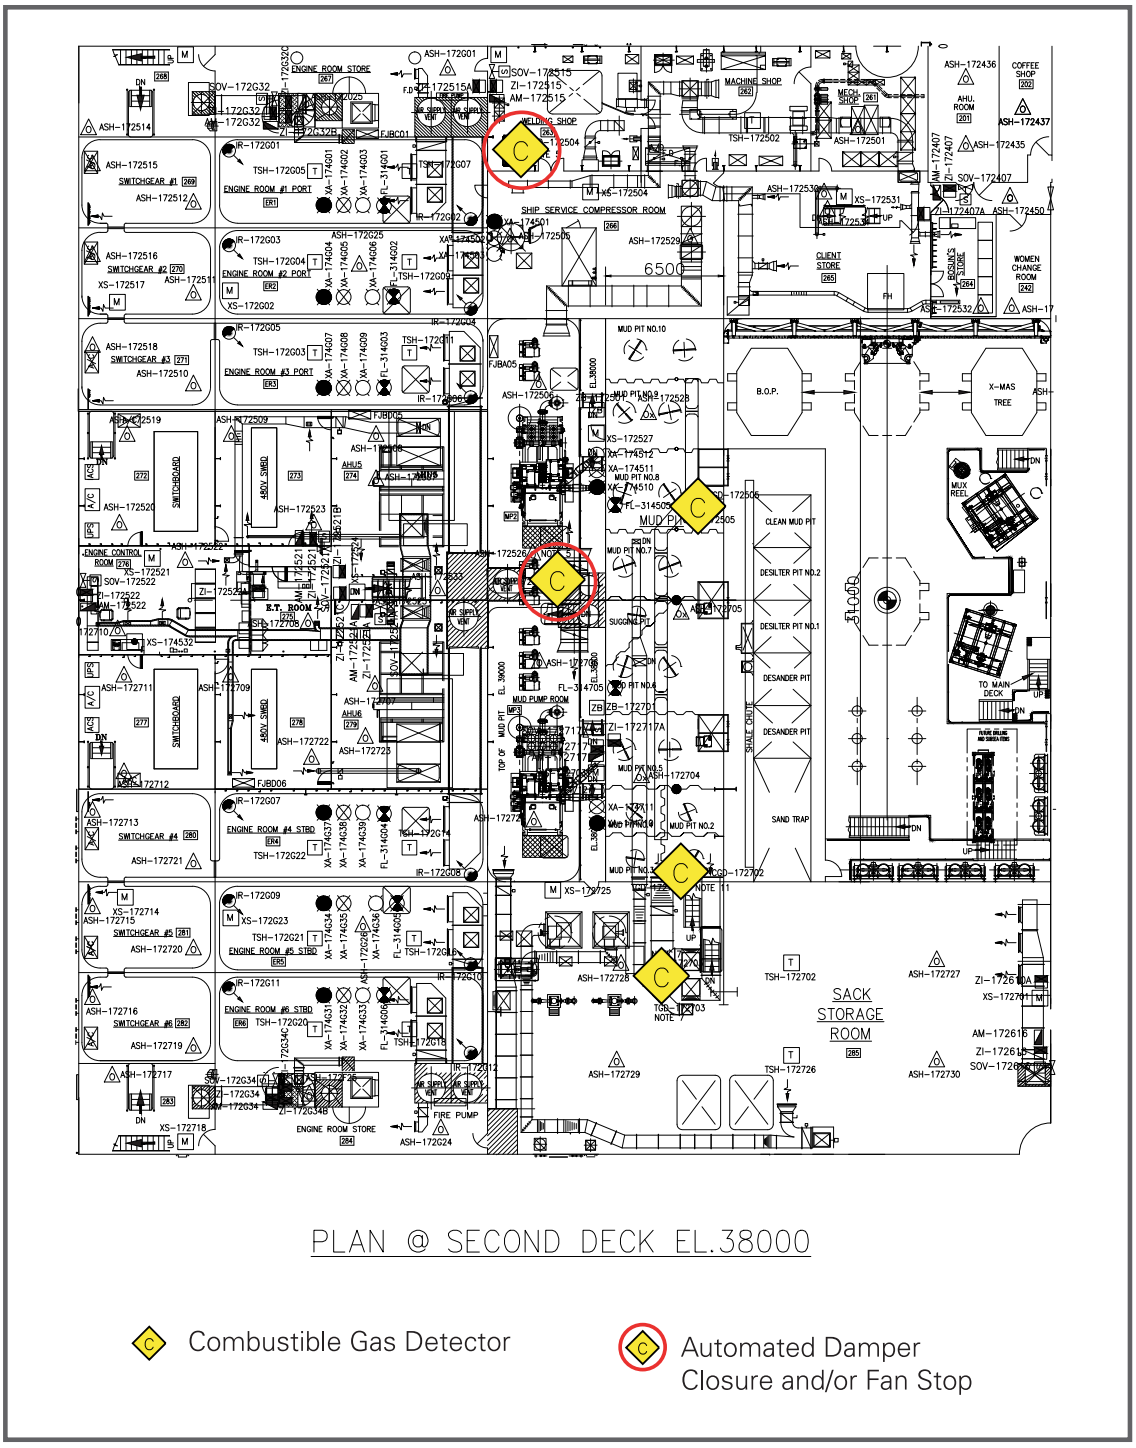
Figure 19. CGD Locations—Second Deck.

The mud pump rooms on the second and third decks were supplied with air from the main deck by two fans located under the aft catwalk. (Refer to Figure 21.) Exhaust was provided by two fans that were also located on the aft deck. (Refer to Figure 21.) According to the C/E matrix in the *MOM*, automated actions should have closed the fire dampers and shut down the ventilation fans to the mud pump rooms upon high-level gas detection. The relevant CGDs were located near the ventilation fan intake on the main deck and in the mud pump room. (Refer to Figure 20 and Figure 19.)
