Deepwater Horizon Accident Investigation Report

September 8, 2010

This is the report of an internal BP incident investigation team. The report does not represent the views of any individual or entity other than the investigation team. The investigation team has produced the report exclusively for and at the request of BP in accordance with its Terms of Reference, *and any decision to release the report publicly is the responsibility of BP. It has not been prepared in response to any third party investigation, inquiry or litigation.*

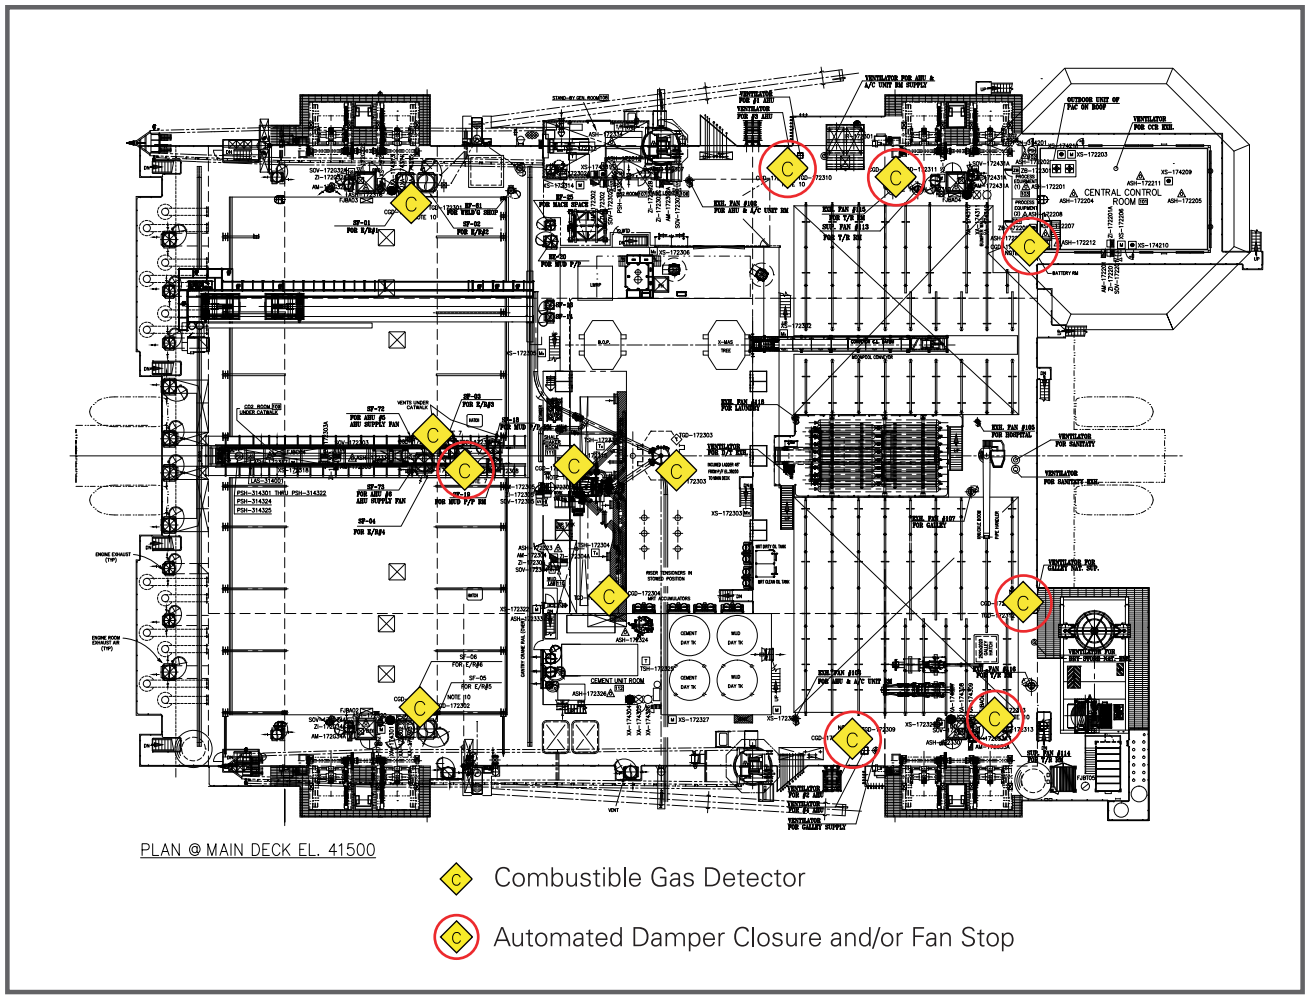
The physical locations of the CGDs are shown in *Figure 18* (drill floor and above), *Figure 19* (second deck) and *Figure 20* (main deck). These figures show the 13 CGDs that had automated actions and the 14 CGDs that did not.

CGDs were located near the supply intakes for all the engine rooms, but these CGDs did not have associated automated actions to prevent gas ingress to the engine rooms. Therefore, the investigation team concluded that the HVAC system may have transferred gas into the engine room enclosures.

Figure 20. CGD Locations—Main Deck.

The mud pump rooms on the second and third decks were supplied with air from the main deck by two fans located under the aft catwalk. (Refer to Figure 21.) Exhaust was provided by two fans that were also located on the aft deck. (Refer to Figure 21.) According to the C/E matrix in the *MOM*, automated actions should have closed the fire dampers and shut down the ventilation fans to the mud pump rooms upon high-level gas detection. The relevant CGDs were located near the ventilation fan intake on the main deck and in the mud pump room. (Refer to Figure 20 and Figure 19.)

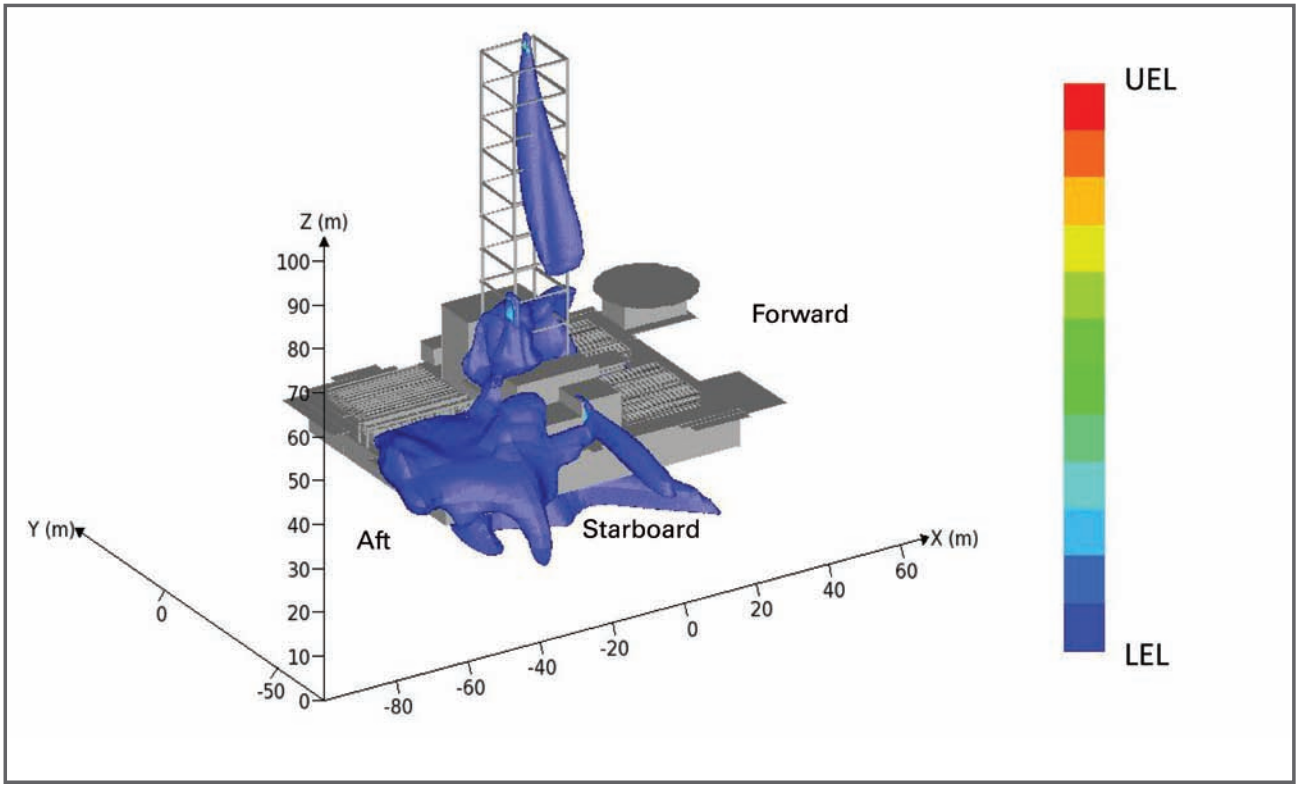
Although the F&G system visual and audible alarms were automatically triggered upon gas detection, there were no automated actions to close the fire dampers or shut down the engine room ventilation fans. *Figure 22* shows the modeled vapor dispersion cloud across the aft main deck 190 seconds after gas reached the surface. Gas would probably have reached the engine room HVAC fans and been transferred into the enclosures for engine rooms #3, #4, #5 and #6.

Figure 22. Vapor Dispersion Aft Deck—190 Seconds.

A review of personnel injury locations (including fatalities) and facility damage accounts suggested that one likely epicenter of the explosion was in the starboard aft quadrant; this corresponded to the area of the rig containing engine rooms #3 and #6 (the running engines) and the mud pump rooms. The initial vapor release probably reached the HVAC intakes in this area. (Refer to Figure 22.)

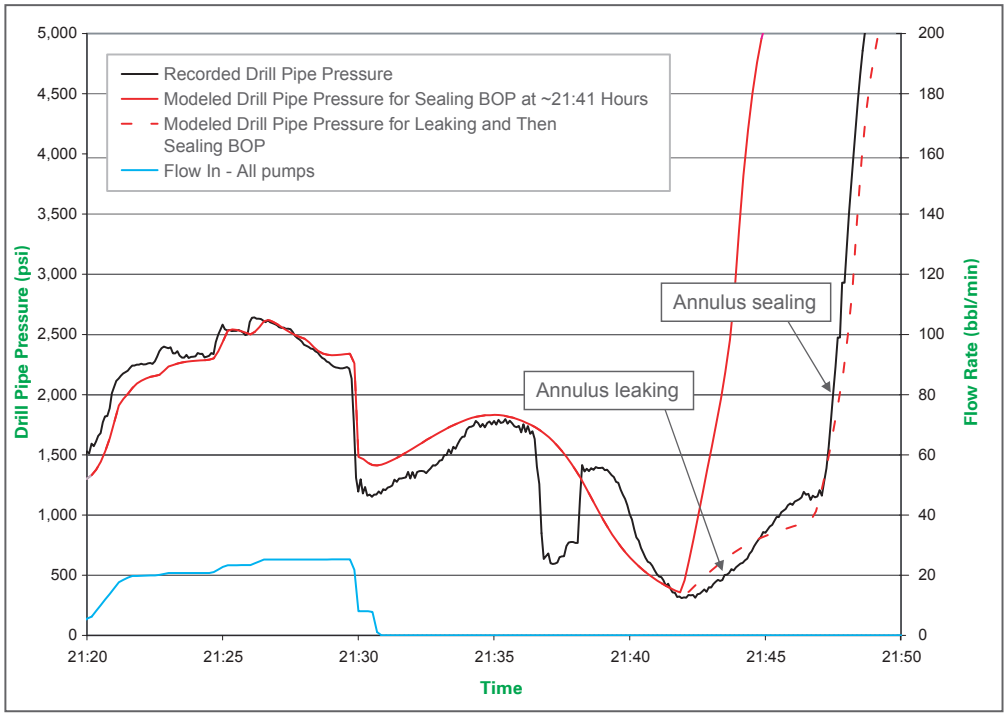
The recorded surface data, from approximately 21:41 hours to 21:49 hours on April 20 (the time at which Sperry-Sun real-time data stopped transmitting), is critical to understanding the BOP operation prior to the explosions. The data suggests that the normal mode of BOP operation sealed the annulus less than 2 minutes prior to the loss of data transmission just before the explosions. (Refer to *6. Modes of BOP Operation* of this analysis, which provides a discussion of BOP normal and emergency modes of operation.) The BOP closed, but it was slow to seal. Based on the evidence and analysis to date, it is not certain which BOP components were operated to seal the annulus prior to the explosions. It is likely that a variable bore ram (VBR) eventually sealed the annulus.

As established in *Analysis 5B.*, the rig crew activated the BOP at approximately 21:41 hours. *Figure 1* shows the results from the OLGA® well flow modeling of the BOP as activated at 21:41 hours and closing and sealing the annulus in 30 seconds (solid red curve). (Refer to *Appendix W. Report–Dynamic Simulations* Deepwater Horizon *Incident BP.*) However, the recorded drill pipe pressure (solid black curve) indicates that the annulus was sealed approximately 5 minutes later than the OLGA® well flow modeling predictions. Further OLGA® well flow modeling of the BOP closing in 30 seconds, but allowing leakage past the annular preventer for 5 minutes before fully sealing the annulus, resulted in a drill pipe pressure (dashed red curve) that closely followed the recorded pressure. This analysis indicates that the BOP closed within the expected time, but it did not fully seal for another 5 minutes.

Figure 1. Drill Pipe Pressure—OLGA® Well Flow Modeling of Drill Pipe Pressure for a Closing BOP Versus Recorded Data.

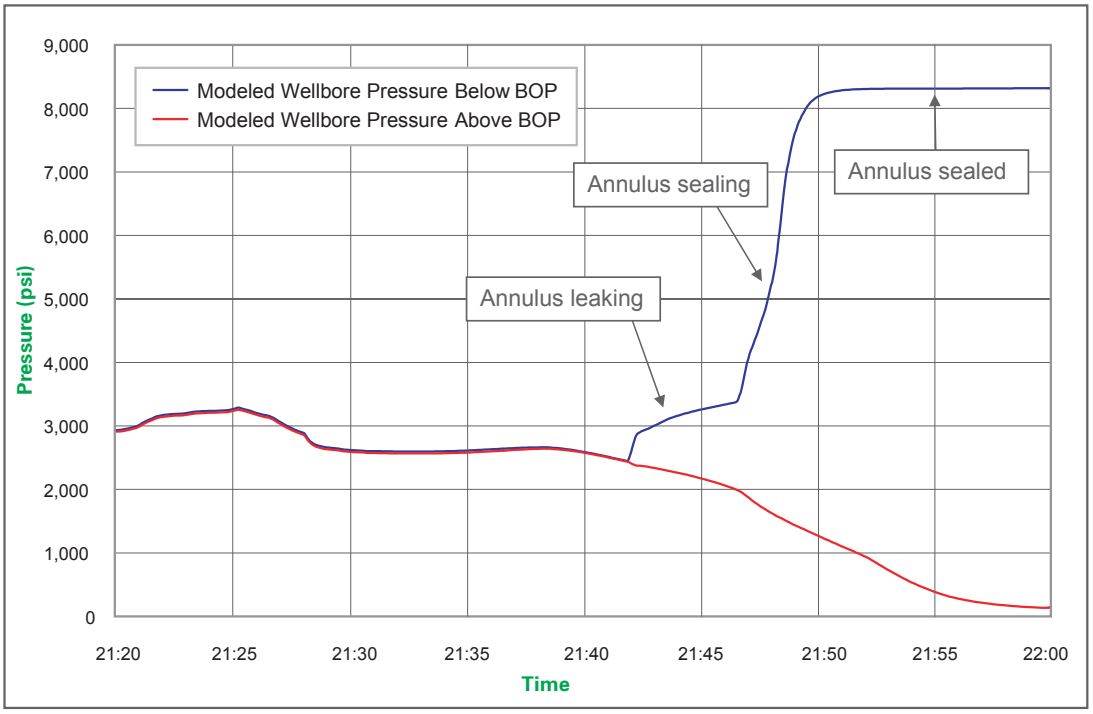
Wellbore pressure simulation using OLGA® well flow modeling indicates a differential pressure across the annular preventer of over 8,000 psi after the annulus was sealed. (Refer to Figure 2.) Given that the lower annular preventer was rated at 5,000 psi working pressure, it might not have held a differential pressure of over 8,000 psi. It is therefore less likely that the lower annular preventer would have sealed the annulus.

Figure 2. OLGA® Well Flow Modeling of Wellbore Pressure for a Leaking and Sealing Annular Preventer.

The annular preventer likely leaked for 5 minutes before the annulus was sealed. Given this finding combined with the evidence suggesting that at least one VBR could have been closed by the rig crew, it is likely that a VBR eventually sealed the annulus. (Refer to *4.1* of this analysis.) However, events subsequent to the explosion and fire could have impaired the integrity of the seal. (Refer to *4.2 Status of the Drill Pipe Across the BOP After the Explosion* of this analysis.)

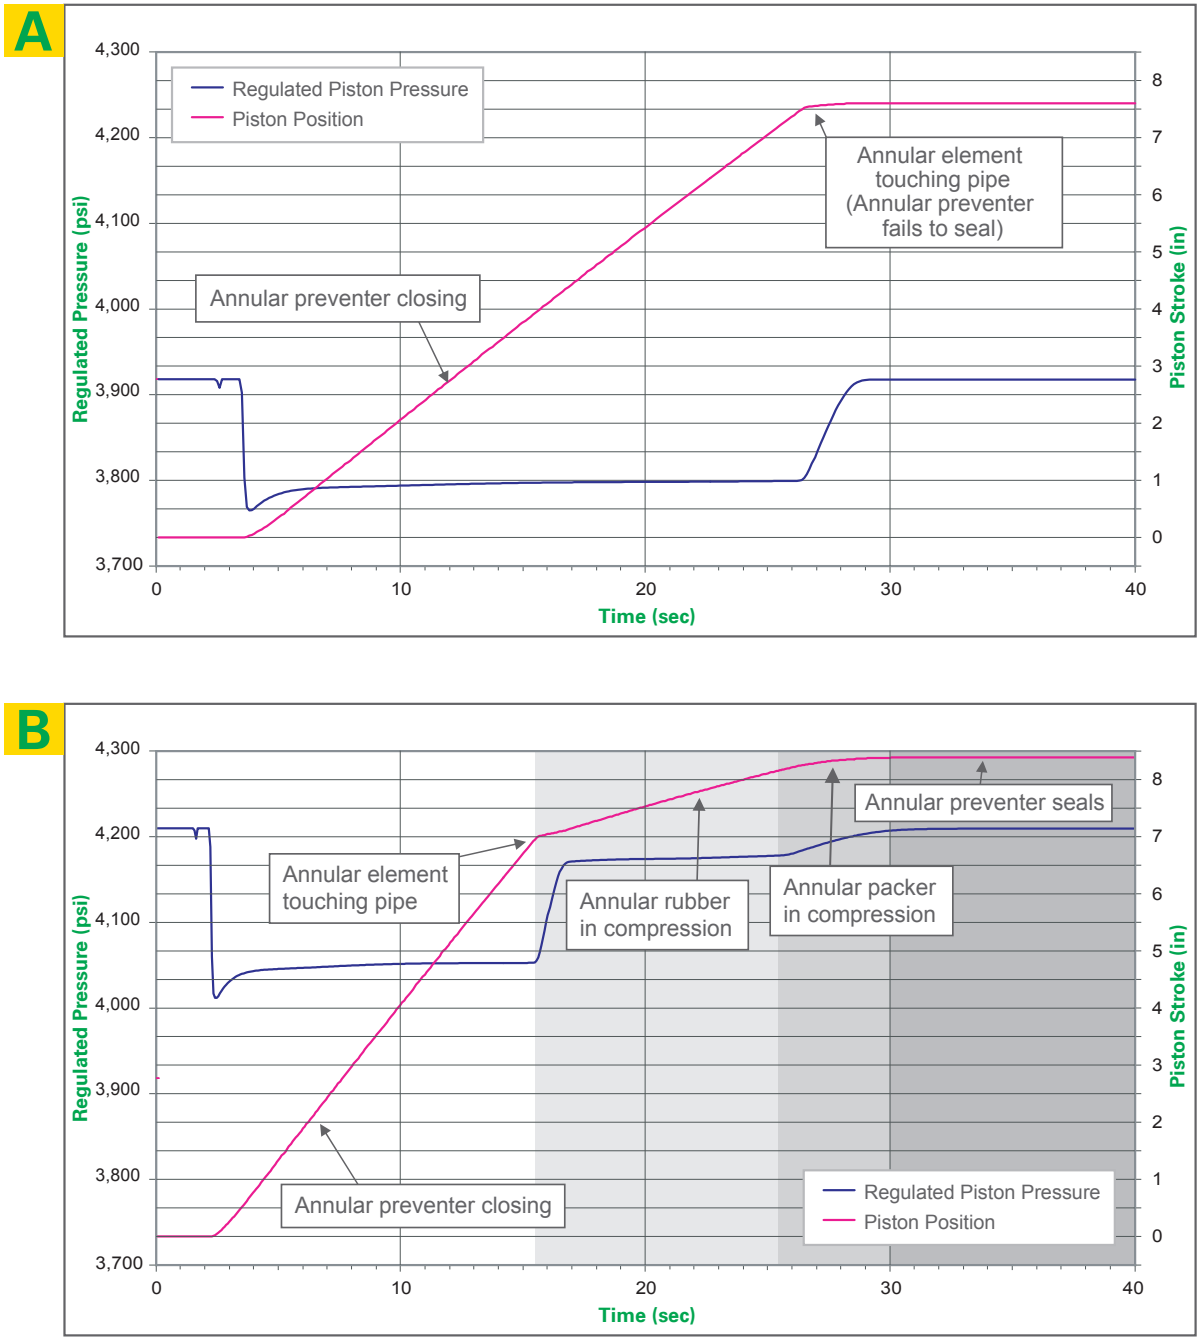
Figure 5 shows the dynamic response of an annular preventer at 5,000 ft. water depth (WD) operating under 1,700 psi and 2,000 psi regulated closing pressures. (Refer to Figure 5.) (Hydraulic pressures in this analysis are quoted in terms of differential pressure, which is the difference between the hydraulic system pressure and the hydrostatic pressure at the sea bed.) The wellbore pressure at the time of the closure of the annular preventer was approximately 2,500 psi. To represent an annular preventer closing in a flowing condition, the simulated pressure in the BOP was increased from 2,500 psi to the shut-in pressure of approximately 8,000 psi as the annular preventer elastomeric element was about to touch the drill pipe.

The dynamic response of the annular preventer operating under 1,700 psi regulated pressure indicated that the annular preventer failed to seal due to rapid increase in wellbore pressure as shown in *Figure 5(A)*. Hydraulic analysis further indicates that an annular preventer would seal around the pipe under a regulated pressure setting of 2,000 psi, as shown in *Figure 5(B)*.

Figure 5. Hydraulic Analyses of an Annular Preventer.
(A) Regulated Pressure of 1,700 psi.
(B) Regulated Pressure of 2,000 psi.
(All pressures in the figure include hydrostatic head at the seabed.)

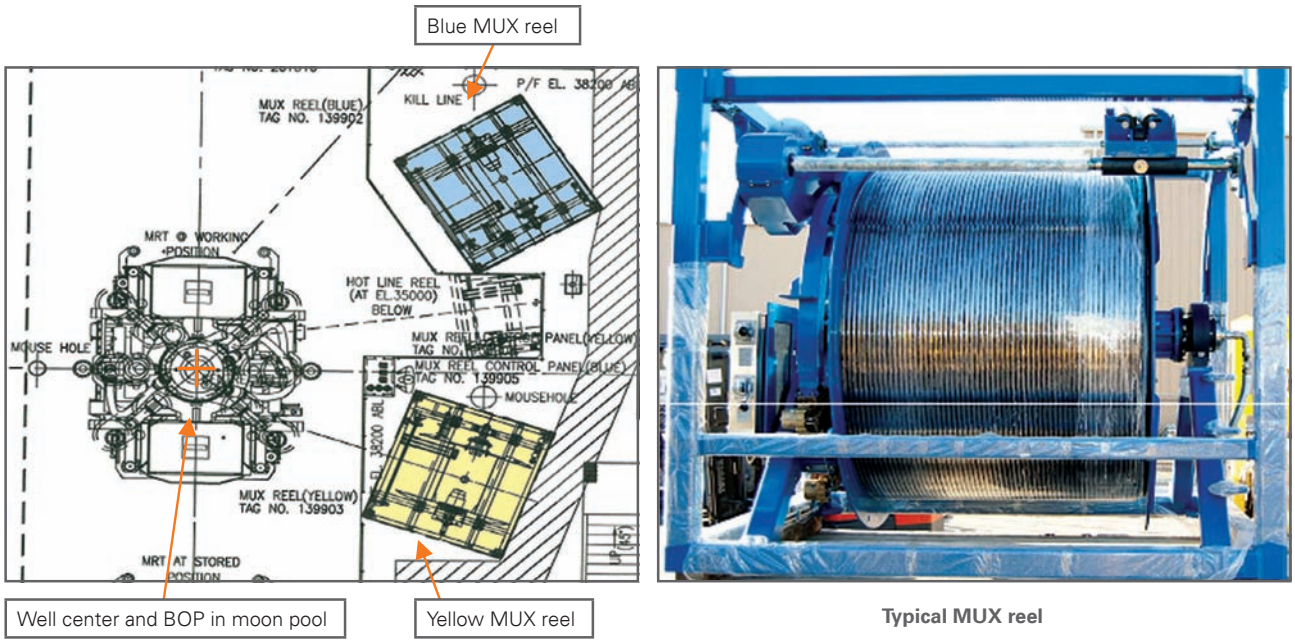
Figure 6. Moon Pool Layout Showing the Location of Blue and Yellow MUX Reels.

The MUX reels were located in the moon pool area within the explosion and fire zone. (Refer to Figure 6.) Since the MUX cables were not protected against explosions or fire, it is very likely that the early explosion and fire damaged the MUX reel slip rings and the cables to the extent that the communication line and electrical power required to initiate the high-pressure BSR and EDS functions were no longer available.

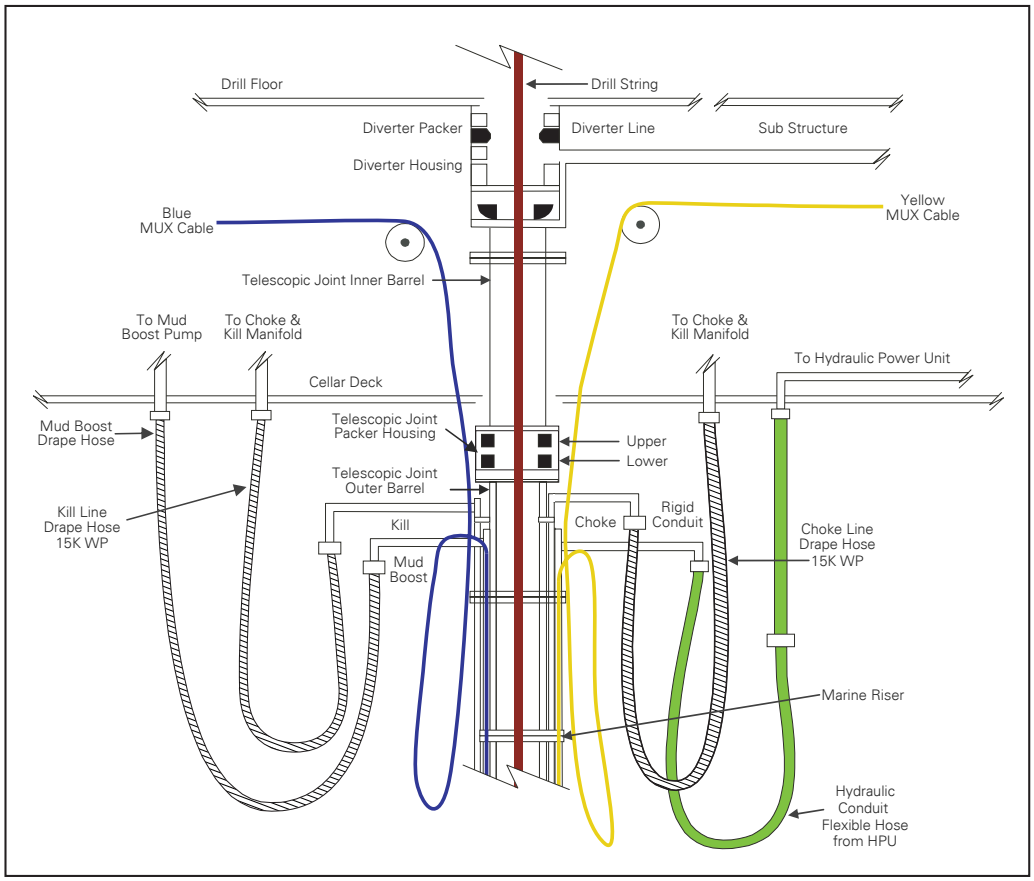
The AMF sequence is initiated when electrical power, communications and hydraulic pressure are lost to both pods. To initiate an AMF, all three services must fail (i.e., after damage to the MUX reels or cables and to the hydraulic conduit, caused by explosions and fire). As indicated in *3.1* of this analysis, the MUX cables, which carry electrical power and communications, were vulnerable to explosion and fire damage. Though the hydraulic conduit flexible hose was less vulnerable to damage than the MUX cables, it was located close to the MUX cables in the moon pool and could have been damaged by the explosions and fire. (Refer to Figure 7.)

Figure 7. Typical Configuration of Flexible Hoses in the Moon Pool. (Hydraulic conduit flexible hose is shown in green).

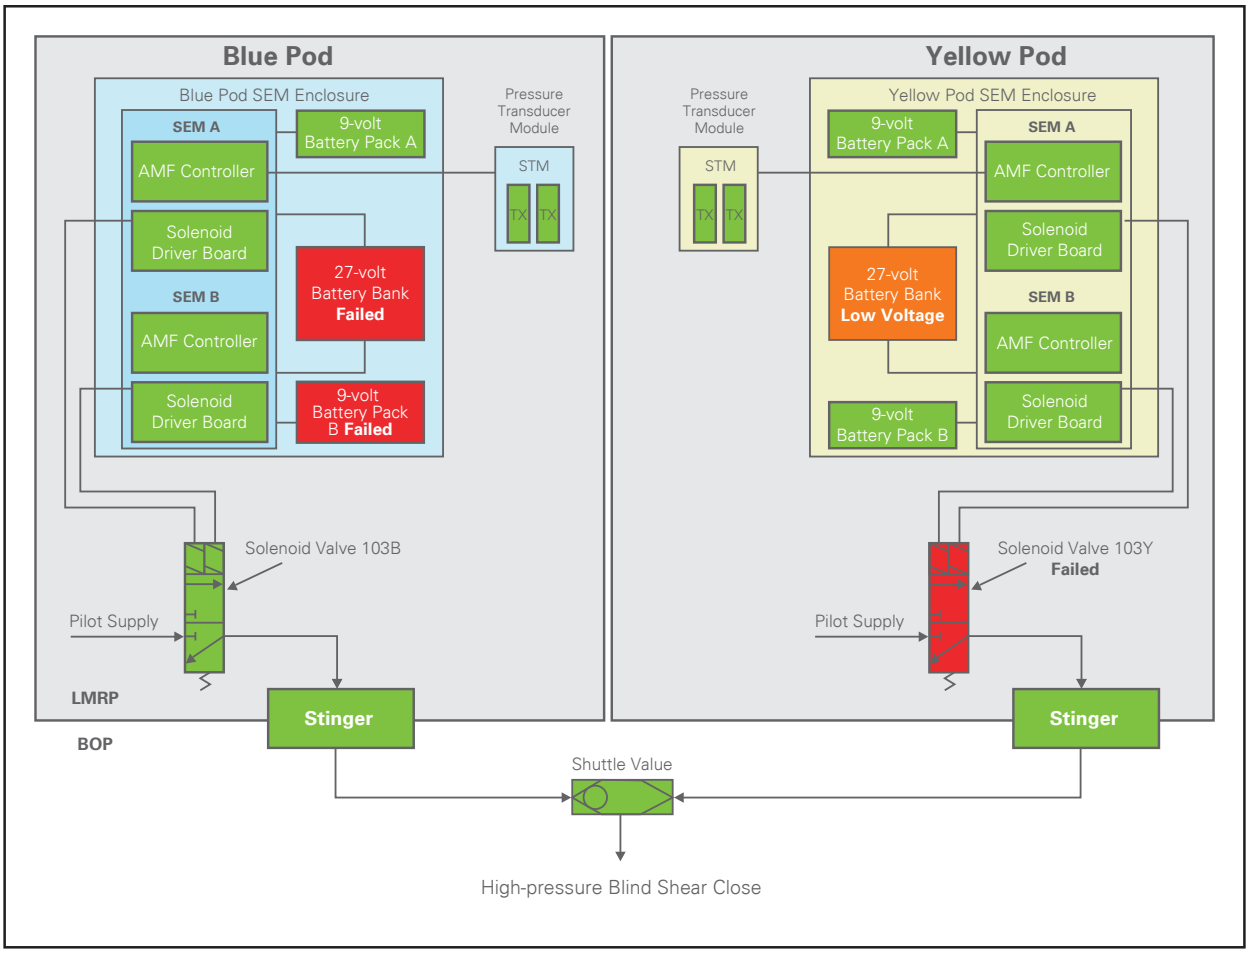
During the yellow pod test performed by Transocean and Cameron after the accident, both coils on solenoid valve 103 failed to energize, suggesting electrical coil faults. The investigation team found no evidence that this failure occurred after the accident; rather, the team concluded that this failure condition very likely existed prior to the accident. (Refer to *5.1 Maintenance* of this analysis.) A faulty solenoid valve 103 would mean that the yellow pod could not have performed the AMF sequence, as no pilot

Figure 8. Simplified Schematic of the AMF Control System.

Figure 8 shows a simplified schematic of the AMF system. There were two 9-volt battery packs and a 27-volt battery bank (made up of 3 packs of 9-volt batteries connected in series) in each pod. These batteries were not rechargeable. The 9-volt AMF battery packs were used to power the AMF card processors. When the AMF was enabled, these batteries provided continuous power to the AMF cards. The 27-volt battery bank was used to provide power to the 24-volt rated AMF card relays, the pressure sensors and the solenoid valves that were used in the AMF sequence, including solenoid valve 103.

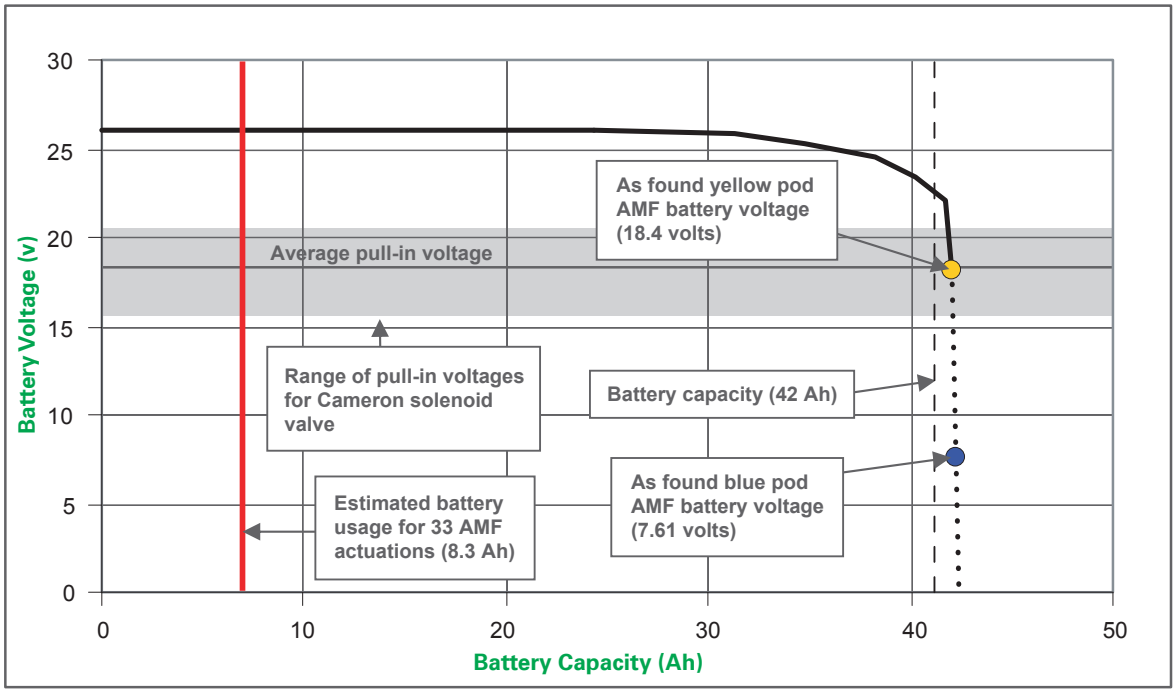
In 2004, Cameron, the BOP manufacturer, issued an engineering bulletin, *EB 891D,* recommending that battery banks be replaced after one year of operation or when the number of actuations exceeds 33 for that year, whichever comes first. The discharge curve for a 27-volt battery bank indicates that after 33 actuations, the battery bank would have expended only 20% of its expected life, as measured in ampere hours (Ah). The measured charge of 7.61 volts on the 27-volt battery bank was past the expected annual usage and was beyond the design life of the battery bank. (Refer to Figure 9 and *Appendix X.* Deepwater Horizon *Blue Pod AMF System Batteries*.)

The investigation team considers that it is very likely that the charge at the time of the accident would have been insufficient to activate the AMF.

The available maintenance records from 2001 to 2010 indicate that during this period, the AMF batteries were changed at a frequency less than the manufacturer's recommendation. The BOP control diagnostic functionality did not include measuring the charge on the AMF batteries. Transocean maintenance records for AMF batteries are discussed in *5.1* of this analysis.

Figure 9. Discharge Curve for a 27-volt AMF Battery Bank.

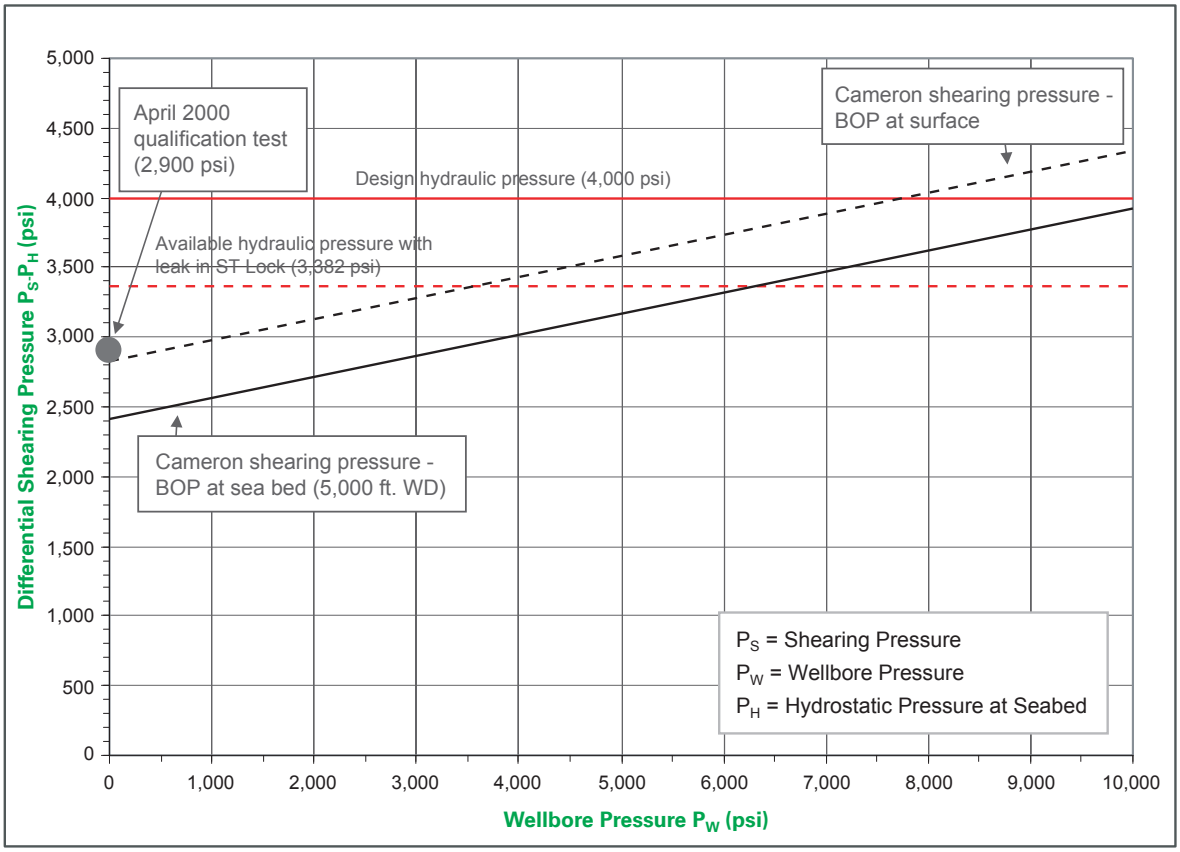
Figure 10. Shear Pressure Requirement for 5 1/2 in., 21.9 ppf, S-135 Drill Pipe.

Based on Cameron's shearing formula (*EB 702D, Revision B9*, dated January 21, 2008), the hydraulic pressure required to shear 5 1/2 in., 21.9 ppf, S-135 pipe at the surface is estimated as 2,840 psi. Cameron's shearing formula is plotted in *Figure 10* for varying wellbore pressures for a BOP at the surface (dashed black line) and a BOP at 5,000 ft. WD (solid black line). Shearing pressure is represented with respect to hydrostatic pressure at the sea bed. This formula takes into account the statistical variance in pipe wall thickness, material yield strength and ductility. A qualification test of *Deepwater Horizon* BOP BSRs was conducted at the surface in April 2000, when a joint of 5 1/2 in., 21.9 ppf, S-135 drill pipe was successfully sheared at a shearing pressure of 2,900 psi, which is slightly greater than the pressure predicted by Cameron's shearing formula.

It is not expected, therefore, that the increase in wellbore pressure would have been greater than 3,000 psi. *Figure 10* shows that at 4,000 psi design hydraulic pressure, the BSR should have been capable of shearing the 5 1/2 in. pipe. This assumes that there was no reduction in the available hydraulic pressure due to leaks or loss of BOP stack accumulator nitrogen pre-charge pressure.

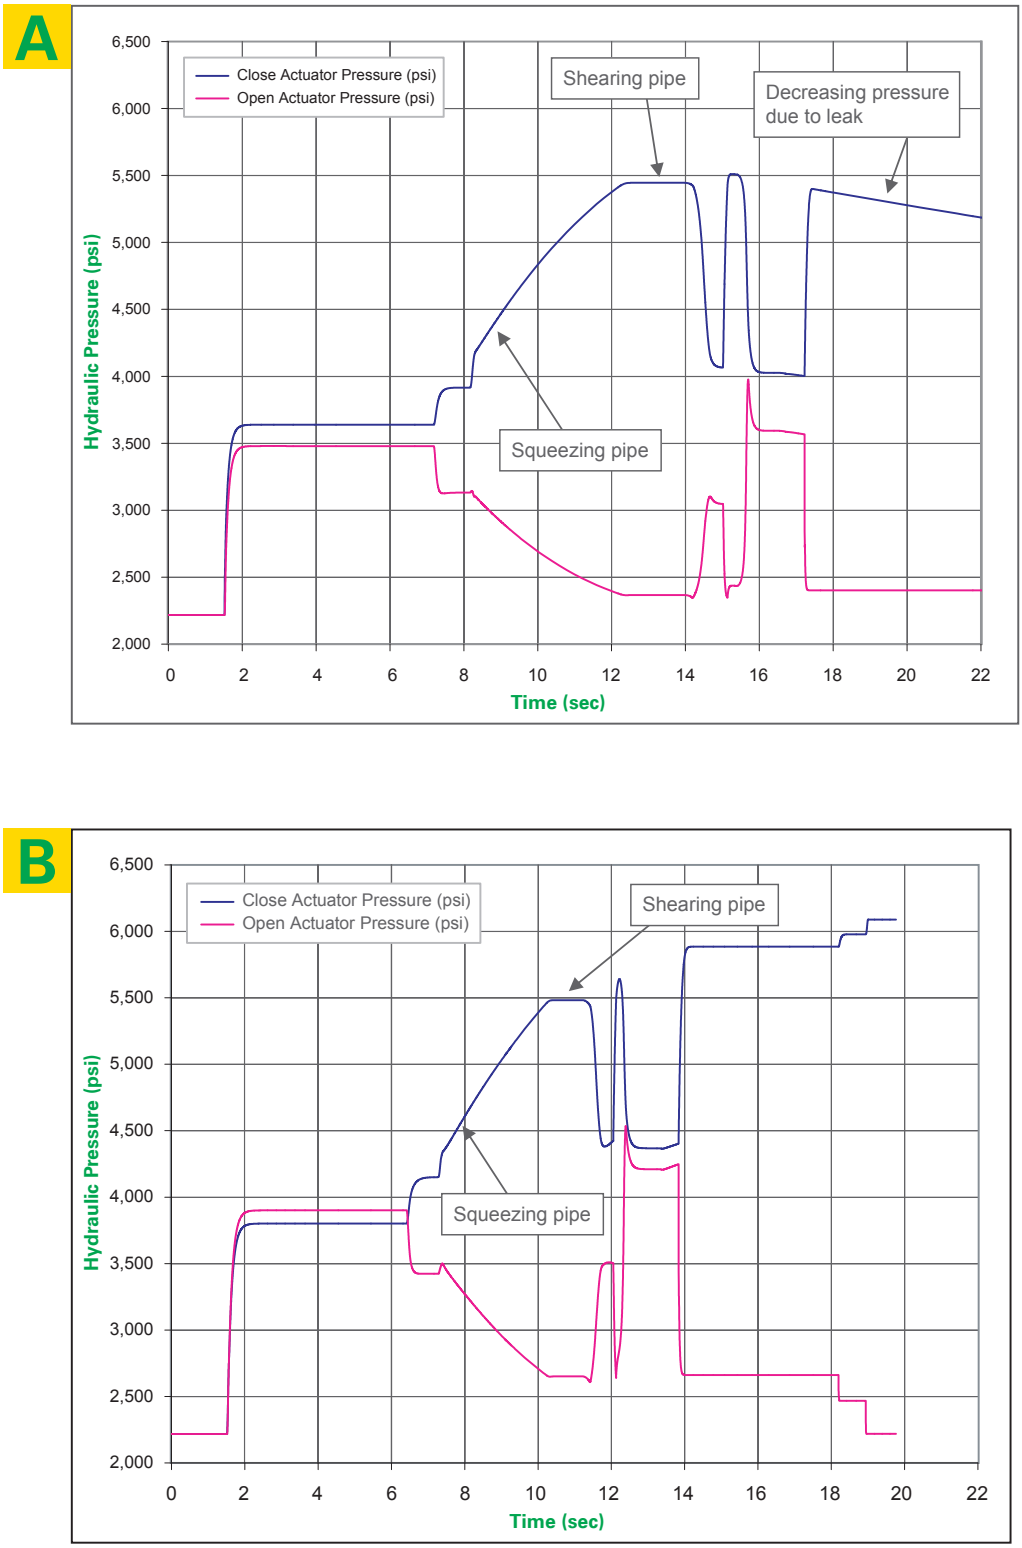
Figure 11 shows the responses of the BSR with and without a leak in the ST lock hydraulic circuit. The analysis assumes a pipe shearing pressure derived using Cameron's formula for 5 1/2 in., 21.9 ppf, S-135 pipe at a wellbore pressure of 3,000 psi. *Figure 11(B)* illustrates that without a leak, there was sufficient pressure to shear and seal the drill pipe. In comparing *Figure 11(A)* and *Figure 11(B)*, the impact of a leak is seen to increase the time it takes to build up hydraulic pressure in the actuator to be able to shear the pipe (12.5 seconds versus 10.5 seconds). However, even with the presence of the leak, sufficient hydraulic pressure was achieved to complete the shearing operation. With the leak, the overall shearing operation would have taken 17 seconds to complete, whereas without a leak, shearing operations would have finished in 14 seconds.

Figure 11. Hydraulic Analyses of BSR Closure Response (at a Wellbore Pressure of 3,000 psi and 5,000 ft. WD) **(A)** With and **(B)** Without a Leak in the ST Lock Hydraulic Circuit. (All pressures include hydrostatic head at the sea bed.)

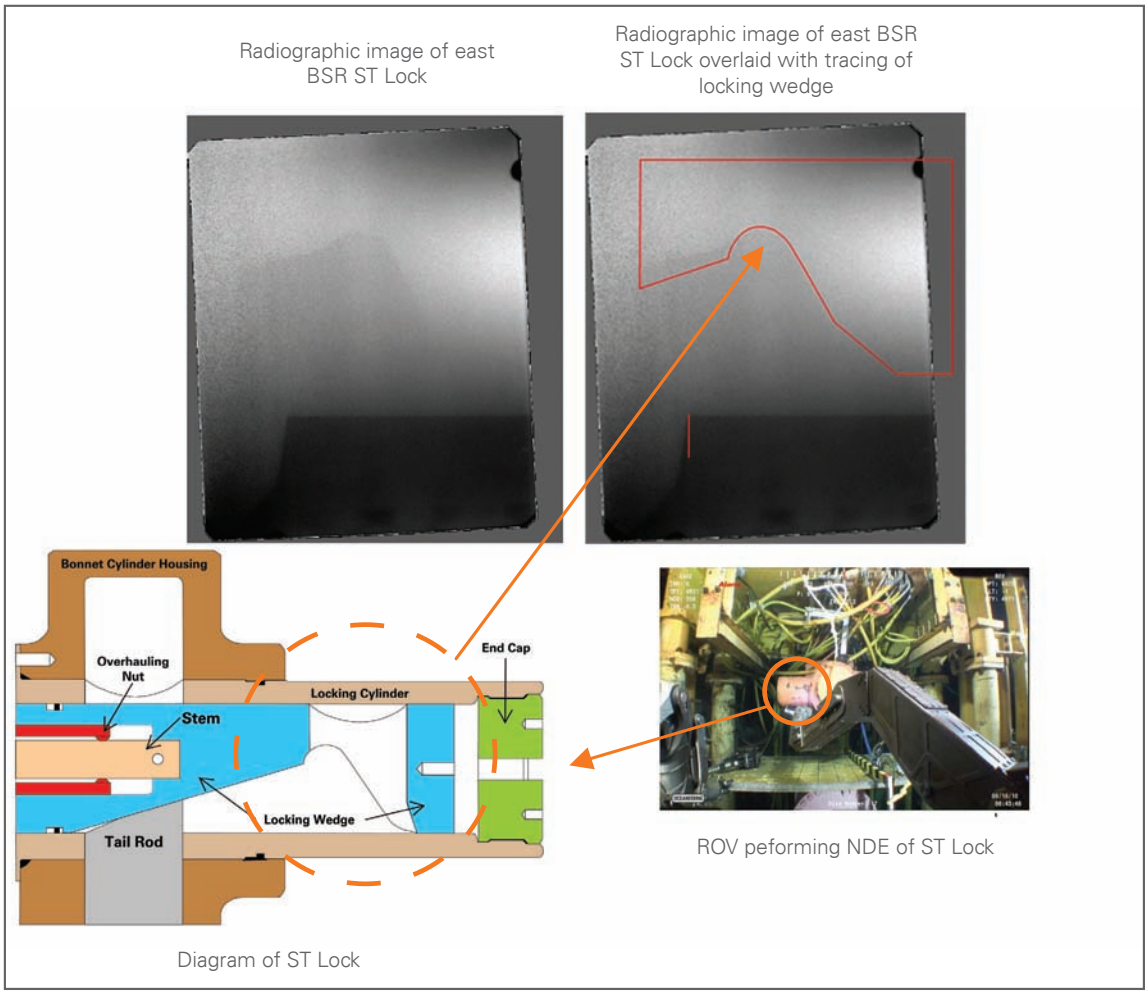
Figure 12. Radiograph Image of ST Lock in Closed Position Taken by ROV After the Accident.

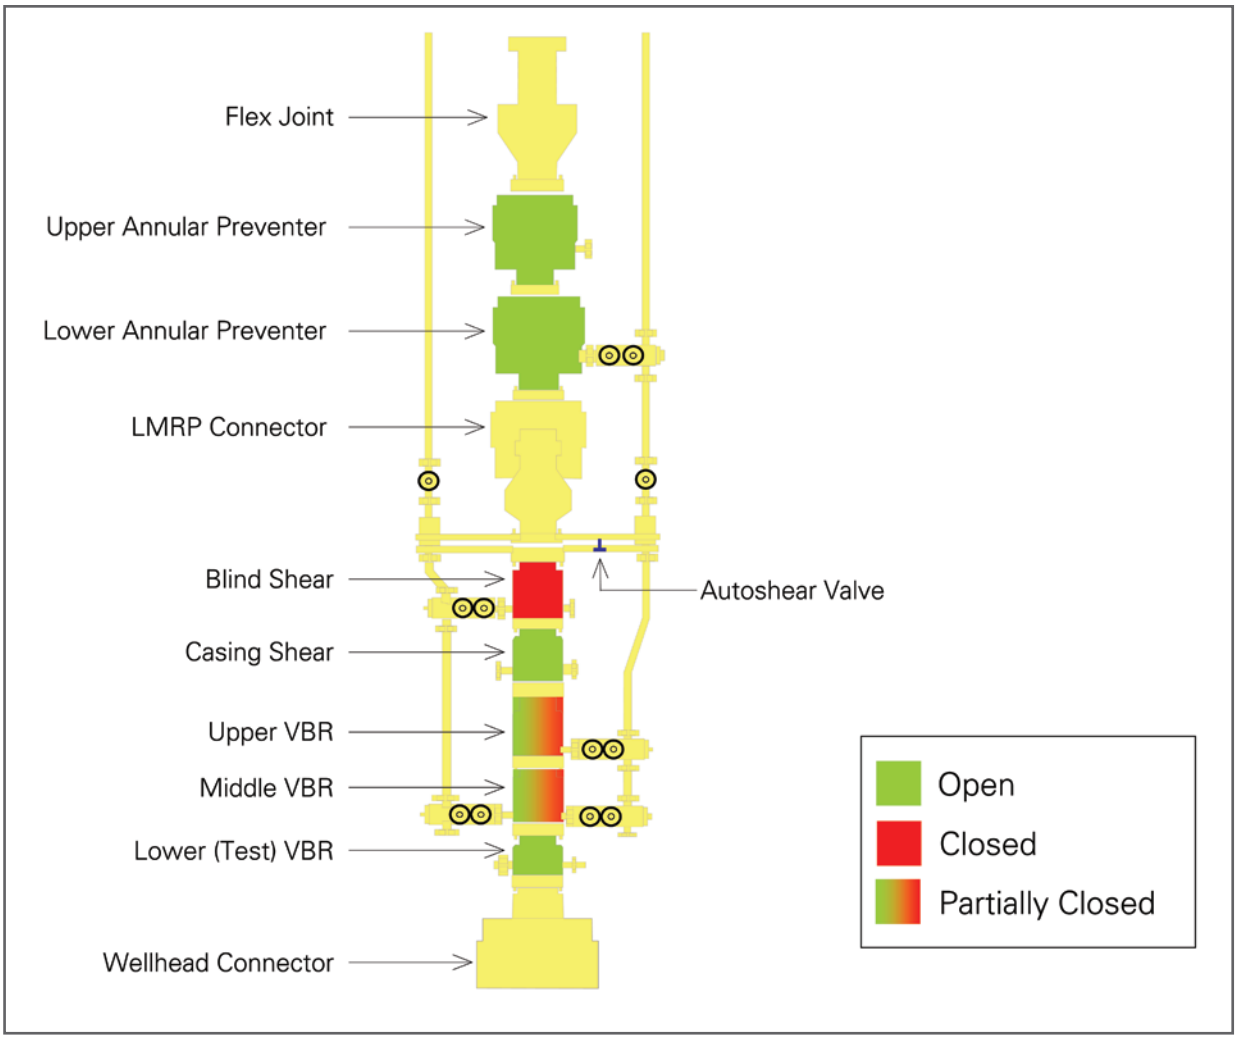
Based on these findings, the investigation team concluded that the upper, and possibly the middle, VBRs were likely closed by the rig crew.

Figure 13 shows the likely status of the BOP rams immediately after the initiation of autoshear.

Figure 13. Likely Status of BOP Rams Immediately After Autoshear Initiation.

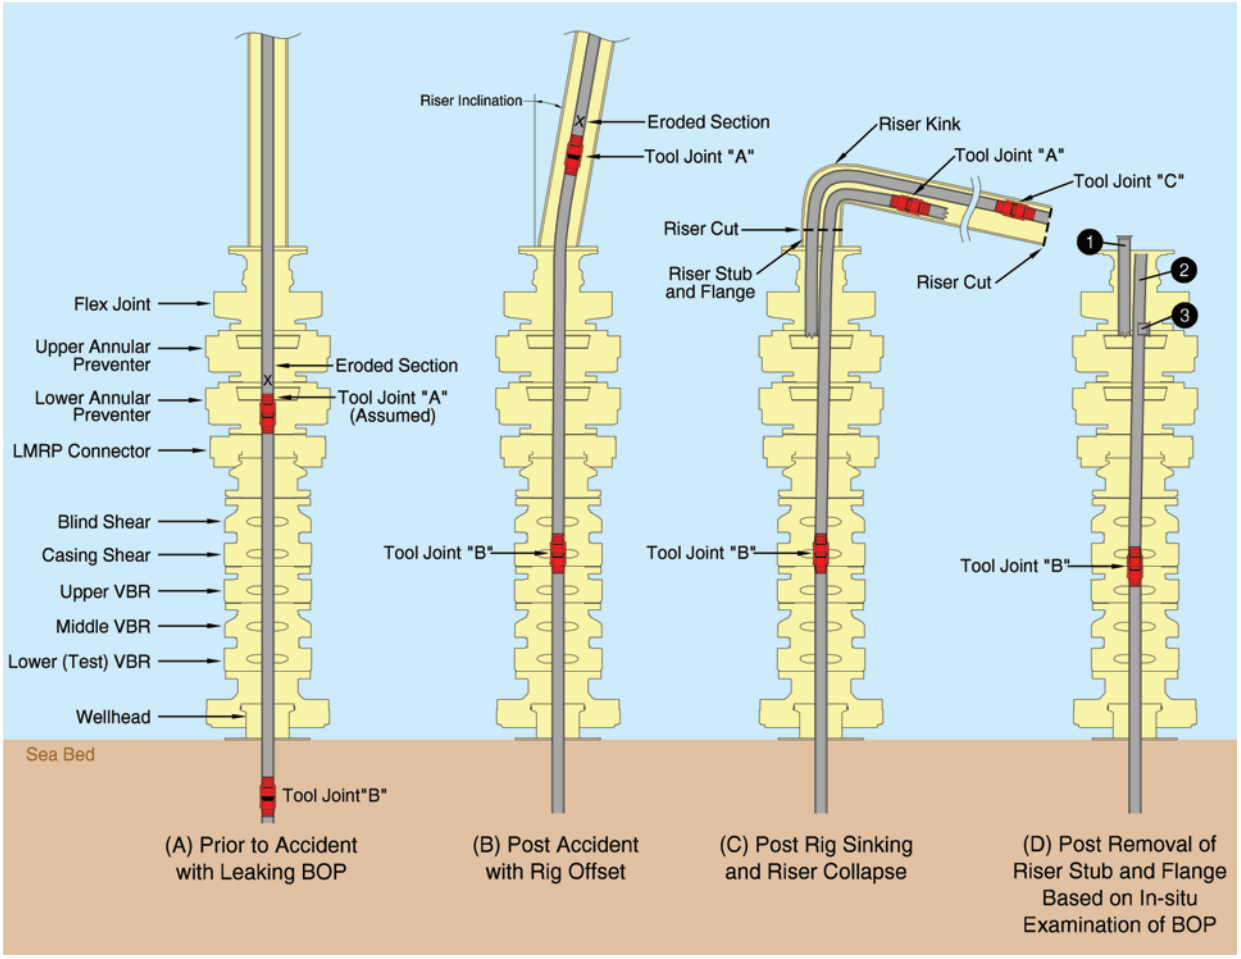
The investigation team determined that this erosion may have occurred when the section of pipe was in the BOP, where it experienced extremely high flow velocities during the leaking of a ram or annular preventer, indicating that this section of drill pipe was continuous through the BOP. The approximately 22 in. long erosion zone could suggest that the erosion event took place in an annular preventer.

Assuming the erosion took place at the lower annular preventer, the right-hand pipe must have moved by approximately 25 ft. This could have happened as the rig drifted off location after power was lost. (Refer to time period [B] in Figure 15.) The metocean records indicate that the current velocity at sea level at the time of the accident could have been above 0.69 ft./sec. The investigation team did not have access to the vessel's hydrodynamic characteristics in order to perform a drift-off analysis of the rig. However, it is likely that a current of this magnitude would have caused the vessel to drift off after the power was lost at approximately 21:49 hours.

Figure 15. A Schematic of Drill Pipe Configuration Across the BOP Over Time.

For the drill pipe to have moved upward by 25 ft., the next tool joint down the drill string (Tool Joint "B" in Figure 15 with an outside diameter of 7 in.), would have had to pass through the middle and upper VBRs. This could indicate that the ST locks were not operated when the rig crew likely attempted to close the VBRs, and the rams allowed the pipe to move upward through the BOP.

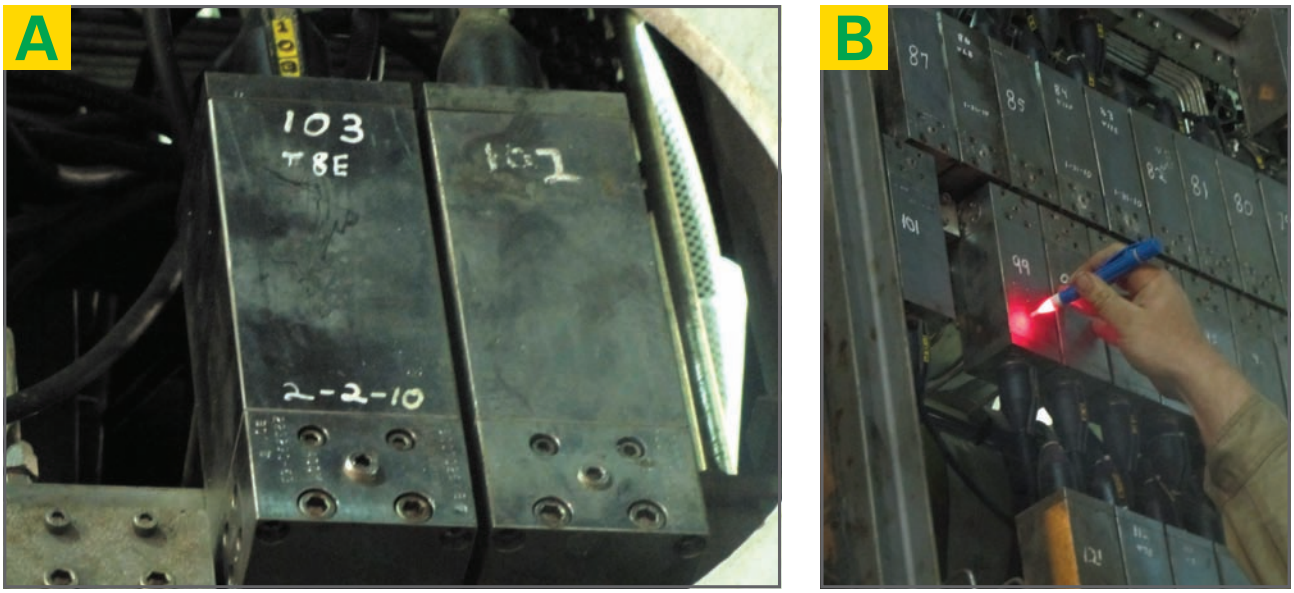
Figure 16. (A) Photograph of Solenoid Valve 103 in the Yellow Pod. **(B)** Testing of Solenoid Coils.

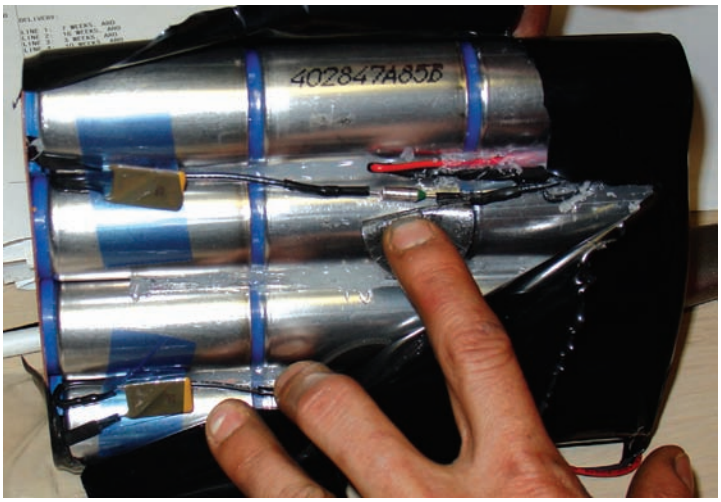
- The 27-volt AMF battery bank in the yellow pod (made up of three packs of 9-volt batteries), which was required to operate the AMF, had a charge of 18.41 volts. (Refer to Figure 17.) The battery bank discharge curve indicates that the battery bank voltage was already in rapid decline. (Refer to Figure 9.) While this charge was low, it was sufficient to complete the AMF sequence multiple times during tests conducted at the surface. During the August 23-27, 2010, MBI hearings, a subsea superintendent stated that the battery bank voltages were measured incorrectly (i.e., the 18.41-volt measurement) and that, prior to re-installing the yellow pod after it was retrieved, the voltages were rechecked and a battery bank voltage of 27 volts was measured.

Figure 17. Photograph of a 9-volt AMF Battery Pack. (Not from *Deepwater Horizon* BOP pod.)

- The 27-volt AMF battery bank in the blue pod, which was required to operate the AMF, was reported to have a charge of 7.61 volts, which was too low to complete the AMF sequence. The investigation team could not determine from the available maintenance records exactly when the batteries were last replaced.
- The charge on the 9-volt AMF battery pack for SEM B in the blue pod, which was required to power the SEM B AMF system, was reportedly measured to be at 0.142 volts (i.e., almost fully discharged).

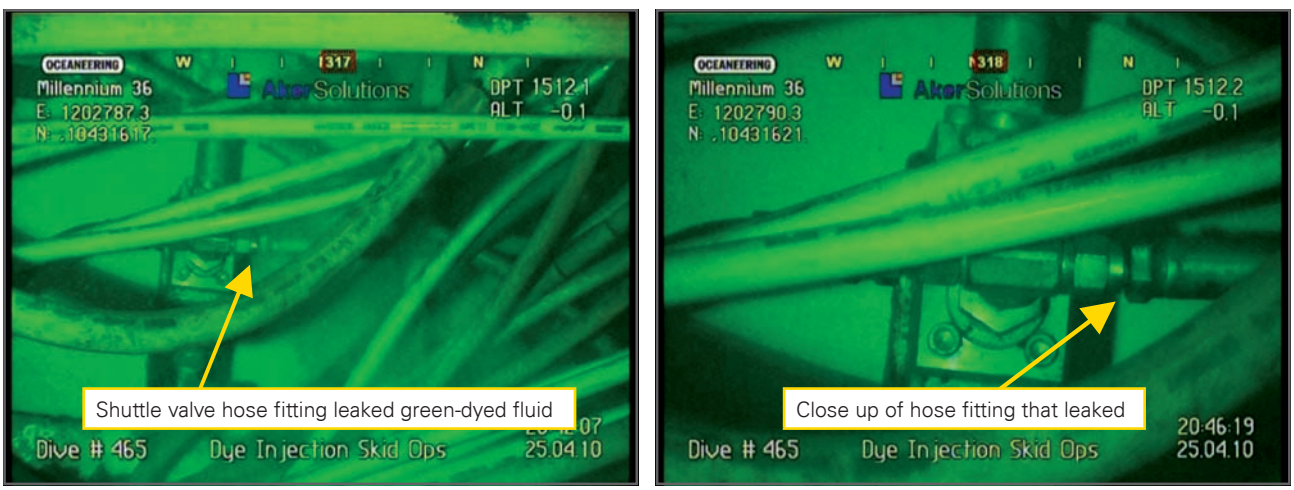
Figure 18. ROV Video Stills of Leaking Hose Fitting on a Shuttle Valve in the ST Lock Hydraulic Circuit. (Green-dyed water around this location indicates the severity of the leak.)

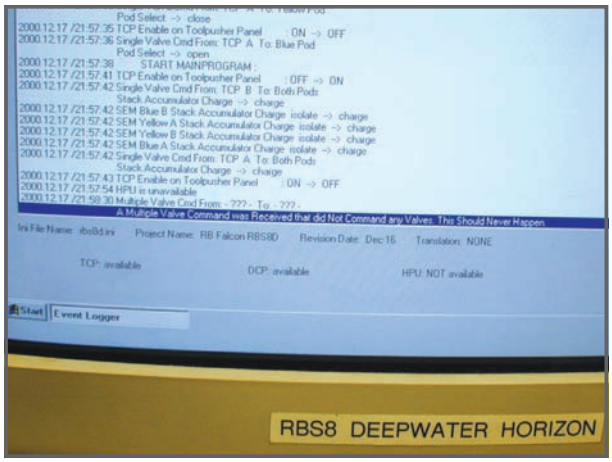
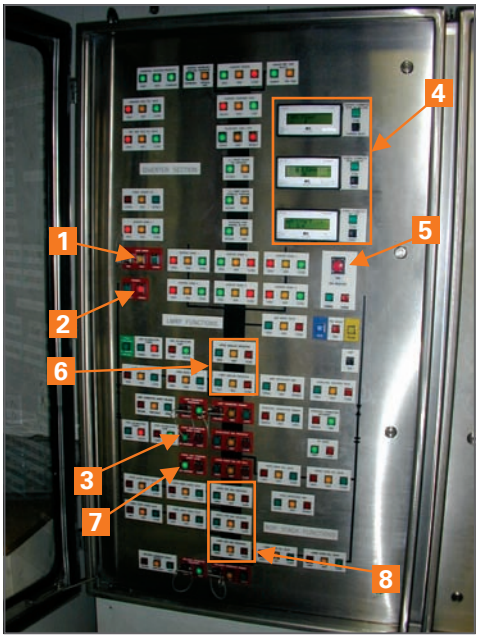
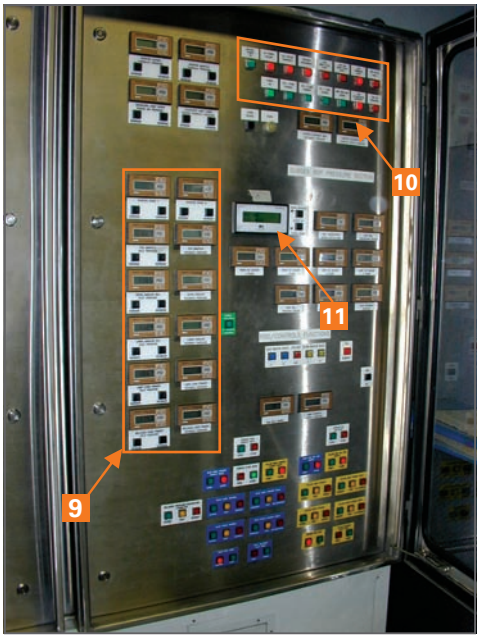
The control system was capable of identifying the coil defects in solenoid valves 103 and 3A in the yellow pod and logging them in the event logger. A failure mode effects and criticality analysis (FMECA) performed as part of a BOP assurance analysis of *Deepwater Horizon* BOP stack identified this failure mode. As stated in the FMECA report, when this failure is detected, the mitigation is "Switch to alternate pod, secure well and pull LMRP."

The charge level of the batteries for the AMF sequence could not have been monitored on the surface while the BOP was deployed subsea. If the battery voltage was not checked on the surface prior to the BOP deployment, there would have been no means of determining the charge on the batteries once the BOP was deployed.
