Deepwater Horizon Accident Investigation Report

September 8, 2010

This is the report of an internal BP incident investigation team. The report does not represent the views of any individual or entity other than the investigation team. The investigation team has produced the report exclusively for and at the request of BP in accordance with its Terms of Reference, *and any decision to release the report publicly is the responsibility of BP. It has not been prepared in response to any third party investigation, inquiry or litigation.*

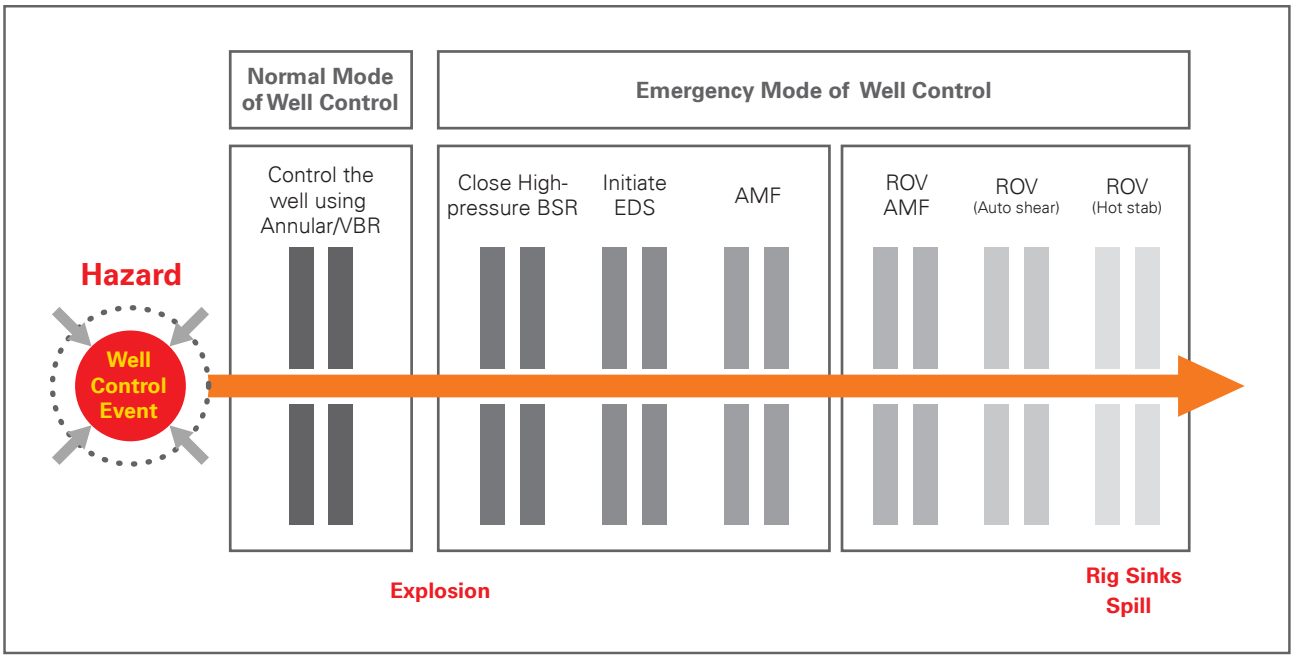
Figure 20. BOP Well Control Modes of Operation.

- **AMF:** an automatic means of closing the high-pressure BSR when electrical power, electronic communication and hydraulic pressure are all lost. AMF is designed to mitigate the risk caused as a result of catastrophic failure of the riser with the resultant reduction of hydrostatic head of mud in the riser to seawater hydrostatic head. This function had to be manually armed by rig personnel from the BOP control panel and required at least one operational control pod. The accumulators on the BOP stack were the only source of hydraulic power for this function. The investigation team concluded that the AMF very likely did not function due to the condition of critical components in the control pods.

- **ROV-initiated AMF:** a simulation of AMF conditions to close the high-pressure BSR by using an ROV to cut power/communication and hydraulic lines at the LMRP. This was attempted hours before the rig sank, but the investigation team concluded that the AMF very likely did not function due to the condition of critical components in the control pods.

The rig crew attempted the normal mode of BOP system operation (using an annular preventer and possibly a VBR) prior to the accident. The emergency mode of well control shown in *Figure 20* relates to the period after the accident, but only the ROV hot stab intervention continued after the rig sank.

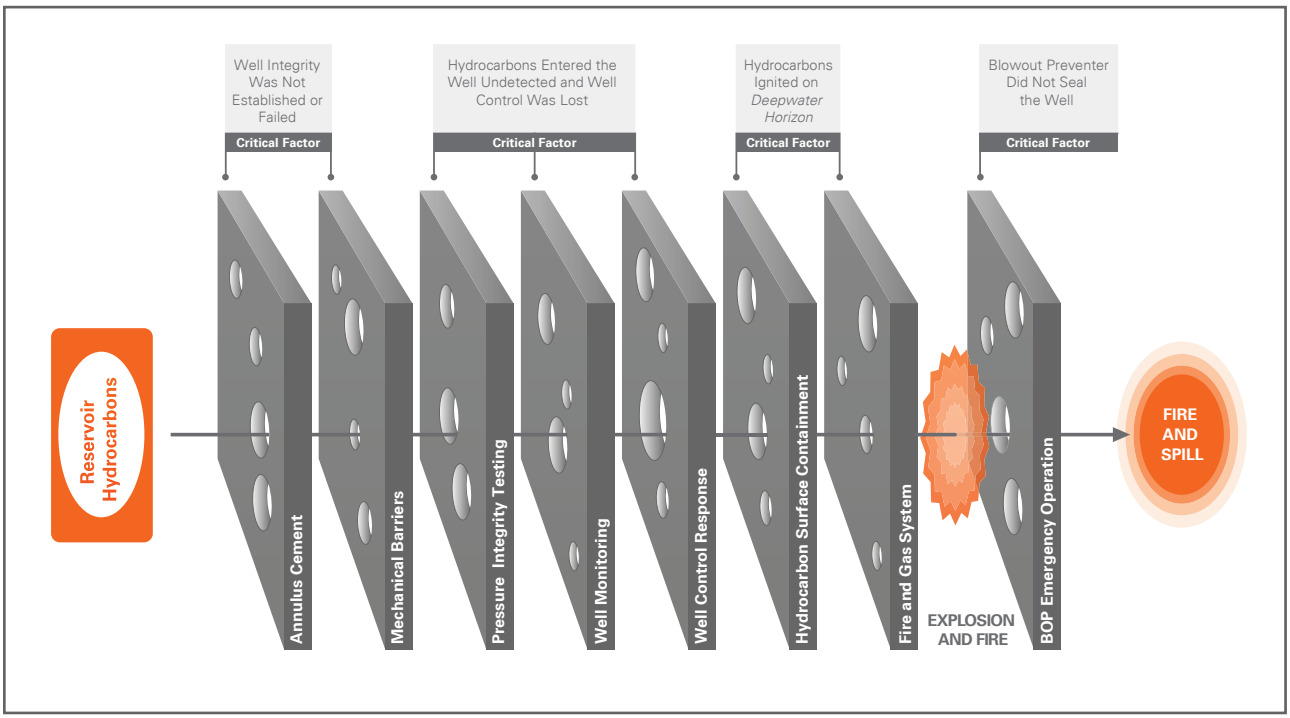
Figure 1. Barriers Breached and the Relationships of Barriers to the Critical Factors.

The purpose of these recommendations is to enable prevention of similar accidents occurring in the future by strengthening the defensive physical or operational barriers needed to eliminate or mitigate hazards. (Refer to Figure 1.) The recommendations are intended to provide a basis for the consideration of actions that can be implemented by both BP and by the contractor community that provides critical services and products to BP's exploration and production operations.
