"RECOVERING FROM HUGO: PREPARING FOR HILDA"

Hurricane Damage Mitigation Field Trip Guide
Folly Island, S.C. to Bogue Banks, N.C.

April 1-4, 1990

Hurricane Damage Mitigation
Folly Island, South Carolina to Bogue Banks, North Carolina

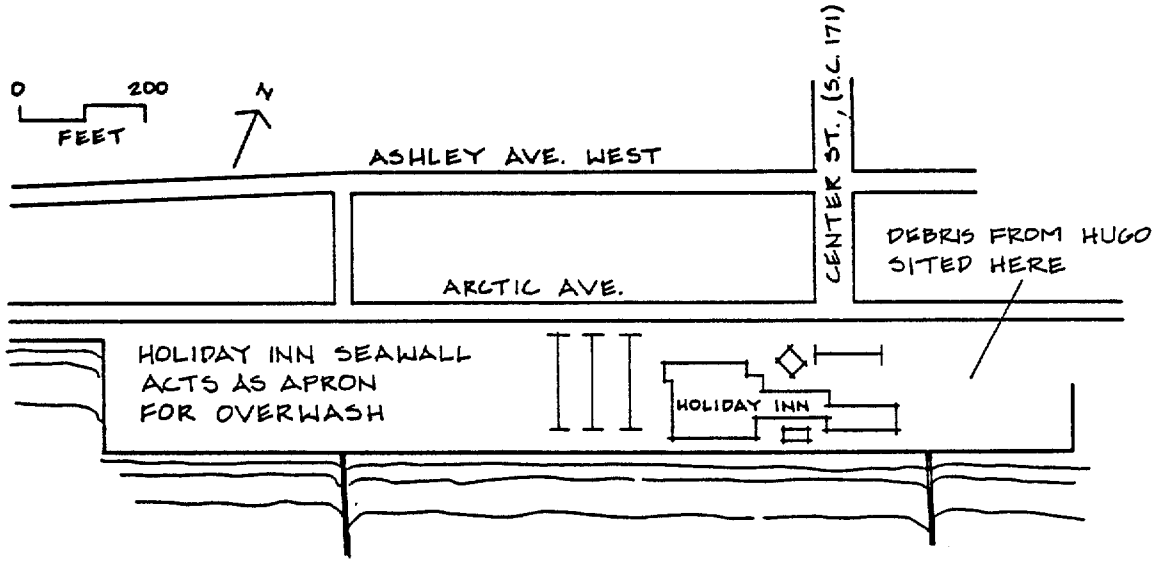
FOLLY ISLAND
STOP # 1
HOLIDAY INN AT END of RT 171

- Ends of the Holiday Inn seawall responsible for channeling of return water

* Rebuild property away from end of seawall
* Raise frontal dune elevation especially at ends of seawall
* Replenish beach
* Curve and elevate road ends

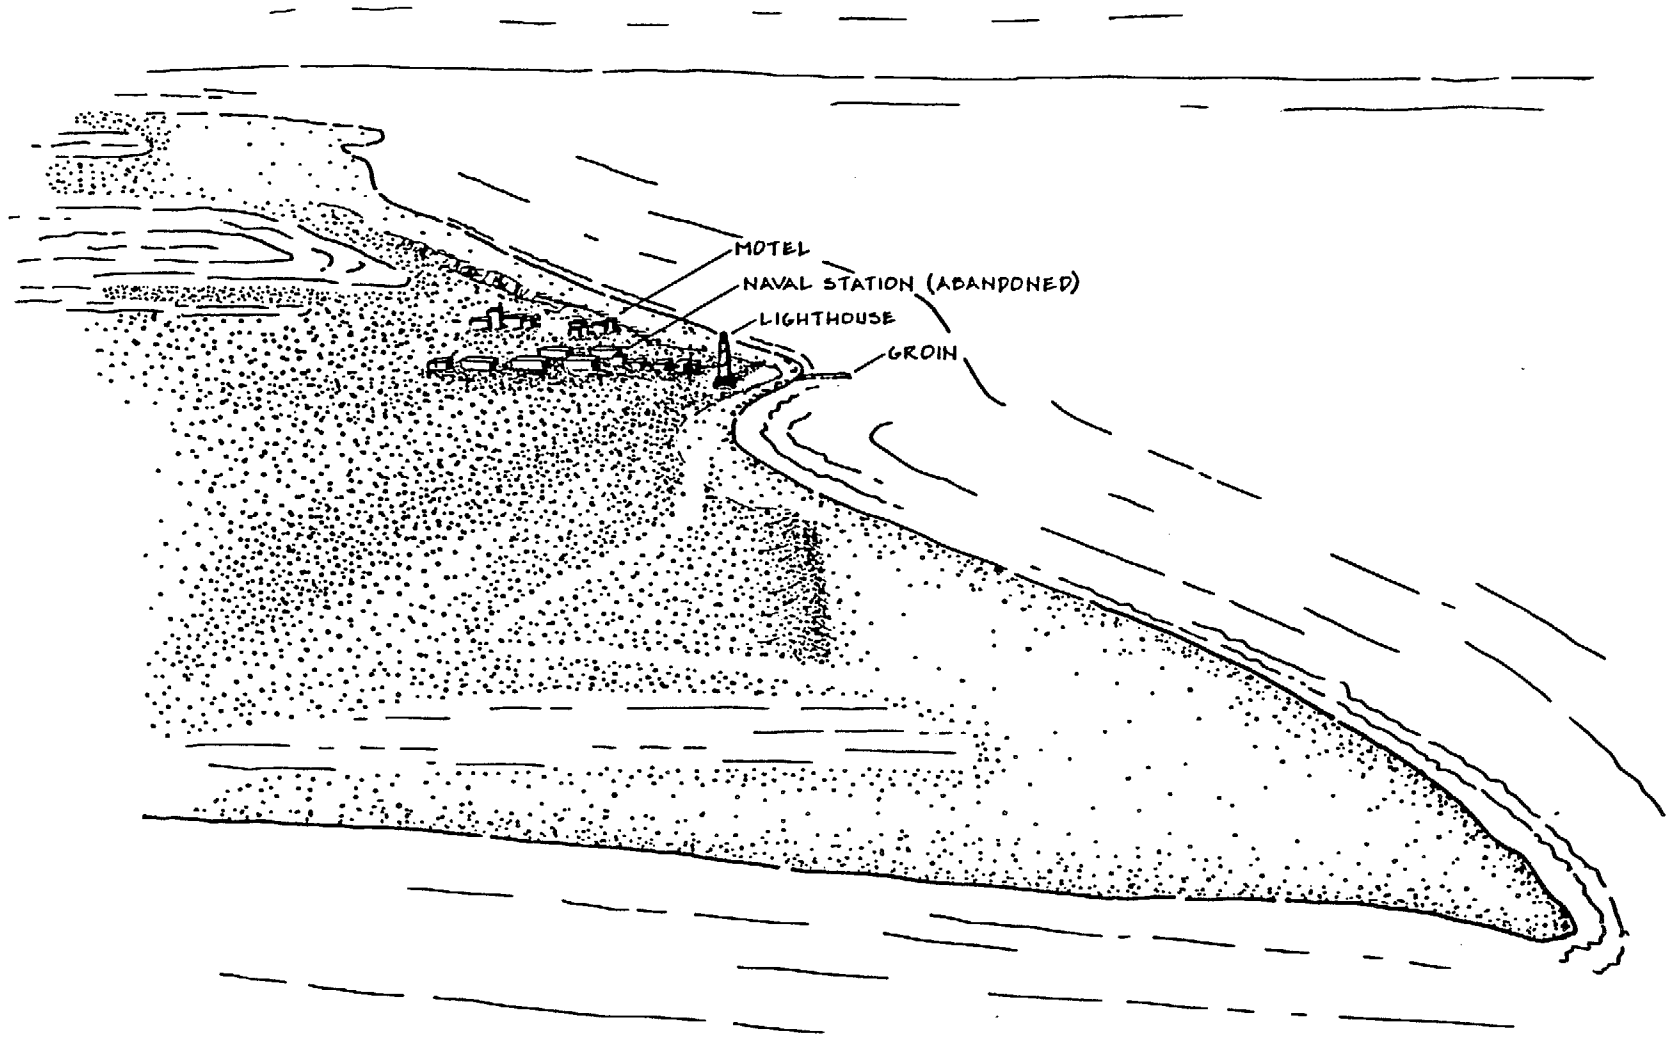
BULGE IN SHORELINE AT LIGHTHOUSE IS A RESULT OF SHORELINE STABILIZATION EFFORTS AT AND NEAR THE CAPE HATTERAS LIGHTHOUSE.

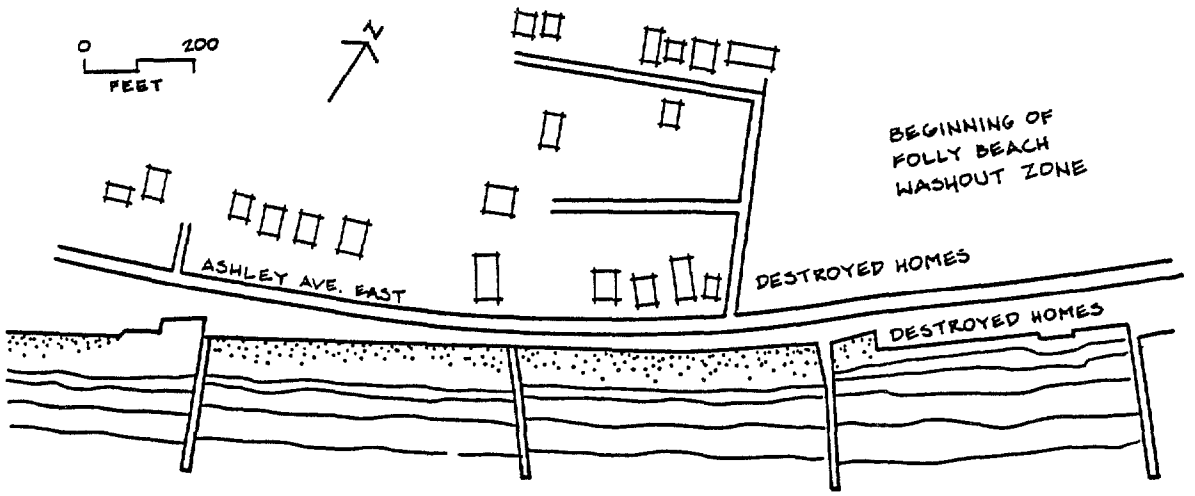
EAST END OF FOLLY BEACH
"WASHOUT ZONE"

- Island very narrow
- Ashley Avenue too close to water
- Historical inlet site

- West end of Ashley Avenue washed away
- Area of most intense property damage

* Build Ashley Avenue as far back as possible following storms
* Replenish beach
* Do not rebuild following storms

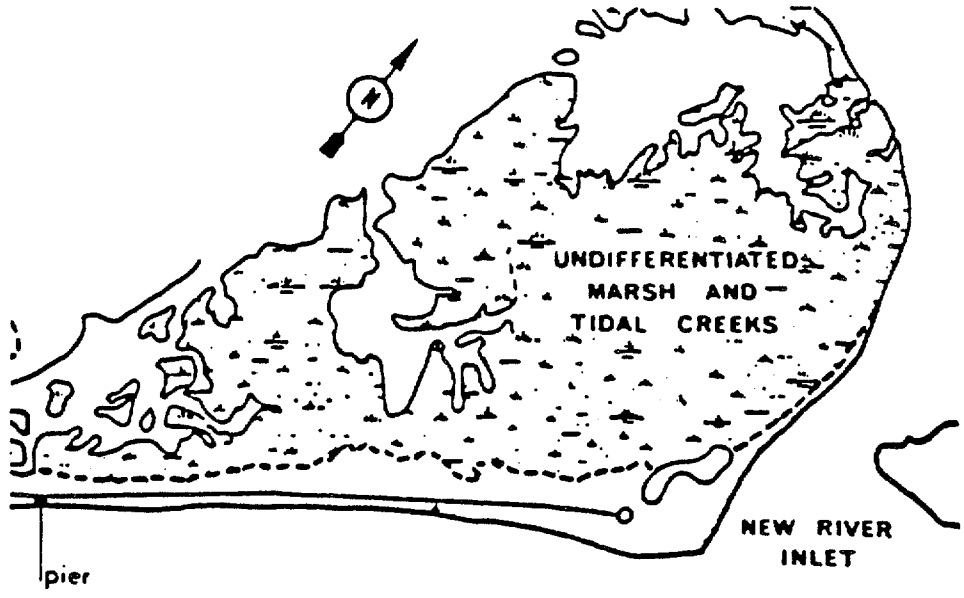
- Inlet hazard area includes everything within a mile of inlet
- Large structures close to beach- overdevelopment
- Road washouts make evacuation difficult
- Shift in inlet will cause high erosion rates

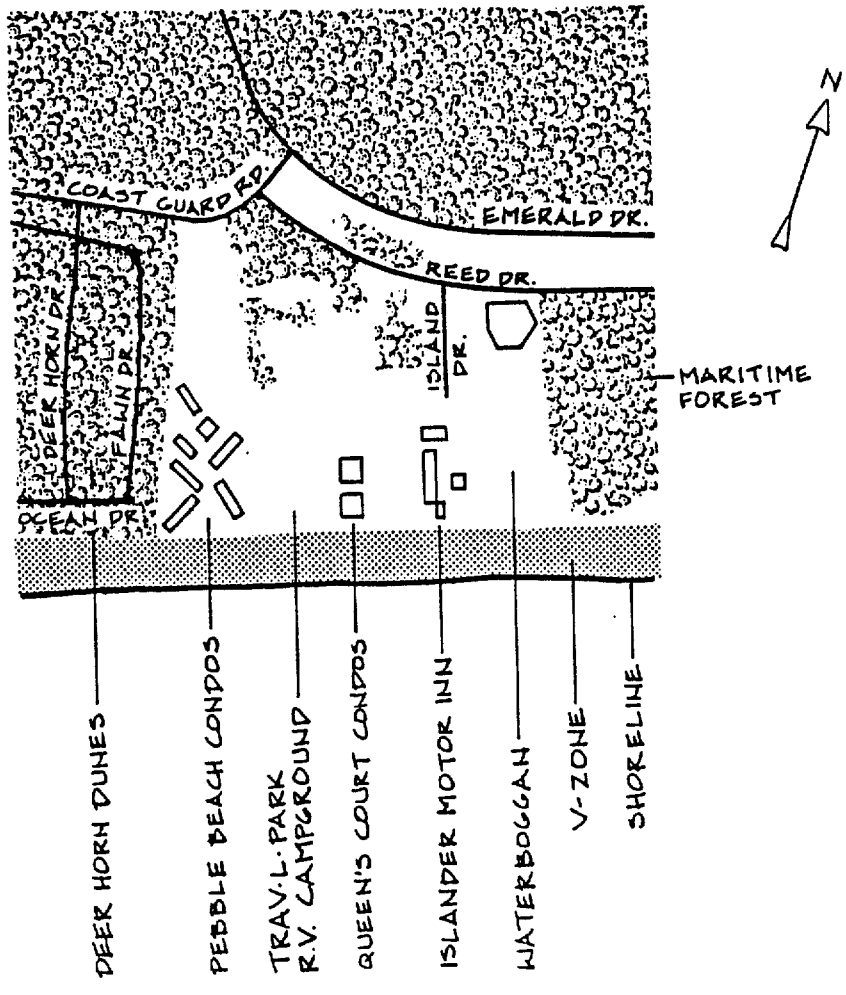
Islander Motor Inn, Bogue Banks: Dune and forest removal for commercial development.

At this location, maritime forest and sand dunes were removed for siting of large commercial structures. These buildings sit on top of what amounts to a sandy bluff, 12 feet or so high, eroding at a long-term average rate of 2 feet per year. In addition, roads run perpendicular to the shore and the dunes are notched which allow for increased overwash penetration and storm-surge ebb flow.

Recommendations for this area are to add new sand on top of the bluff to increase the elevation and to replace sand dunes that were removed. Interior dunes should be replaced as well. The maritime forest should be re-established, although that is a longer-term project. Ocean ends of roads should be curved and elevated where possible.

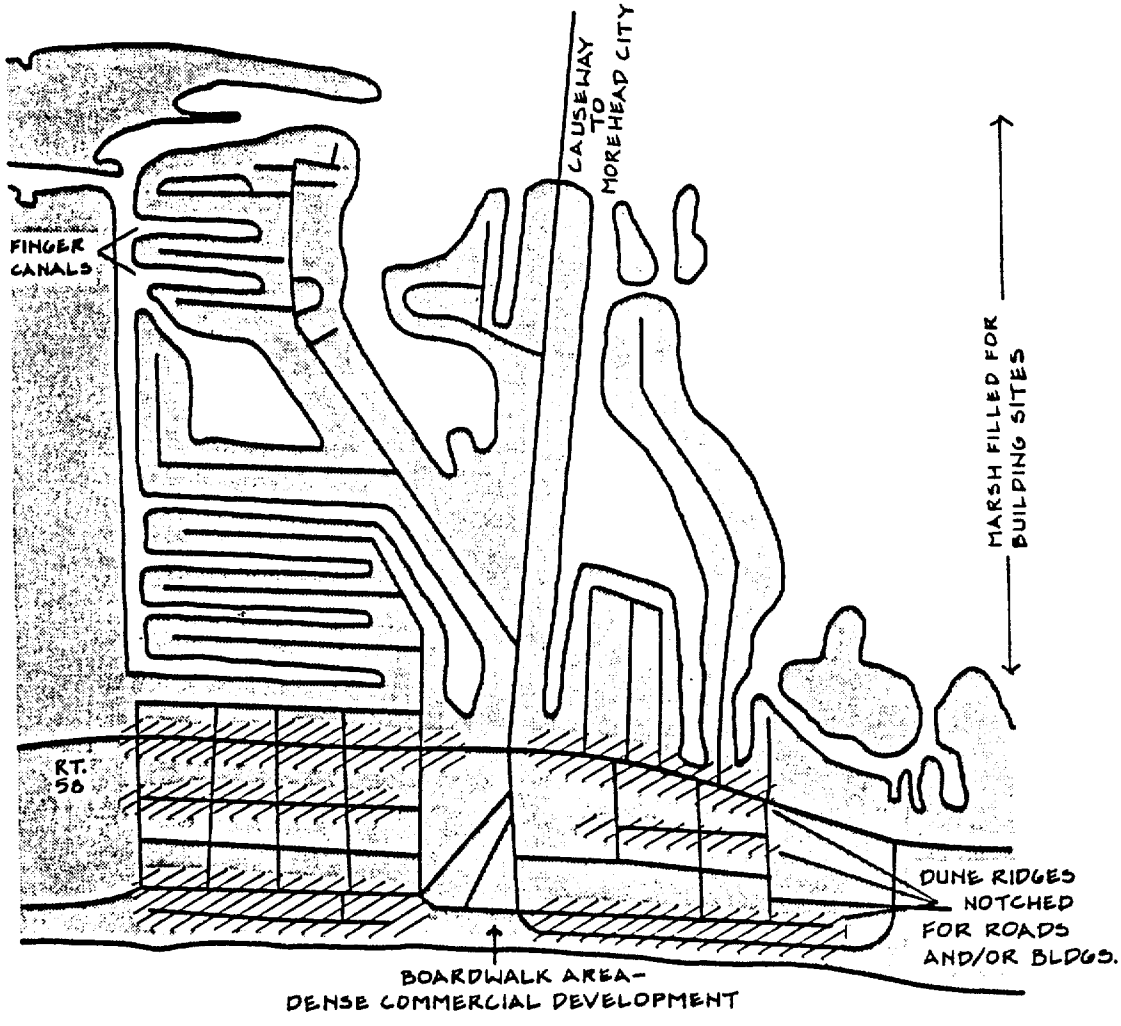
Bogue Banks Stop 4: Giant Notches in Dunes at the Atlantic Beach Boardwalk.

Atlantic beach is very densely developed. Several dune ridges were excavated for siting of all the commercial establishments and even for Morehead Avenue, the main road leading to the causeway and the mainland. This area will allow penetration of overwash waters, putting a great deal of property at risk that otherwise would have been safe behind several rows of high dunes.

Recommendations for this area are to build interior dunes behind the buildings and to build Morehead Avenue up over a rebuilt dune.
