California Coastal Erosion and Storm Damage During the Winter of 1982-83

A Reconnaissance Report

Committee on Natural Disasters

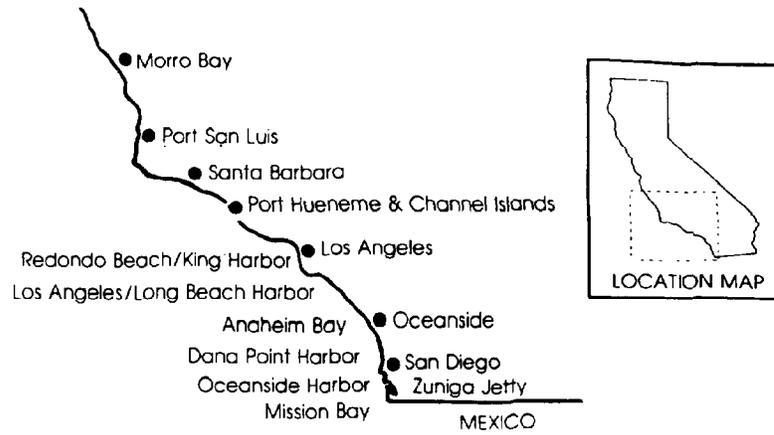
The Los Angeles District of the U.S. Army Corps of Engineers (1983) has detailed the damage to the breakwaters under its responsibility. Table 5 summarizes the locations, character of damage, and repair costs for those structures. Figure 12 shows their locations. The total repair cost is \$17.8 million. In discussing this damage, the Corps comments that the storm waves were "most certainly the largest since 1941, and perhaps the largest since 1838 or before."

FIGURE 12 Locations of damaged breakwaters under the responsibility of the Los Angeles District of the U.S. Army Corps of Engineers.

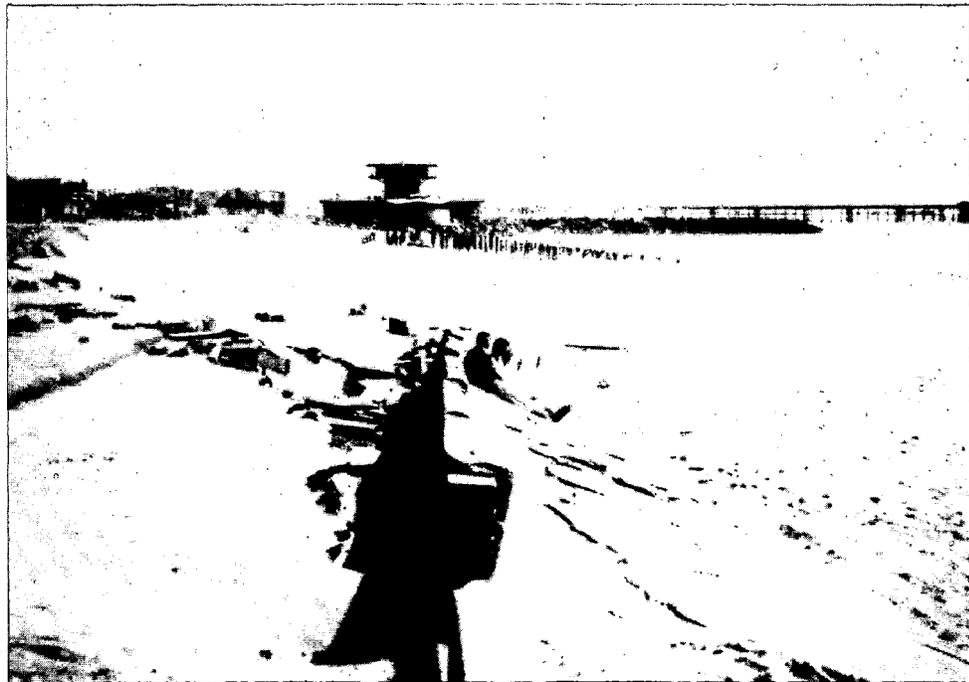
This failure underscores the importance of taking into account the potential depth of wave erosion when designing the foundations of coastal installations. To illustrate this point, Figure 16 shows a small building housing restrooms and changing rooms adjacent to the Venice Pier. This structure escaped destruction because it was founded on piles, even though spread footings would have been enough to carry the foundation's loads.

FIGURE 16 This structure supported by light piles escaped direct wave damage. The Venice Pier is in the background.

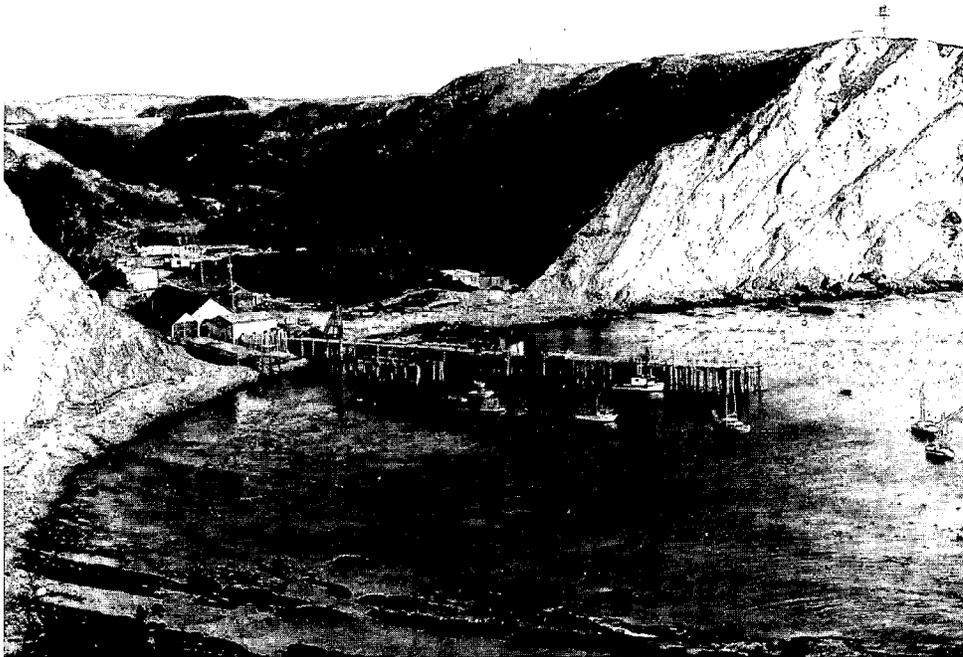
Arena Cove, shown in Figure 17, is one of the few relatively sheltered small fishing harbors along the coast of northern California. On the morning of January 26, 1983, a succession of three very large waves in conjunction with a 2.2-m tide essentially destroyed a newly reconstructed pier and a fishhouse and heavily damaged a boathouse and a shoreside cafe. The occupants of the cafe barely escaped serious injury.

FIGURE 17 Arena Cove on August 29, 1980. Photograph copyright ©Nicholas King.

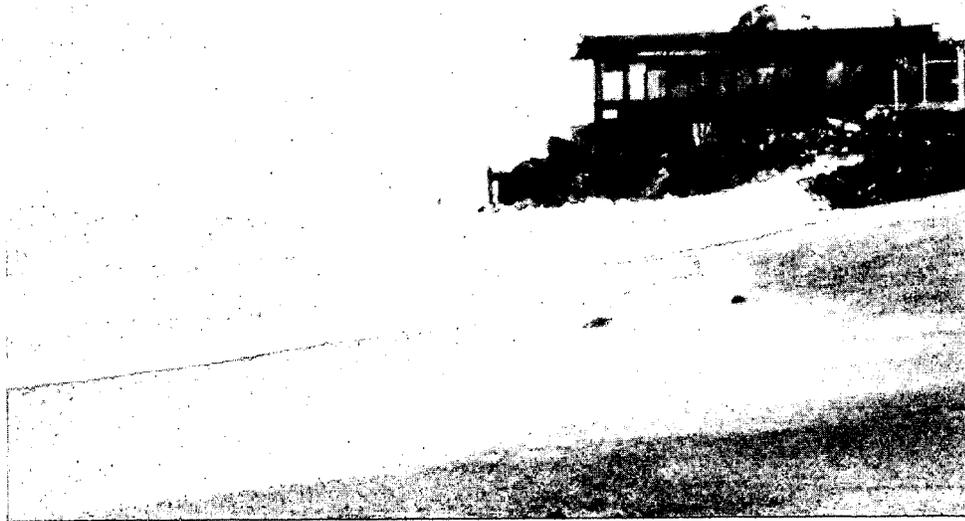
The structures (Figures 25 and 26) consist primarily of single-family dwellings. They have remained largely undamaged because of the presence of very large and high revetments. As shown in the photographs, the beaches are very narrow. At the time of the study team's visit, no well-defined offshore bar was evident, although sand had clearly been transported seaward from the beach. Attempts to control beach erosion at this location by constructing three groins were unsuccessful. Based on model testing conducted at the Waterways Experiment Station, the U.S. Army Corps of Engineers plans to construct a series of offshore breakwaters to control erosion.

FIGURE 25 View of Imperial Beach showing eroded beach and home protected by revetment (photograph was taken at low tide).

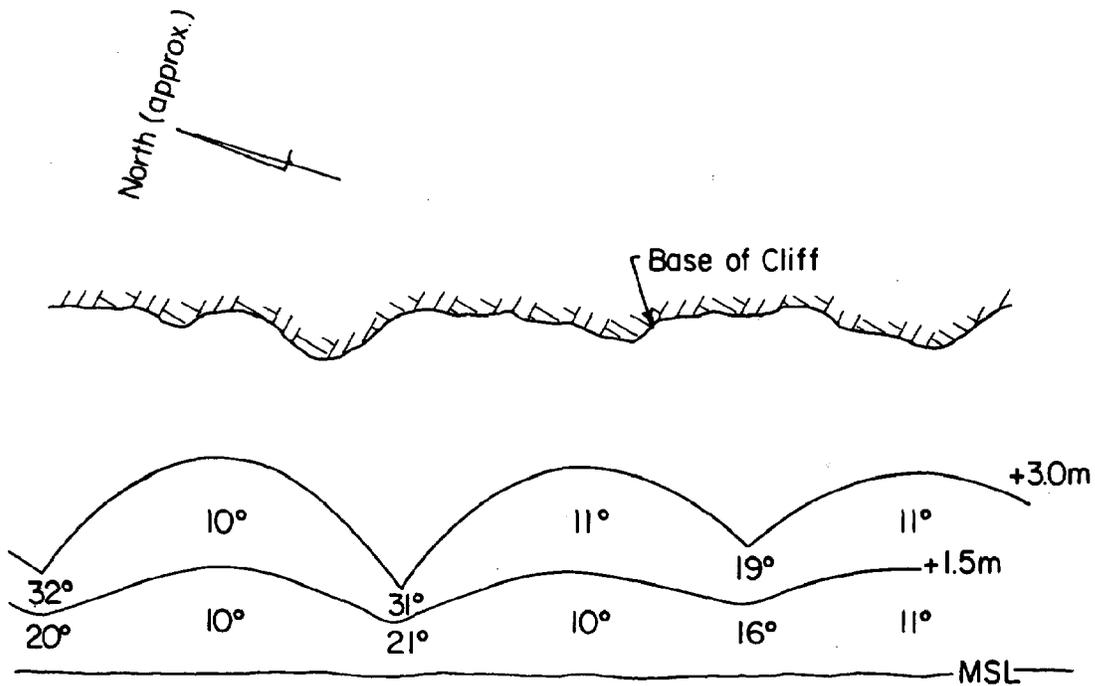
Figure 27, which shows Torrey Pines State Beach toward the south from the access road, contains several features of interest. First, the sand on the beach, at least in places, has been transported and deposited offshore, leaving a more resistant lag deposit of cobbles. Also of interest are the steep cusps that have been formed of the cobbles. The average slope of the horns and swales of these cusps is 25° and 10° , respectively. Figure 28 presents a sketch of the cusp geometry.

FIGURE 28 Approximate planform geometry of the cusps at Torrey Pines Beach on March 9, 1983. Most of the cobbles on the upper portion of the beach were about 6 cm in diameter. The local beach slope was about 21°.

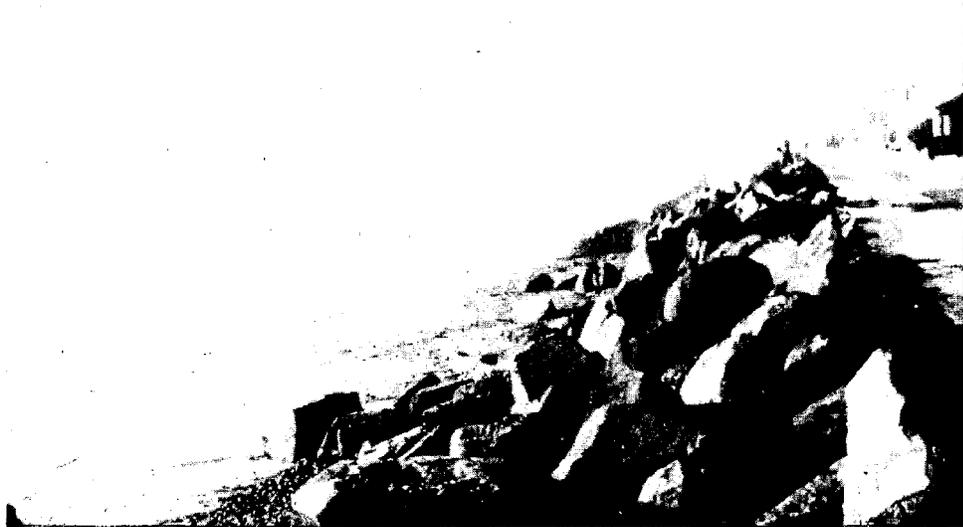
Oceanside Beach has a history of erosion that is believed to be due largely to the stress imposed by the Oceanside Harbor breakwater immediately to the north. Sediment has been deposited north of the harbor complex and also offshore of the breakwater. Figure 29 shows the beaches south of the Oceanside Pier (which is in the background). At other locations, waves have removed some of the sand from the beach, exposing the cobble base. Observers reported that, during the storms, cobbles with diameters of up to 15 cm were propelled by wave action across the street (Pacific Street) paralleling the ocean. It is of interest to note that within the last two years approximately 750,000 m³ of high-quality sand have been placed on the Oceanside beaches.

FIGURE 29 Oceanside Beach with Oceanside Pier in the background. Note the narrow beach, revetment, and evidence of overtopping.

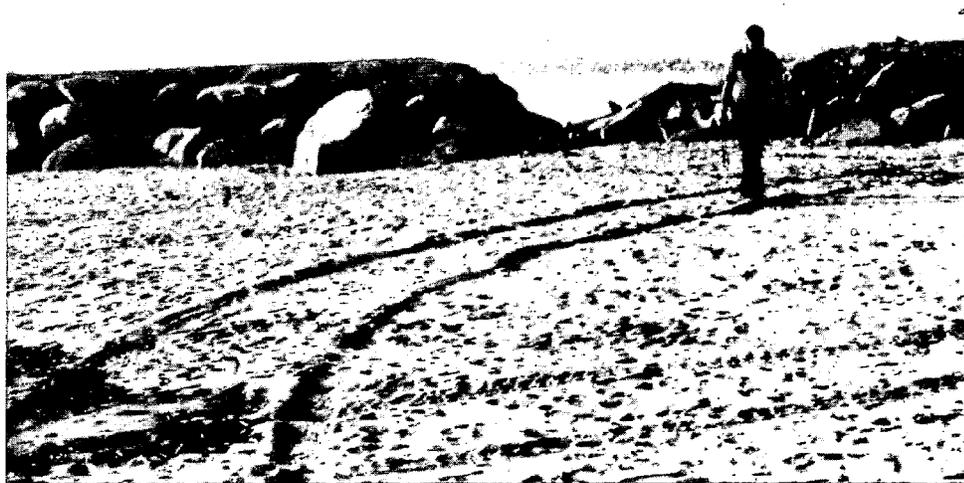
FIGURE 32 Small breach in the south breakwater at Oceanside Harbor.

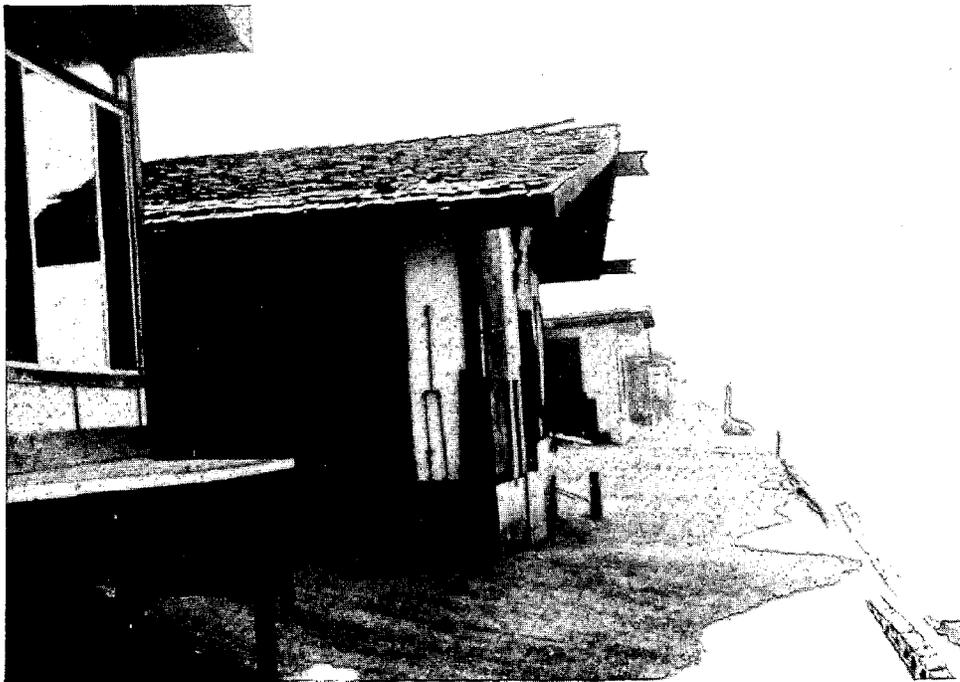
FIGURE 34 Capistrano Shores in the same vicinity as Figure 33.

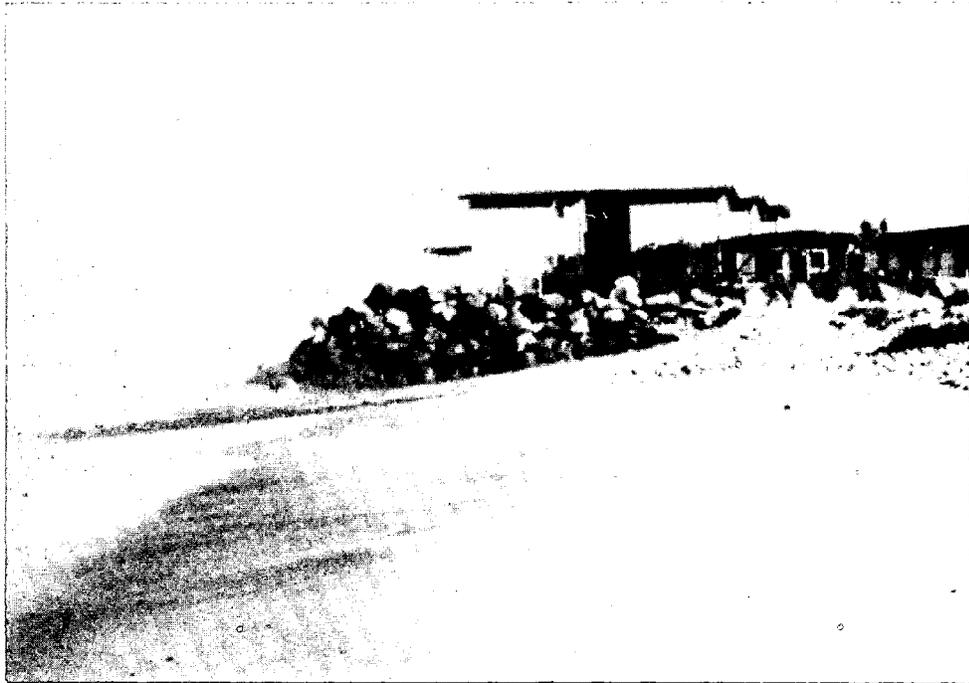
North San Clemente Beach had experienced substantial losses of sand, which undermined several restrooms and other structures (see Figure 35). The location of the house shown in Figure 36 just north of this beach places it in jeopardy from high tides and waves. The transient nature of this beach in the long term is indicated by the wave-cut cliff behind it. That the coastal railroad passes along this fairly narrow beach attests to the fact that, at least in recent years, waves have not acted on the cliff frequently.

FIGURE 36 Revetment protects this North San Clemente Beach dwelling.

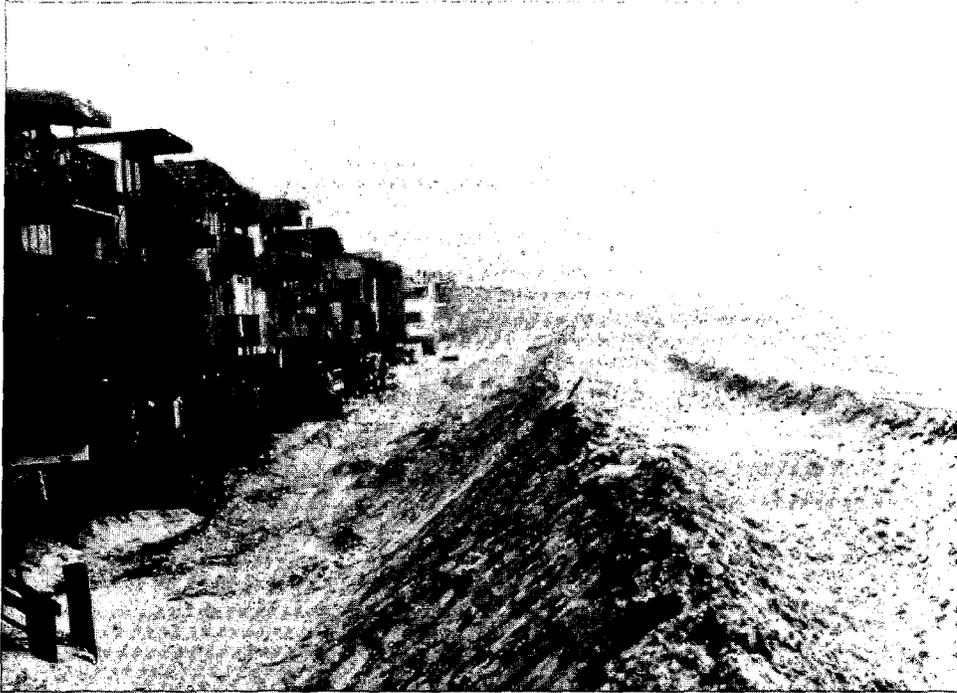
Surfside Colony, a shorefront development, is located just downdrift (southeast) of the entrance to Anaheim Bay. This probably accounts, at least in part, for the relatively large erosional stresses on this beach and the associated need for periodic nourishment. Figure 37 shows a large dike of sand placed to reduce flooding by overtopping. This dike is located over a protective revetment. Figure 38 shows the south jetty at the entrance to Anaheim Bay. Dwellings in Surfside Colony received only limited water damage.

FIGURE 37 A sand berm overlies revetment as protection against flooding at Surfside Colony.

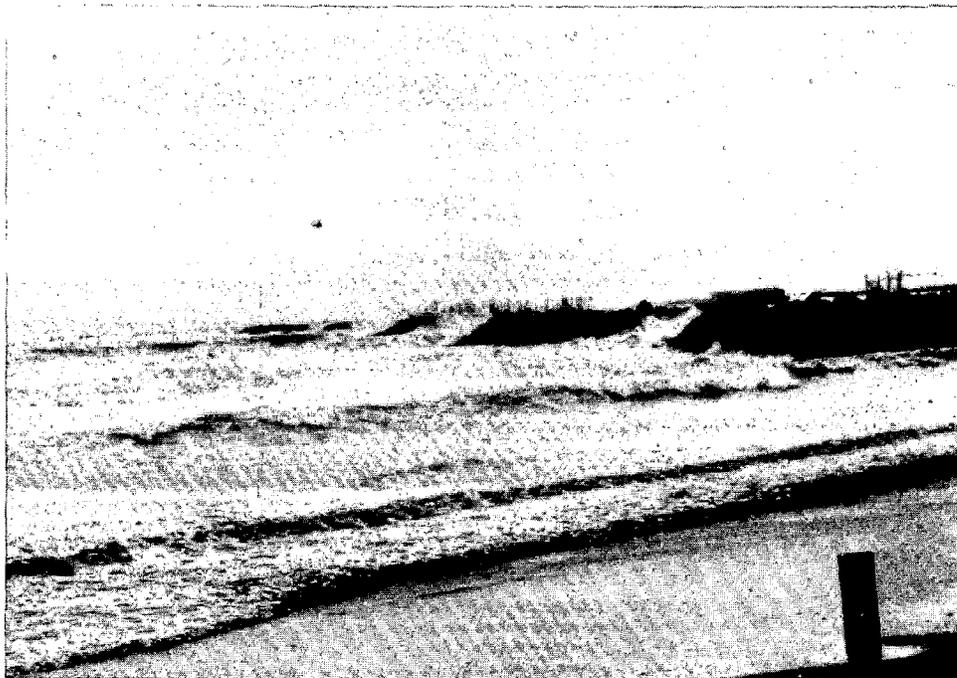
FIGURE 38 The south jetty at the entrance to Anaheim Bay.

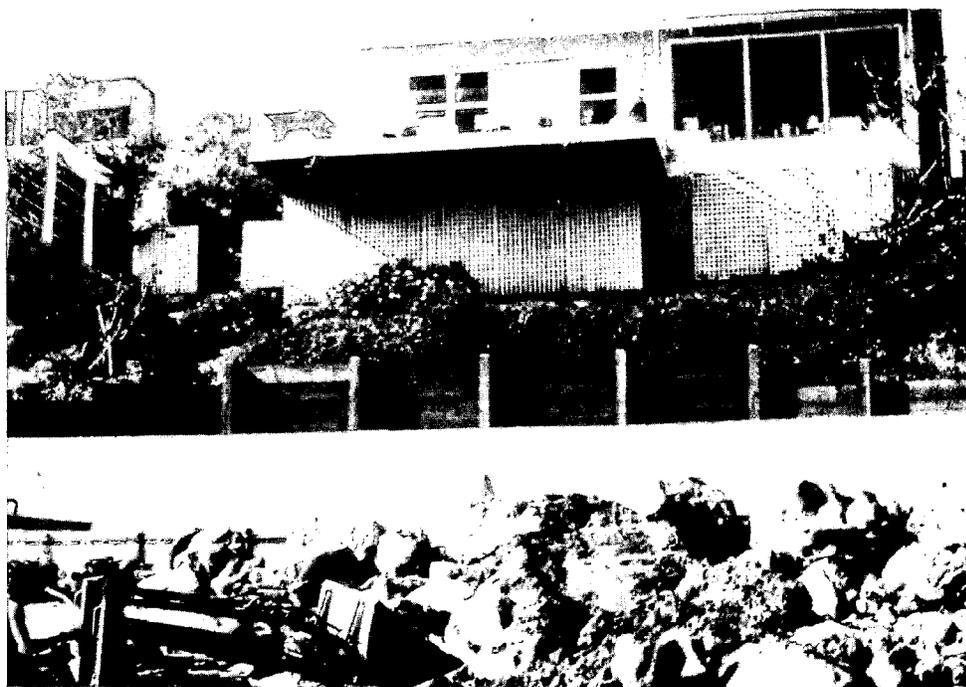
FIGURE 41 Construction during low tide of protective revetment fronting a newly installed seawall.

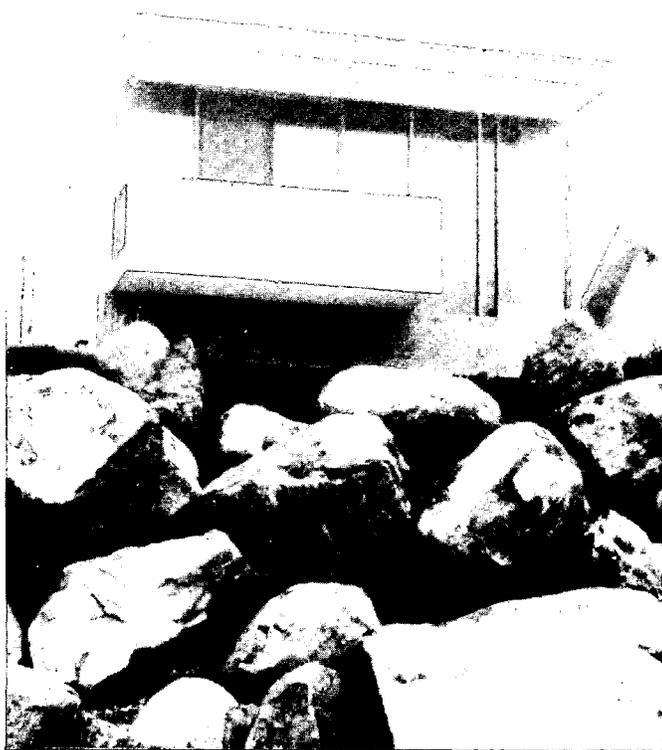
FIGURE 42 Heavy revetment fronting a dwelling in Malibu Beach.

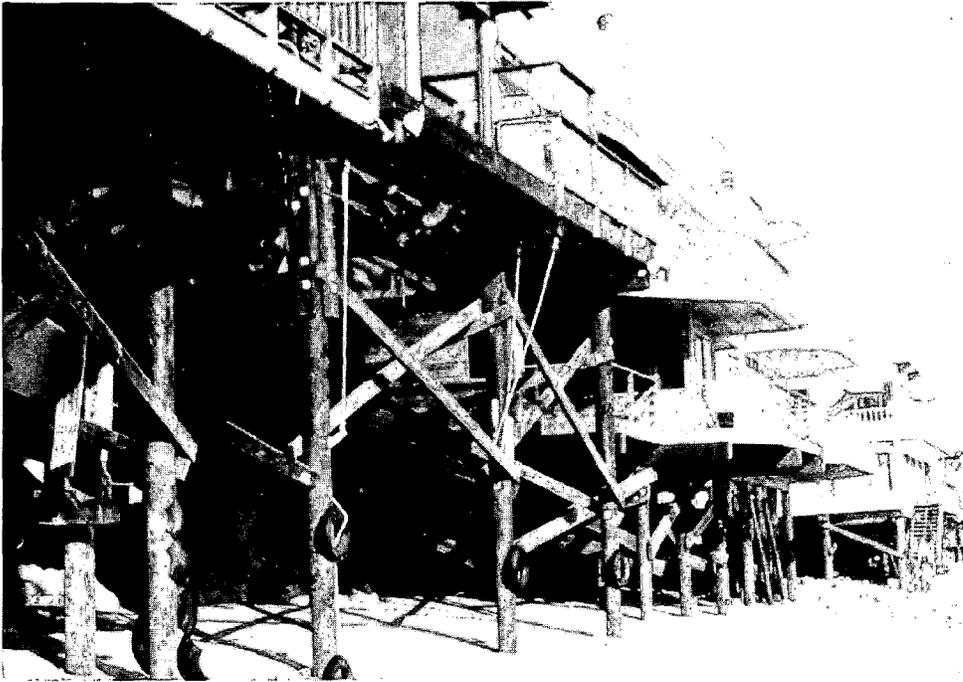
FIGURE 43 Pile-supported structures in Malibu Beach are located near a zone of high wave energy.

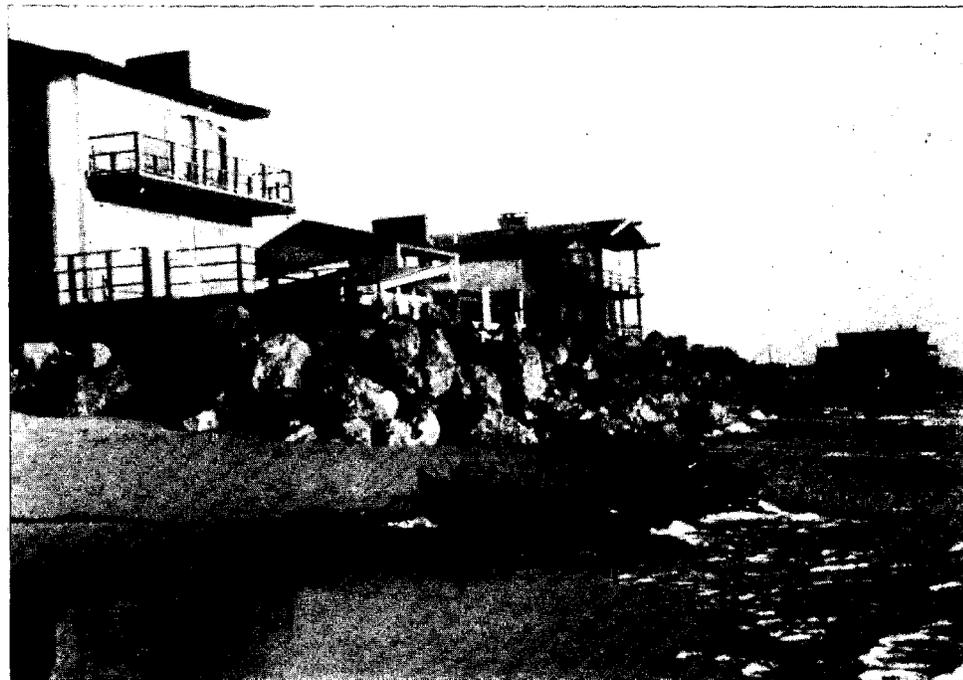
The Oxnard Shores housing development appears to be located on a somewhat transient depositional feature originating by outwash from floods in the Santa Clara River and possibly modification of dunes in conjunction with the development. Storms have caused substantial erosion, requiring that structures be protected from further erosion and direct wave impact (see Figure 46).

FIGURE 46 Dwellings in Oxnard Shores located on unstable shoreline.

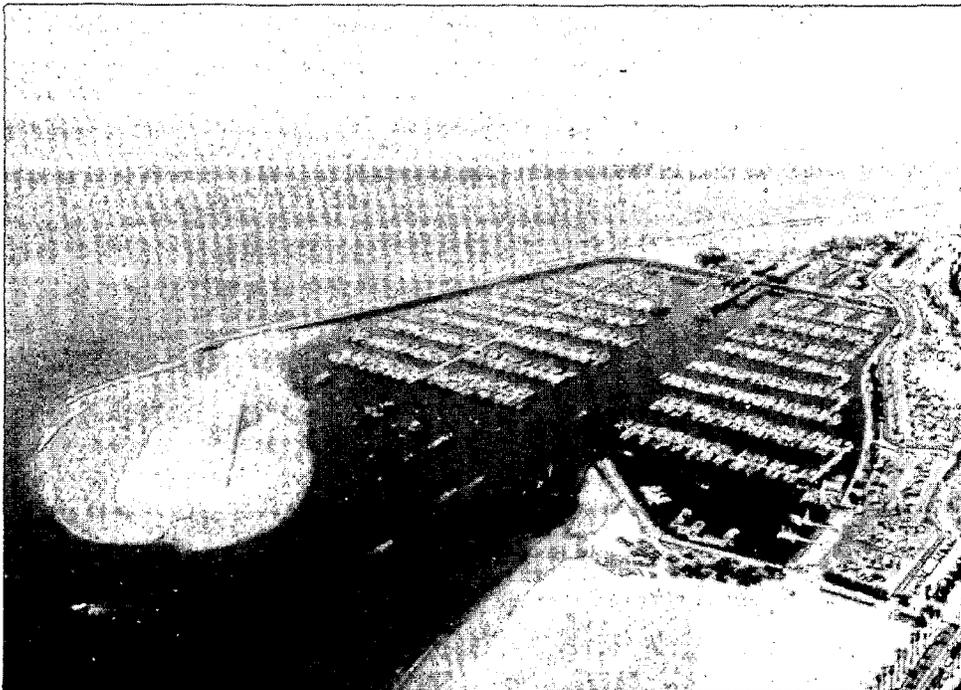
The spit in the lee of the tip of the Santa Barbara breakwater was reduced in elevation by storm wave energy to below mean sea level. Figures 47 and 48 present "before" and "after" oblique aerial views in 1979 and on March 12, 1983, respectively. The flight on March 12, 1983, was conducted at low tide and the spit was barely emergent. At high tide the spit was completely submerged.

FIGURE 47 The Santa Barbara area looking southwest. The Santa Barbara breakwater with lee spit and East Beach can be seen in this 1979 photograph.

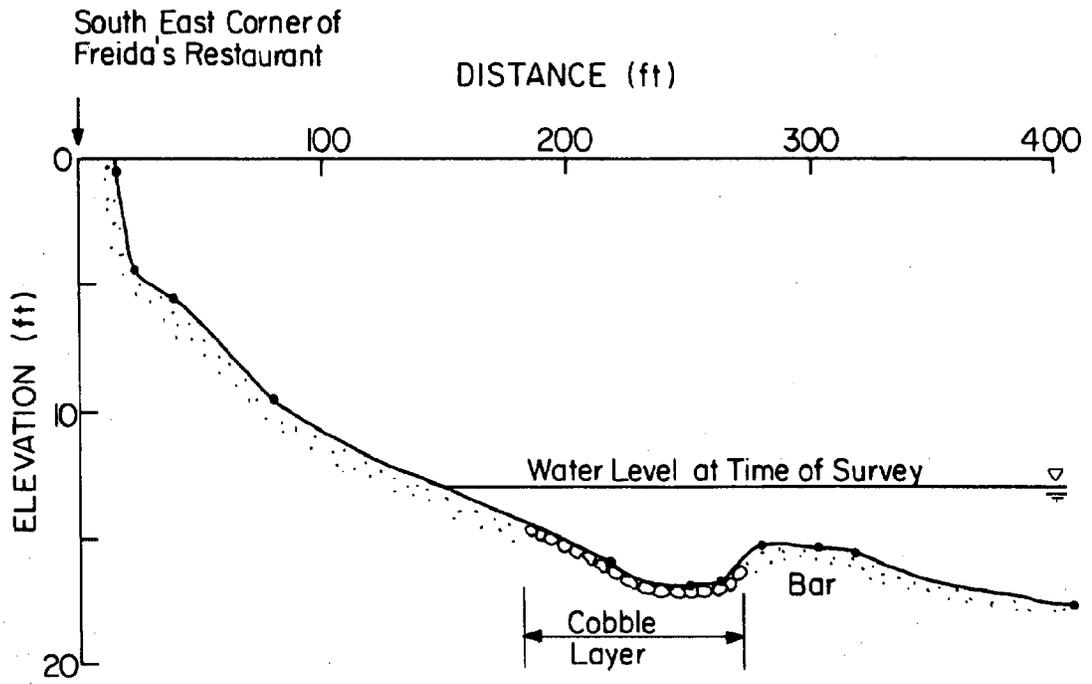
The most impressive effect of the storms of 1982-83 on the Santa Barbara area was the extent of erosion on Leadbetter Beach. The pocket beach had eroded back well beyond limits that have occurred over at least the past several decades. This undermined the parking lot and removed sand from behind a revetment constructed after the winter storms of 1979-80 (see Figure 9). A profile taken off Leadbetter Beach is presented in Figure 49. Of interest are the presence of the offshore bar and the cobble layer limiting the depth of the trough immediately landward of the bar.

FIGURE 49 Profile taken off Leadbetter Beach in Santa Barbara on March 12, 1983, at 2:30 p.m. The profile heading was 170°.

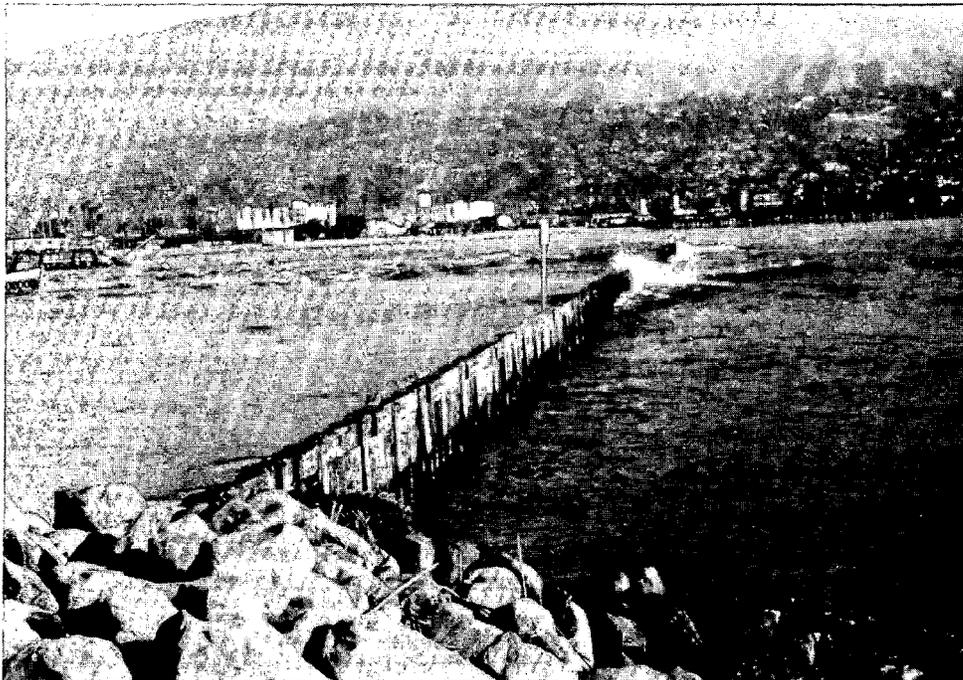
Figures 50 and 51 present views looking west along Leadbetter Beach. In addition to undermining the parking lot, erosion caused a number of palm trees to be lost. Figure 52 shows the timber sheet-pile structure extending north from near the tip of the Santa Barbara breakwater. Usually there is a sand spit on both sides of the timber structure up to 1 m above the mean high water level.

FIGURE 52 View looking north from the base of the timber sheet-pile structure that extends north from the Santa Barbara breakwater.

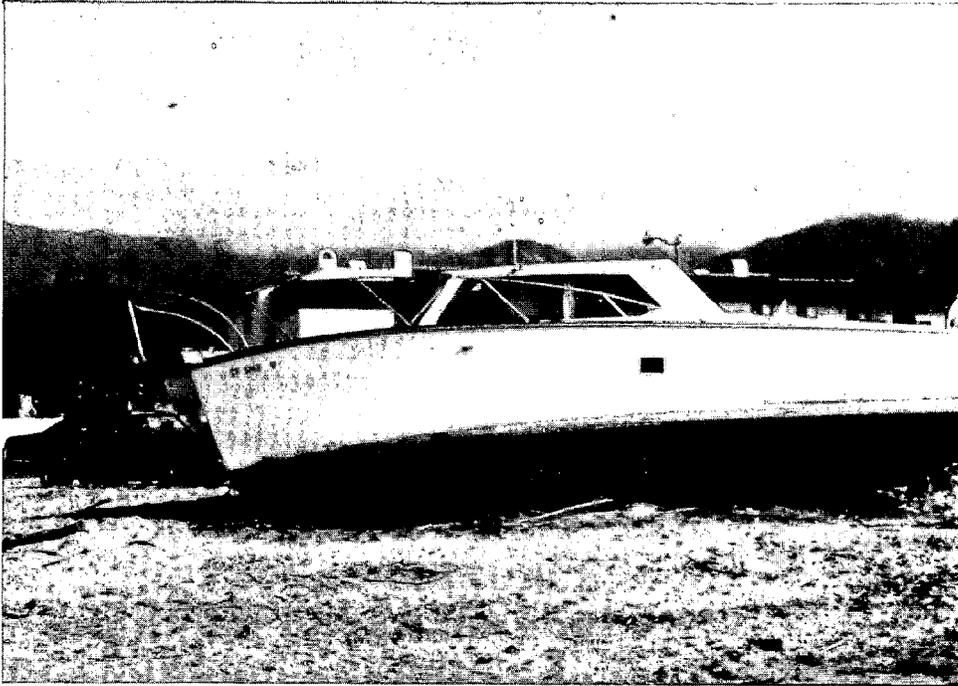
East Beach also experienced substantial erosion and undermining of vegetation. In addition, a number of small boats were beached by the storm, an example of which is shown in Figure 53.

FIGURE 53 Beached boat on East Beach.

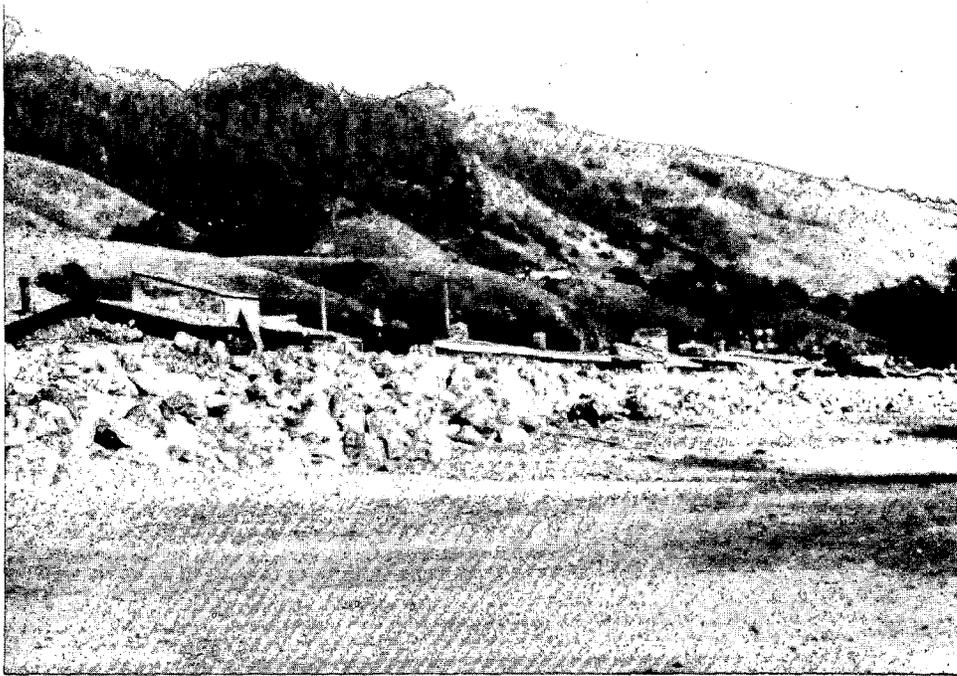
FIGURE 65 Substantial revetment in Stinson Beach to protect dwellings from erosion and waves.

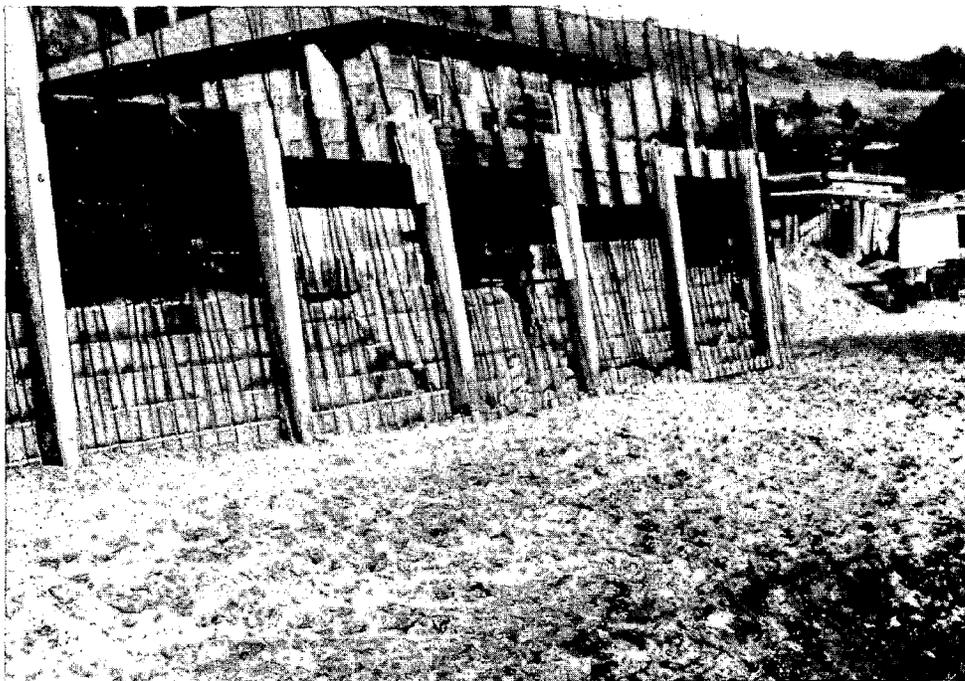
FIGURE 66 Reinforced concrete seawall in Stinson Beach being constructed.

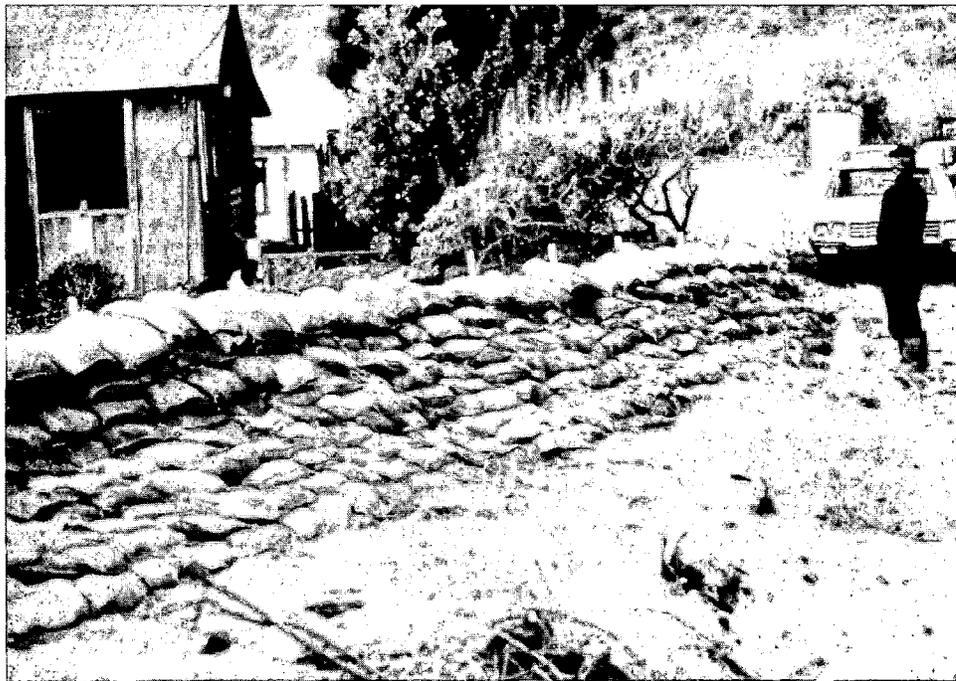
FIGURE 70 Sandbag barrier at Stinson Beach to prevent flooding from waves and sand deposition from overwash.

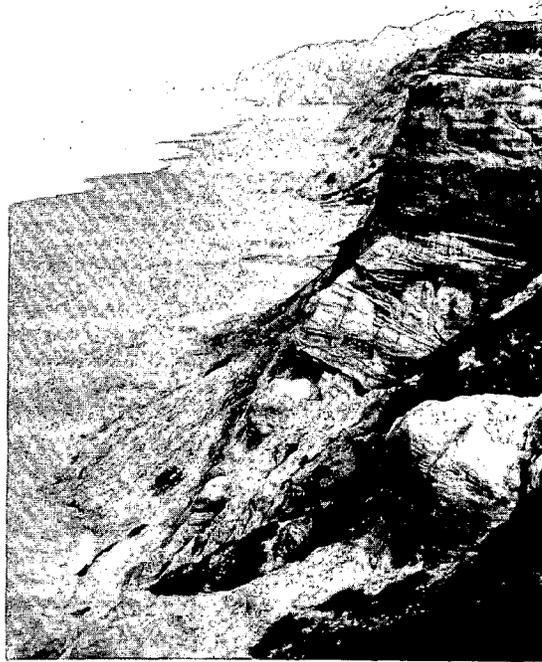
FIGURE 72 Failure of coastal cliff at Capitola.

The winter storms of 1982-83 caused localized cliff erosion. However, it was not possible to quantify this erosion.
