R I D G E T O R E E F S /
P R O T E C T O R E S D E
C U E N C A S / N O A A R C

Hydroseeding Test Plots

Soil Stabilization Test Plots

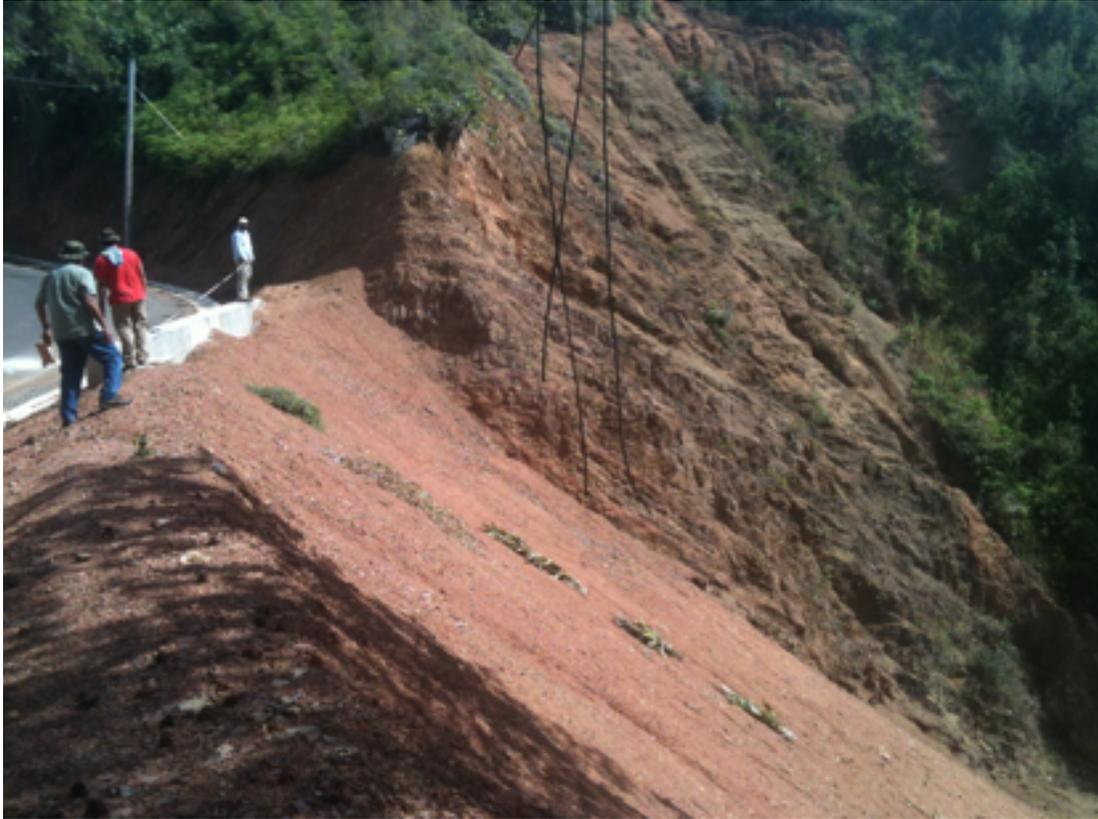
Figure 1. Laying out test plots on a 70-75% slope

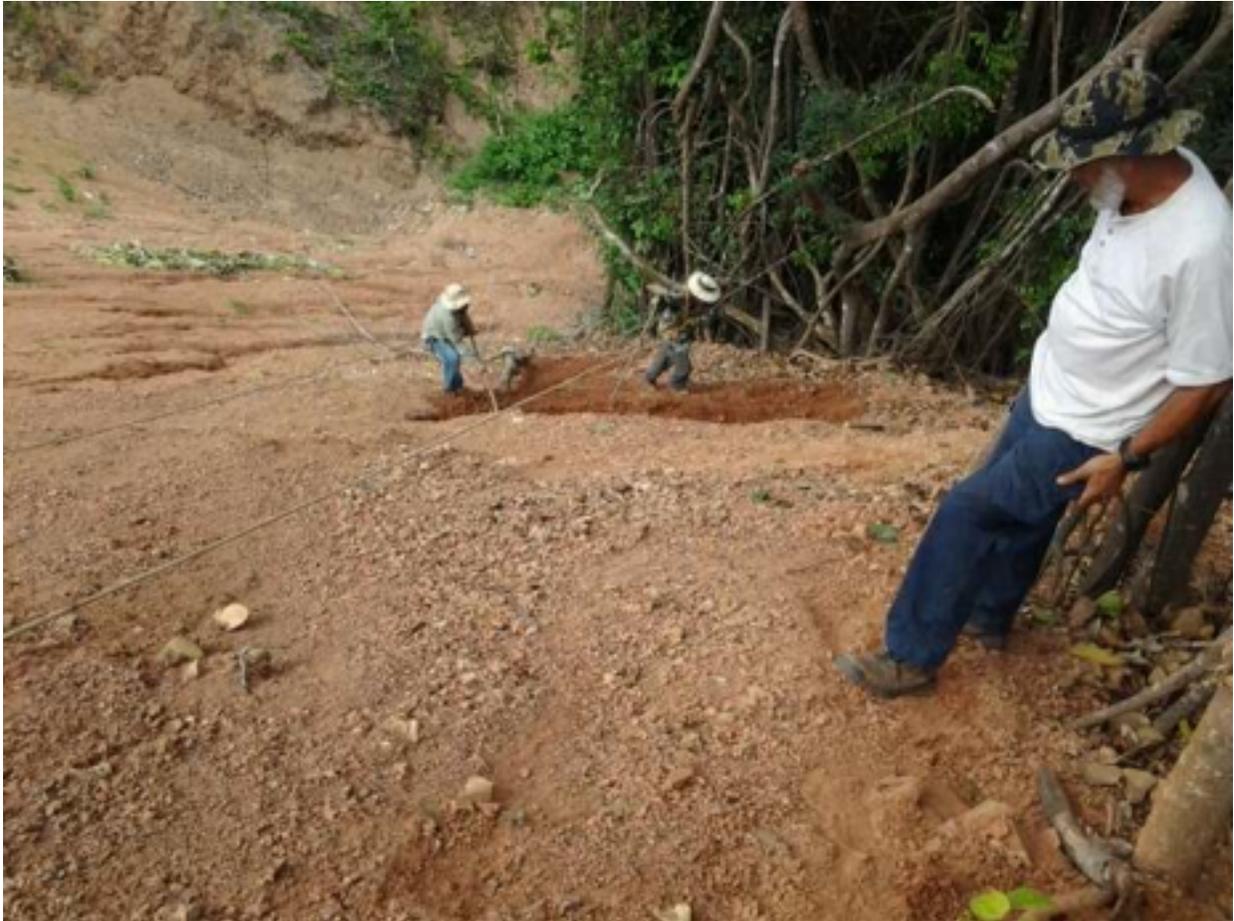
Figure 2. Breaking the slope to reduce concentrated runoff on the hillslope

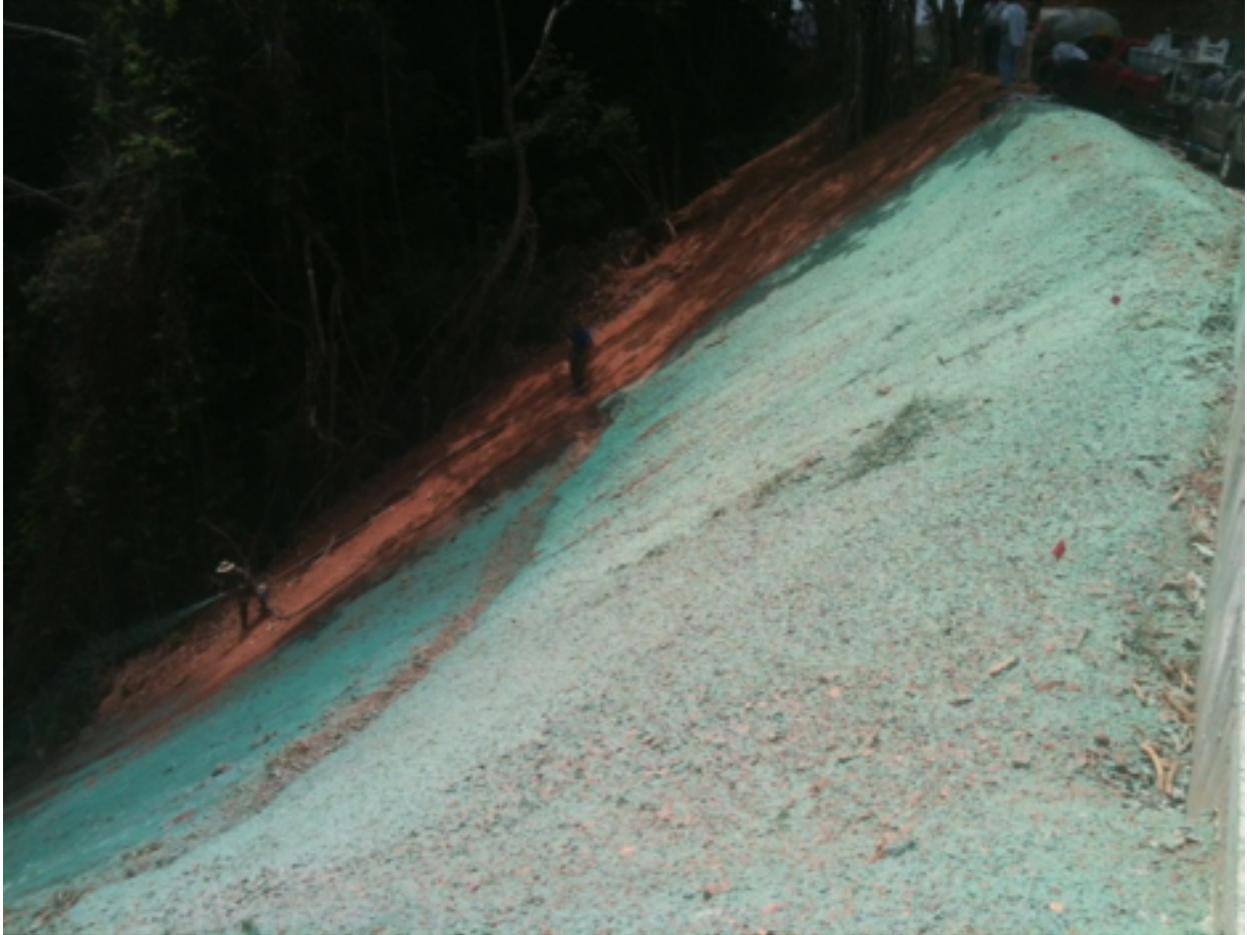
Figure 3. Flexterra application in the foreground and thick application of wood hydromulch in the distant plot (note red flags that delineate plots)

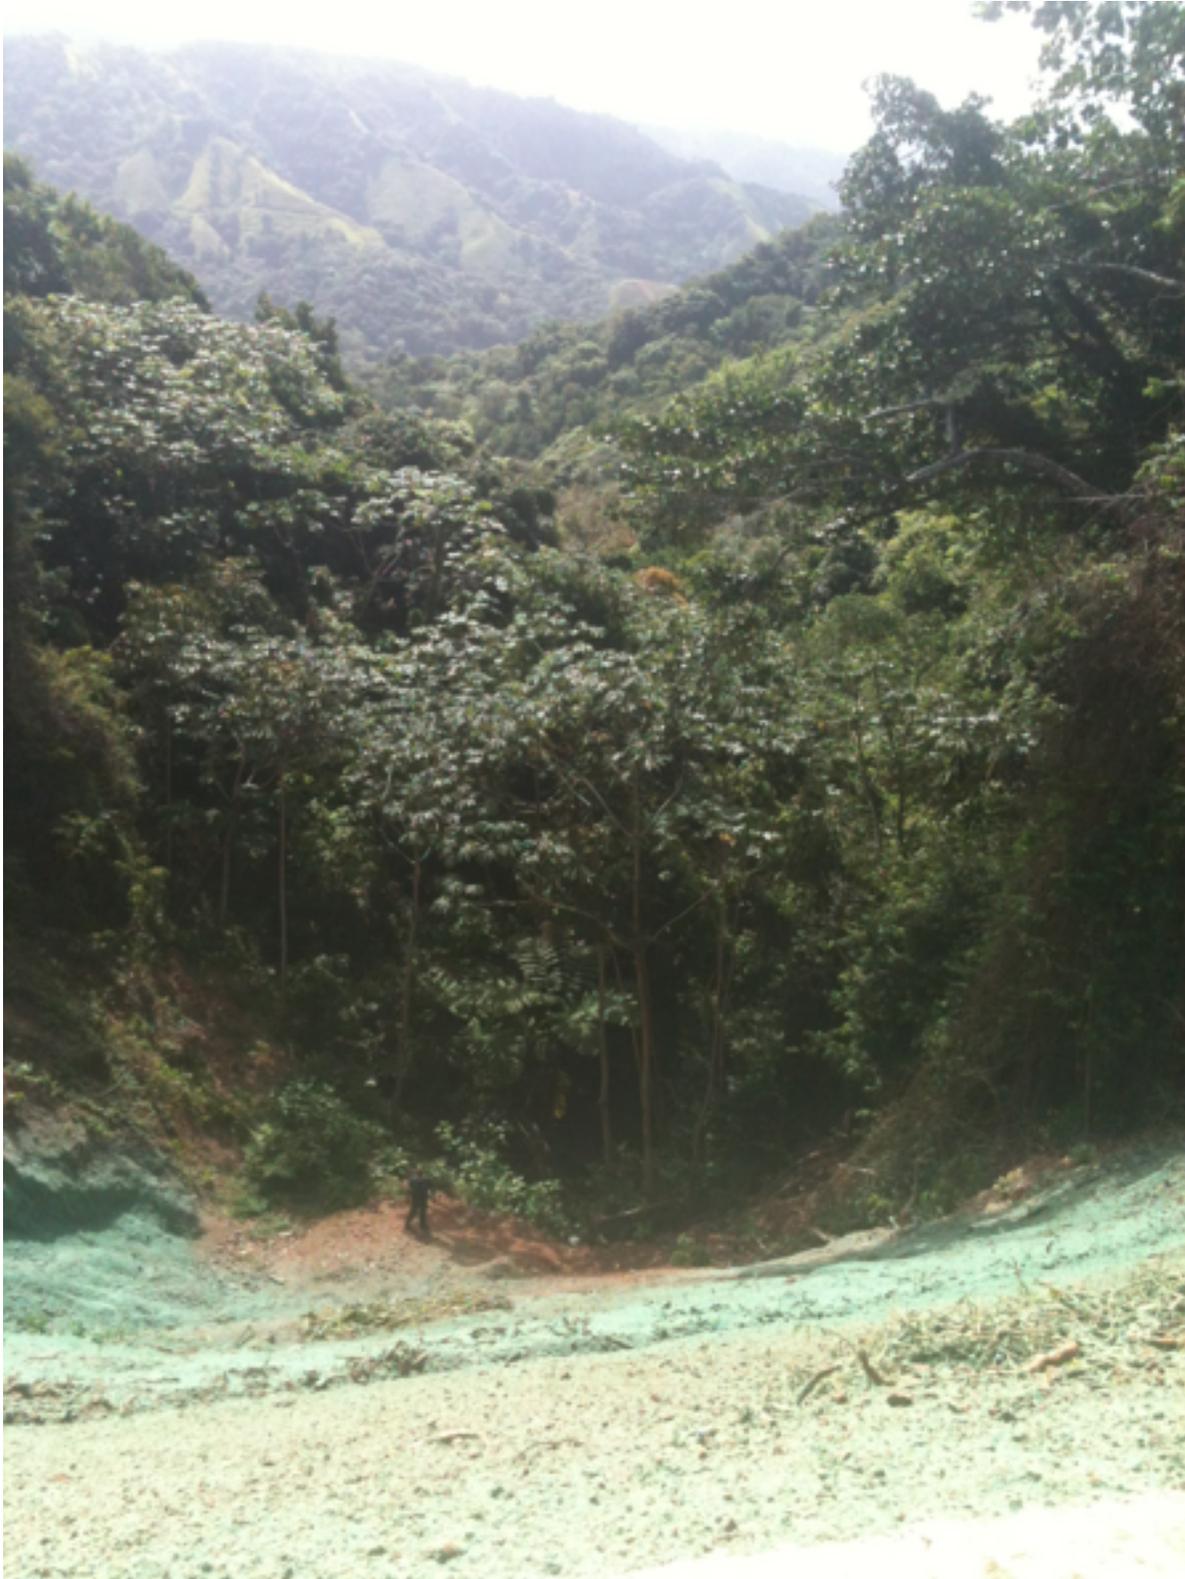
Figure 4. Hydromulching complete on the 70% slope plots

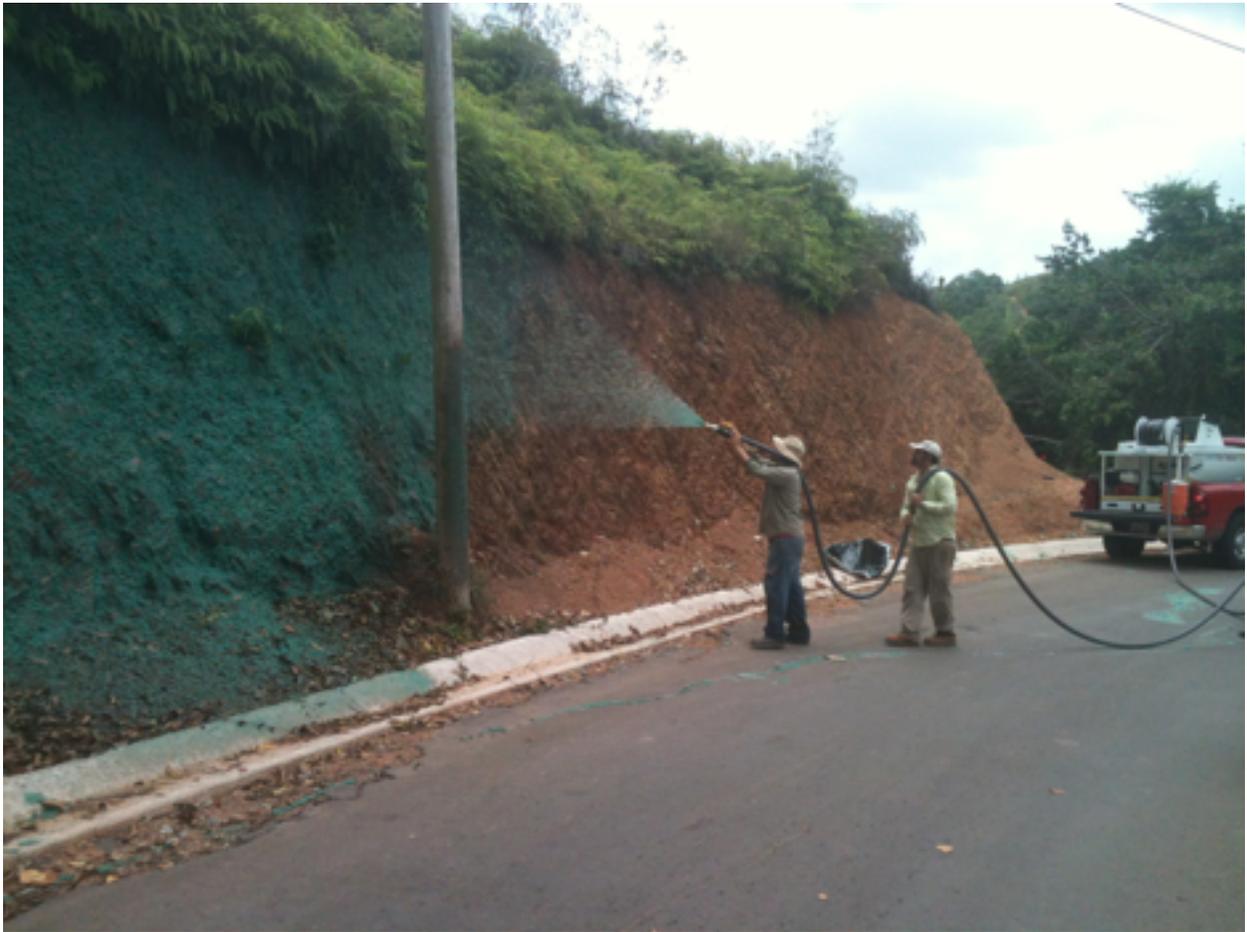
Figure 5. Applying hydromulch to the 85% slope in Plot #2

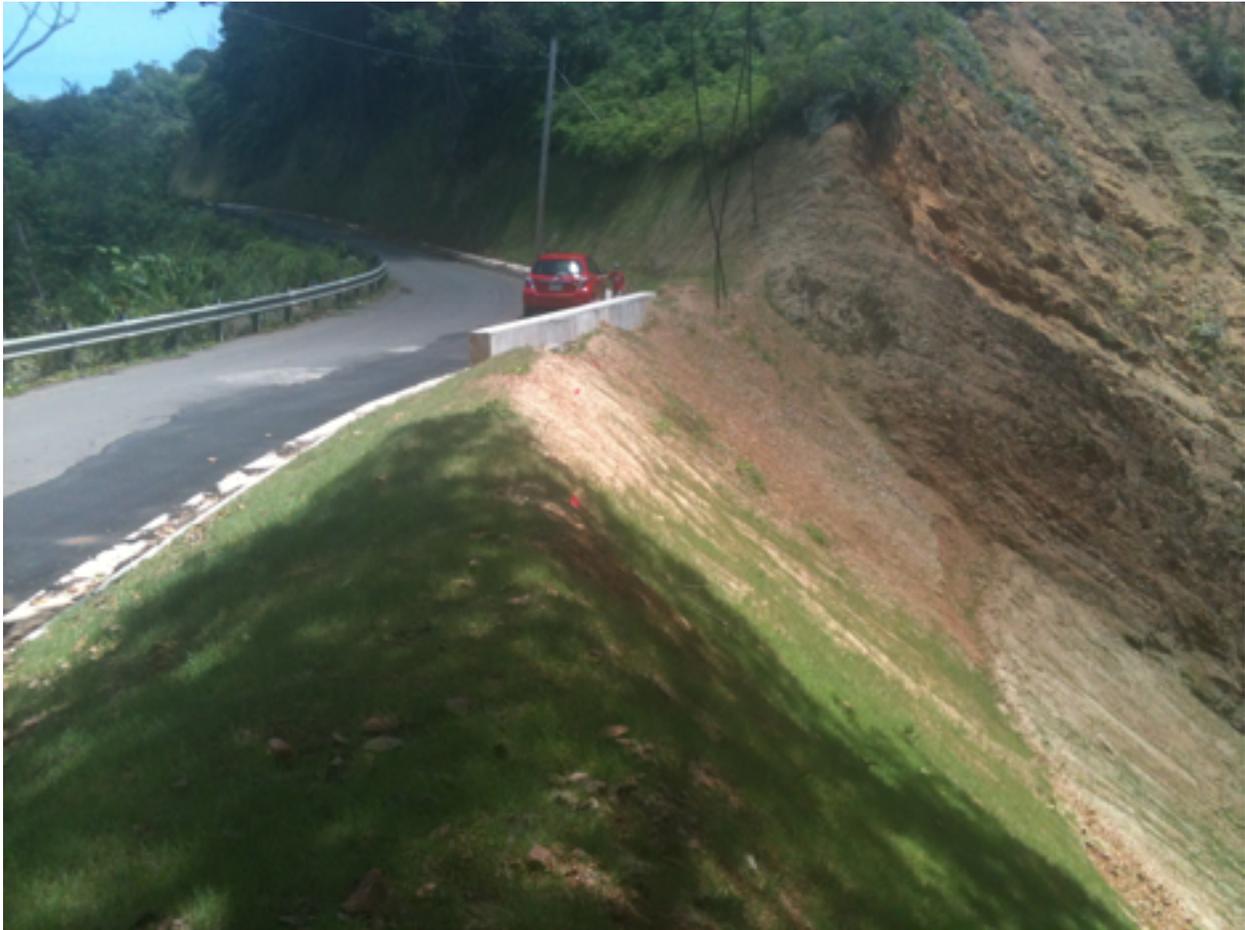
Figure 6. 7-23-12 Note Plot 3 with 50% vegetative cover and less vigorous grass growth was a thinner application of Flexterra (BFM) but also in an area with full sun and and high proportion of rock/consolidated material

- in areas dominated by rock/consolidated material hydromulching efforts had less success in establishing vegetation
- wood mulch with tackifier and PAMs worked equally well or better than more expensive BFM mixes

- applying Flexterra (BFM) at lower application rates was not as successful at stabilization plots as thicker mixtures and those using wood fiber mulch

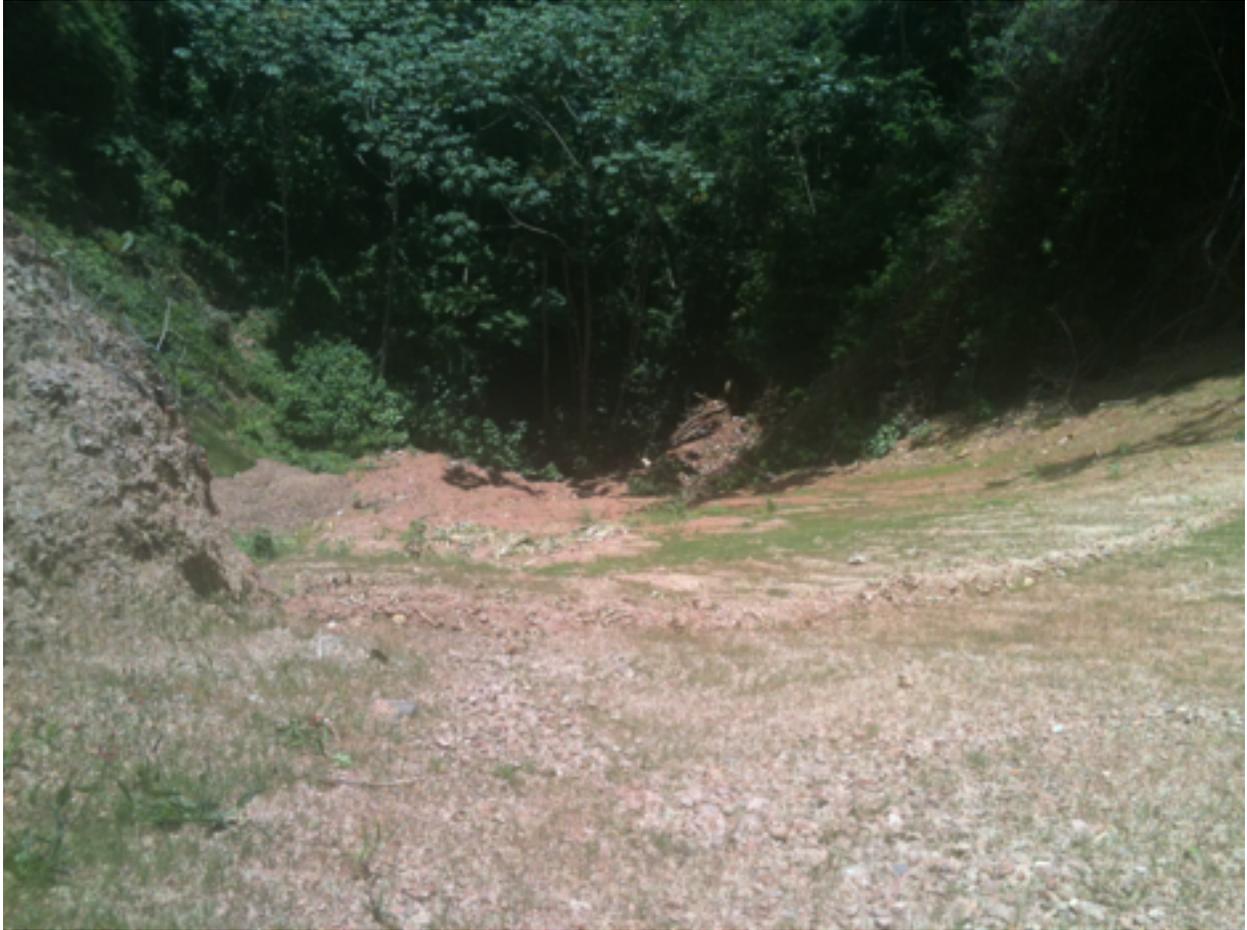
Figure 7. Closeup of Plot 3 -- Thinner application of Flexterra BFM. Note good germination but less vigorous grass growth and the presence of rock

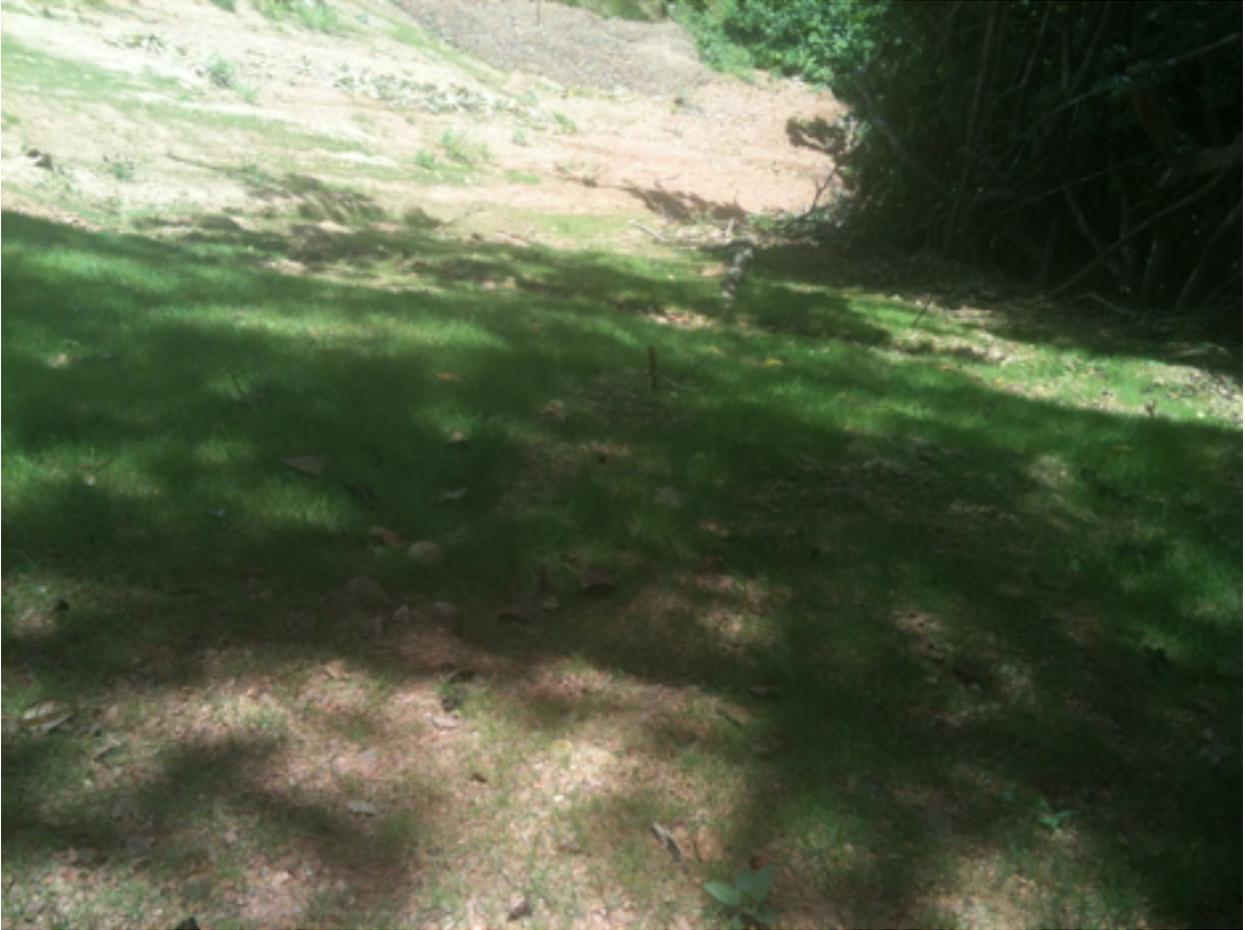
Figure 8. More vigorous plant growth in higher shade areas where Wood Fiber Mulch mixes were used

- Shade improved the overall vigor of the vegetative cover -- likely a combination of reducing the impact of the rain-drops as well as decreased heat and solar impact which can affect soil moisture

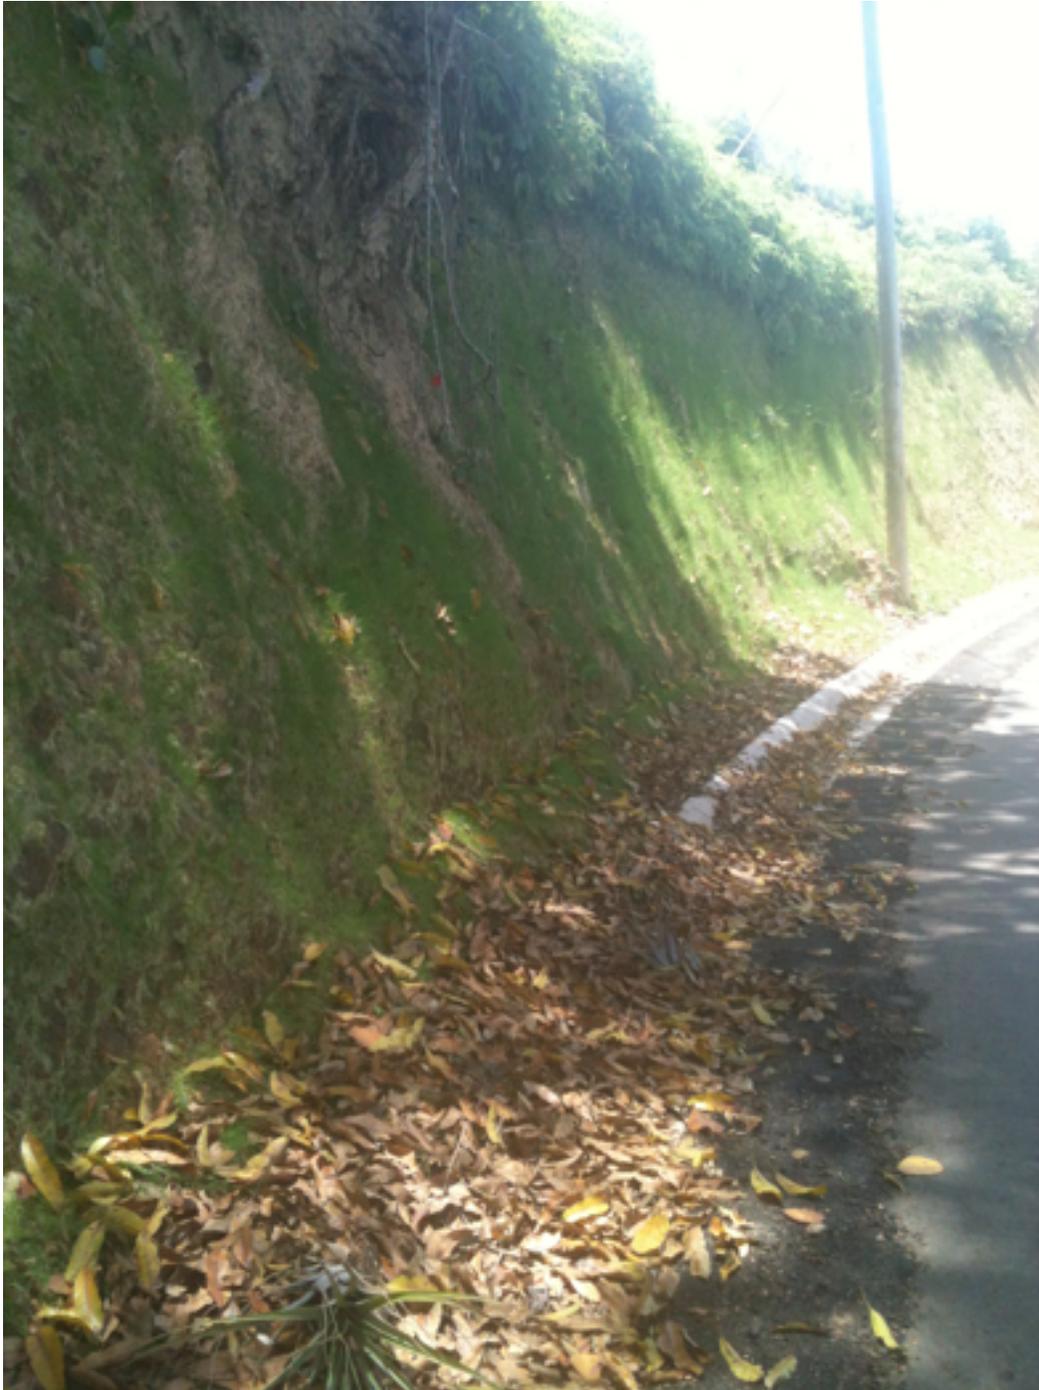
Figure 9. Grass coverage on Plot #2 using Flexterra BFM

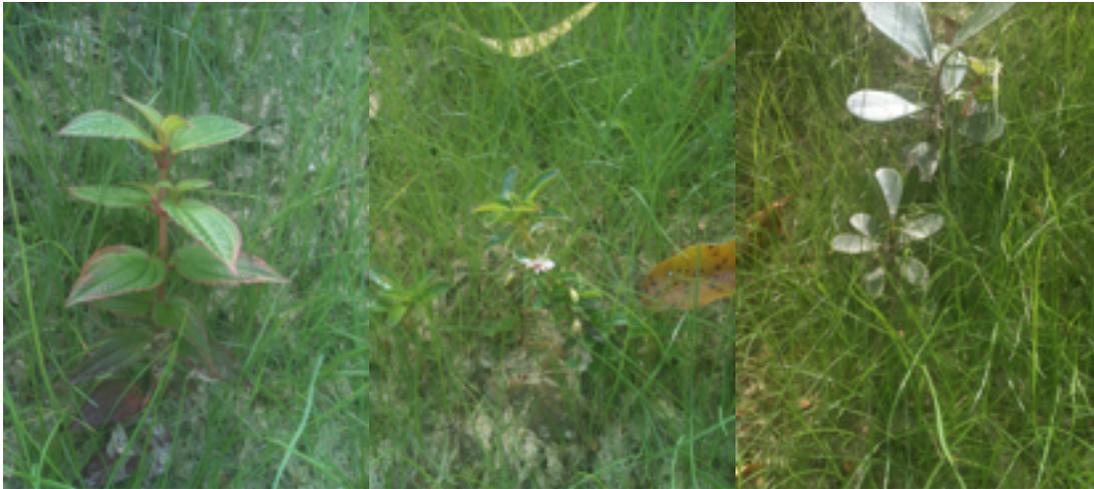
Figure 10. Volunteer species establishing themselves on the plots

- the use of a product to reduce nozzle clogging and to add additional PAMs resulted in the loss of higher amounts of mulch
- volunteer native or native adapted vegetation readily colonized the sites though efforts to incorporate fern spores have not resulted in noticeable germination after three weeks
